ARBORICULTURAL ASSESSMENT & REPORT

Wye River Fire - Tree Issues

GLENN WATERS | ARBORICULTURE

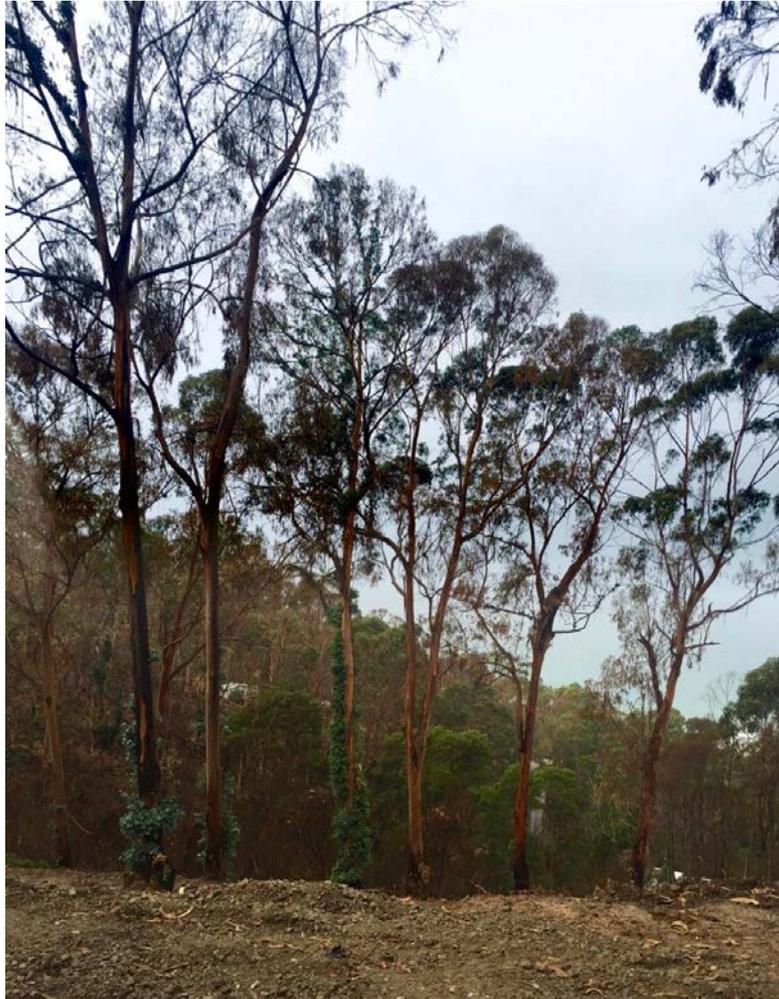
For example, the above image shows a row of trees in close proximity that have sustained a range of damage from trees at the left of view with completely dead canopies with some minor regrowth of epicormics to what appears to be a tree at the right with an almost intact canopy with little heat damage.

Each one of these trees will require a differing management action depending upon the assessed severity of damage and potential ability to be retained.

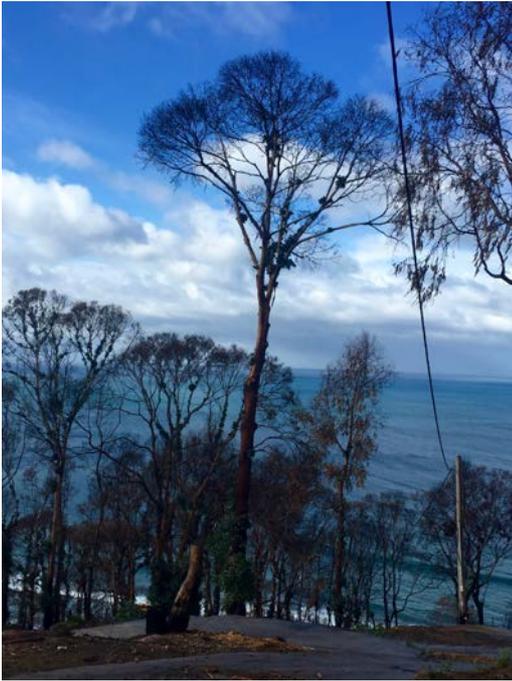
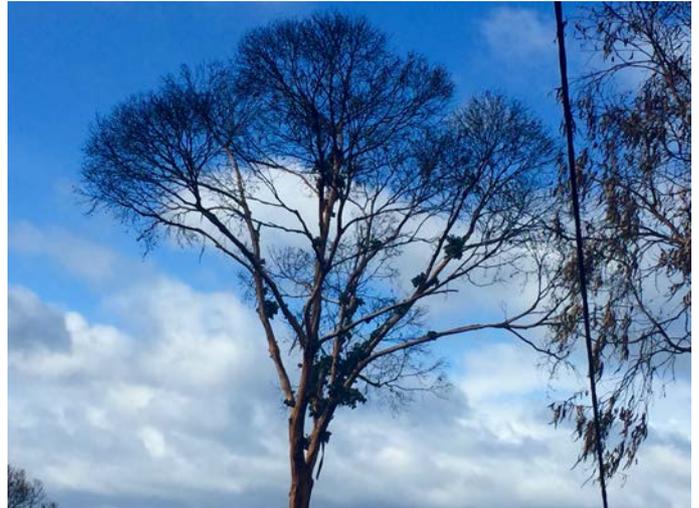
← & ↑ View of a pruned and retained tree with dead canopy still evident.

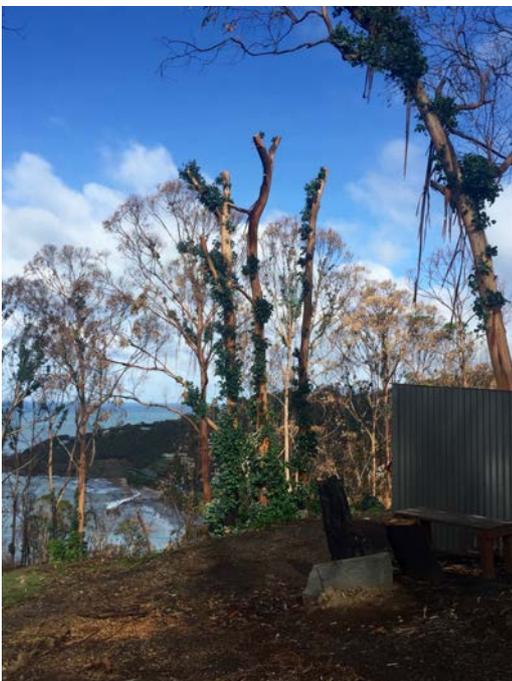
← View of typical 'habitat' pruned trees.
↓ View of a range of trees still to be assessed and pruned.

It is recommended that these trees not just be cut down to the same height all across the area but that individual trees are staggered in heights to attempt a more natural feel.
