Existing Conditions Road Safety Audit

# Kennett River Tourism Infrastructure Improvements

Reference No. 30043113E  
Prepared for Colac Otway Shire  
13 August 2021

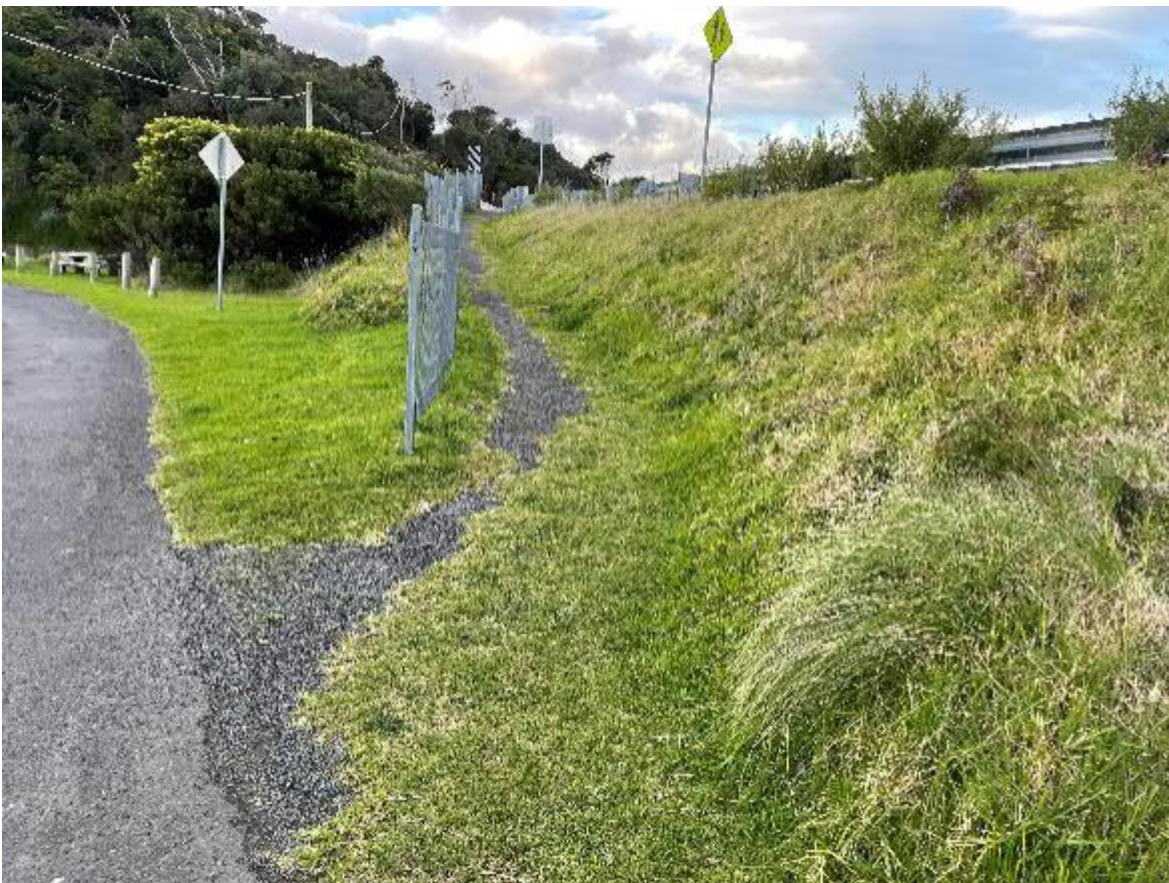
Photograph 10: Great Ocean Road service road – view to Kennett River Bridge.

8	<p><u>Kennett River Bridge Access:</u></p> <p>The access ramp from the Great Ocean Road service road to the bridge path is overground with only a narrow section of visible path remaining.</p> <p>The grades of the access ramp are outside those outlined in VicRoads Accessibility DDA Guidelines. It is noted that a stepped path is being constructed on north side of the bridge to provide a connection to the residential area off Cassidy Drive.</p> <p>Refer to Photograph 10.</p>	Noted	Ensure maintenance activities provides path surface clearing and table drain clearing

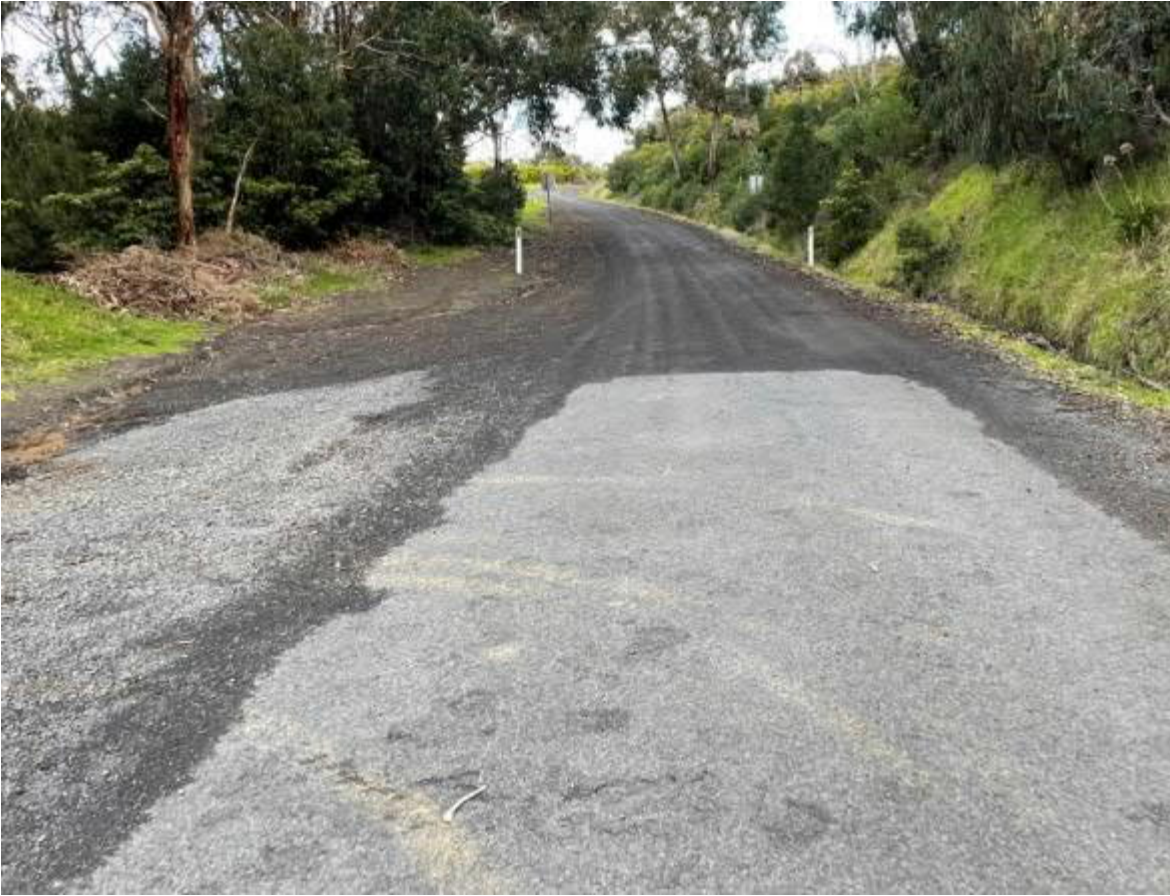
Photograph 11: Grey River Road – view to south adjacent to widening.

ITEM	AUDIT FINDING	RISK	RECOMMENDATION	ACCEPT / REJECT WITH REASON	ACTION / COMMENTS
9	<p><u>Grey River Road Widening:</u></p> <p>Grey River Road provides a narrow sealed pavement with 'no stopping' restrictions for approximately 150m south of Hawdon Avenue. A 3m pavement widening is provided for approximately 30m.</p> <p>It is assumed this widening is to act as an overflow parking area. The exit movement from this area would require a u-turn and return north to Hawdon Avenue.</p> <p>The sight distance to the south is impacted by the horizontal and vertical geometry resulting in sight distance of approximately 120m.</p> <p>Vehicles approaching from the south are within a rural default speed limit zone and are only required to slow to 50km/h approximately 40m prior to the widening.</p> <p>Refer to Photograph 11.</p>	<p><i>Likelihood – Improbable</i></p> <p><i>Severity – Serious</i></p> <p>Medium</p>	<p>Consider re-positioning the 50km/h signage further to the south to ensure approaching traffic has sufficient time to slow prior to the widening.</p>

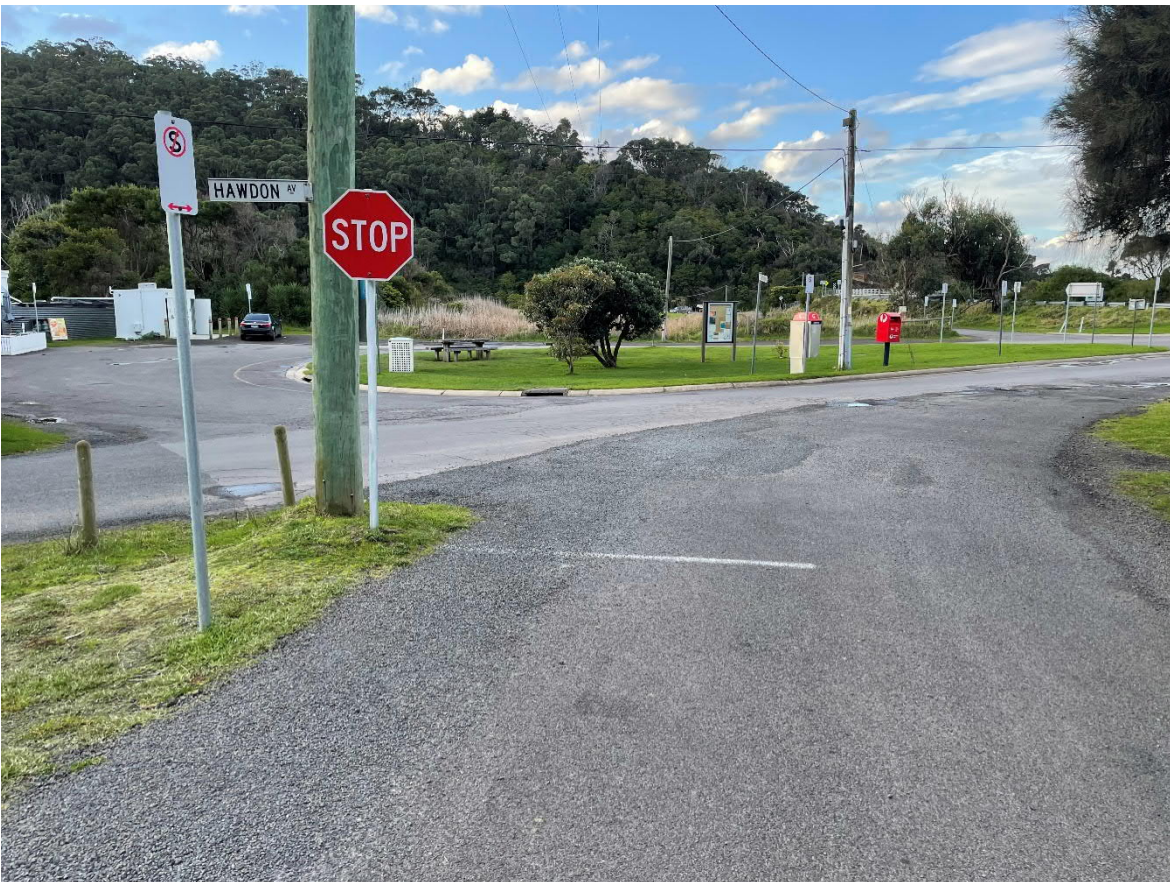
Photograph 11: Grey River Road – view north Hawdon Avenue intersection.

12	<p><u>Intersection Alignment:</u></p> <p>The intersection of Grey River Road/Hawdon Avenue forms a 'Y' shape. The layout leads to potential high angle impacts and provides poor sight lines / observation angles to the north.</p> <p>The intersection geometry results in manoeuvring issues for vehicles performing west to/from south movements.</p>	<p><i>Likelihood</i> – Improbable</p> <p><i>Severity</i> – Serious</p> <p>Medium</p>	<p>Review intersection layout to improve deficiencies. Consider realigning to provide a T-intersection.</p>
