Wye River / Separation Creek

Post-bushfire building survey findings

Report EP16924

Report to the Victorian Country Fire Authority

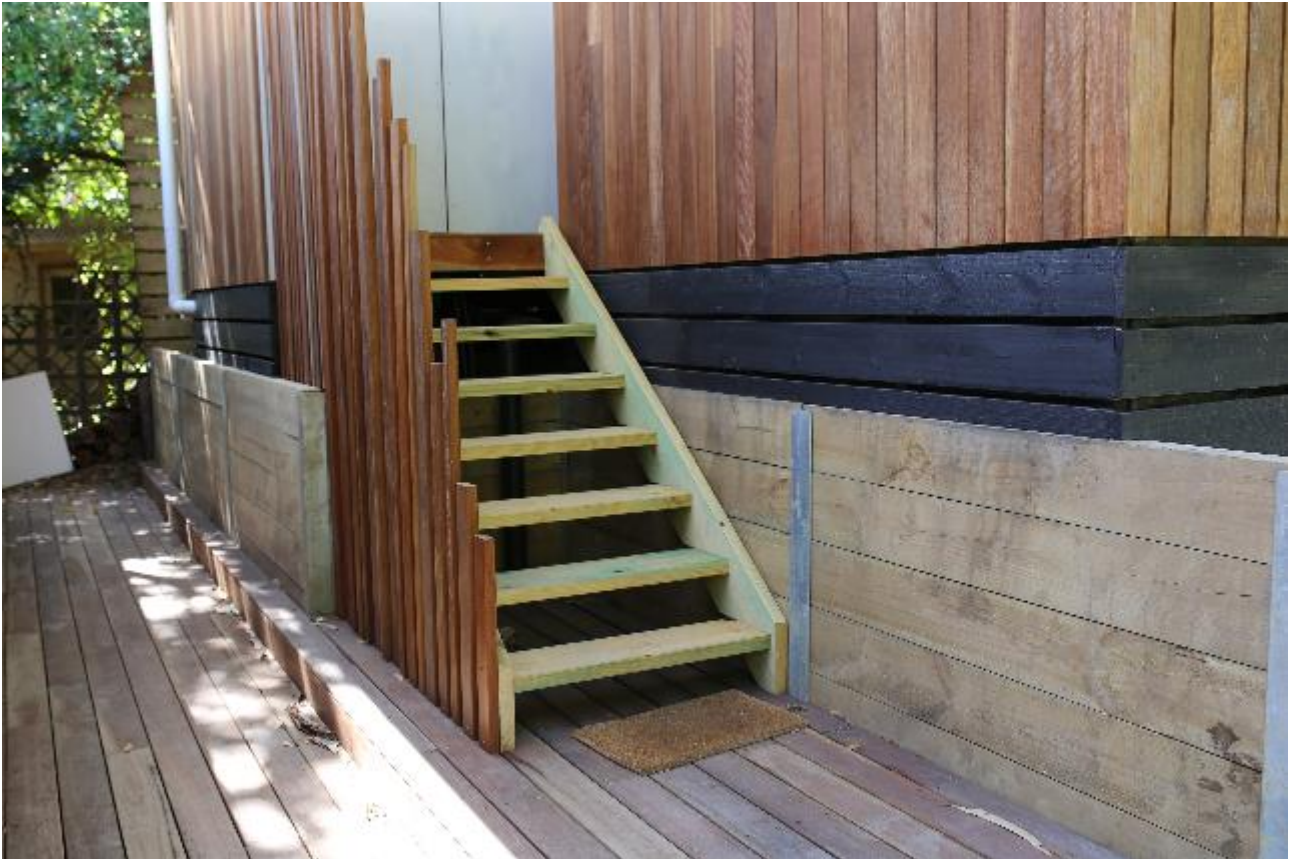
Land stabilisation includes extensive use of retaining walls throughout the fire-affected areas. Some walls are built using non-combustible materials such as concrete. However, the vast majority of walls are constructed of combustible materials such as timber (Figure 4).

Figure 4: Example of land stabilisation using timber sleepers in proximity to other combustible features within Wye River.

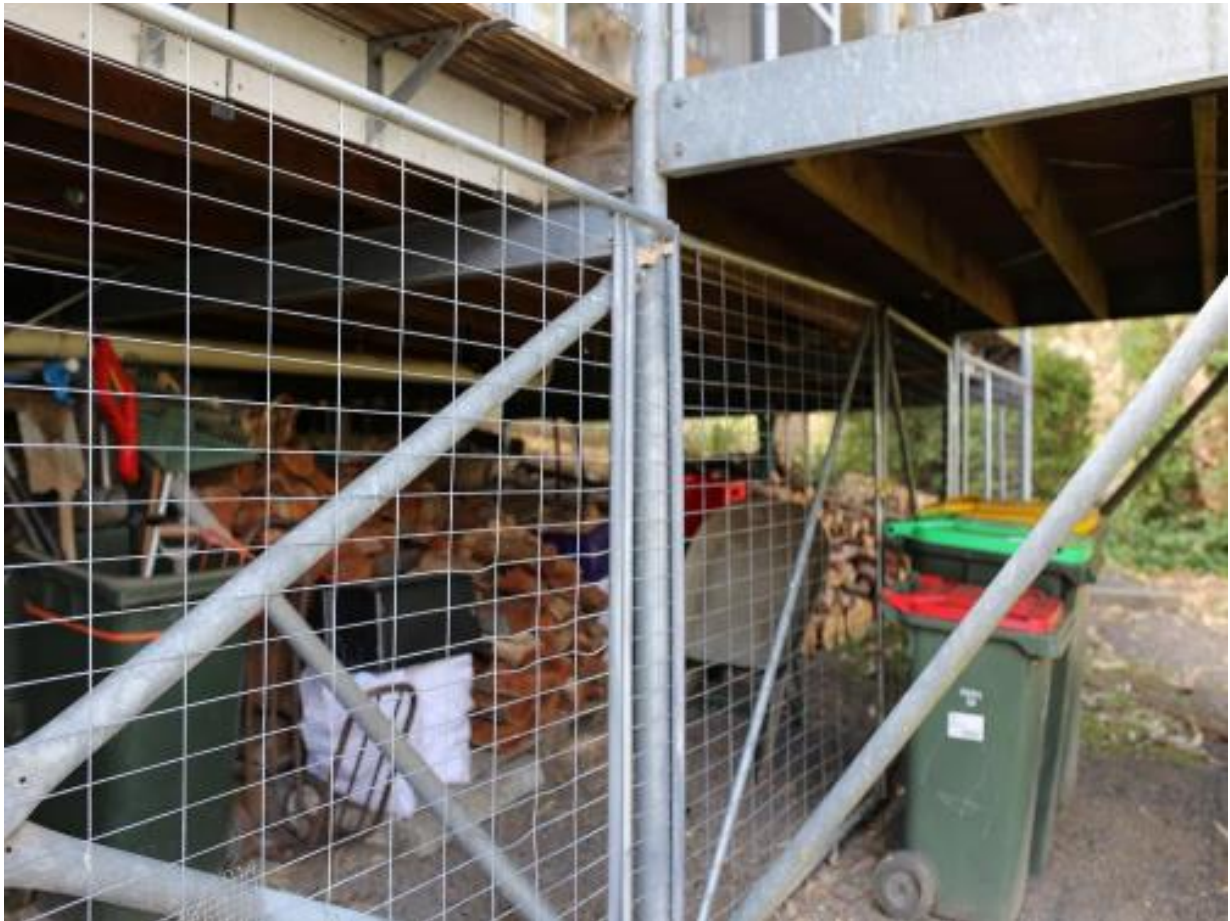
Given the steep slopes, a large proportion of the houses (including those built to recent regulatory standards) within the fire-impacted area project out from ground level with exposed subfloors. This creates the opportunity for storage of heavy fuels such as plastic water tanks, building materials, small garden sheds, boats and kayaks (Figure 8). Sheds underneath houses are common because of the steep slopes. This is of particular interest because current building and planning requirements do not respond to the presence of these fuel types.

Figure 8: A house on Wallace Street, Wye River which was not impacted by fire showing under house fuel loading.

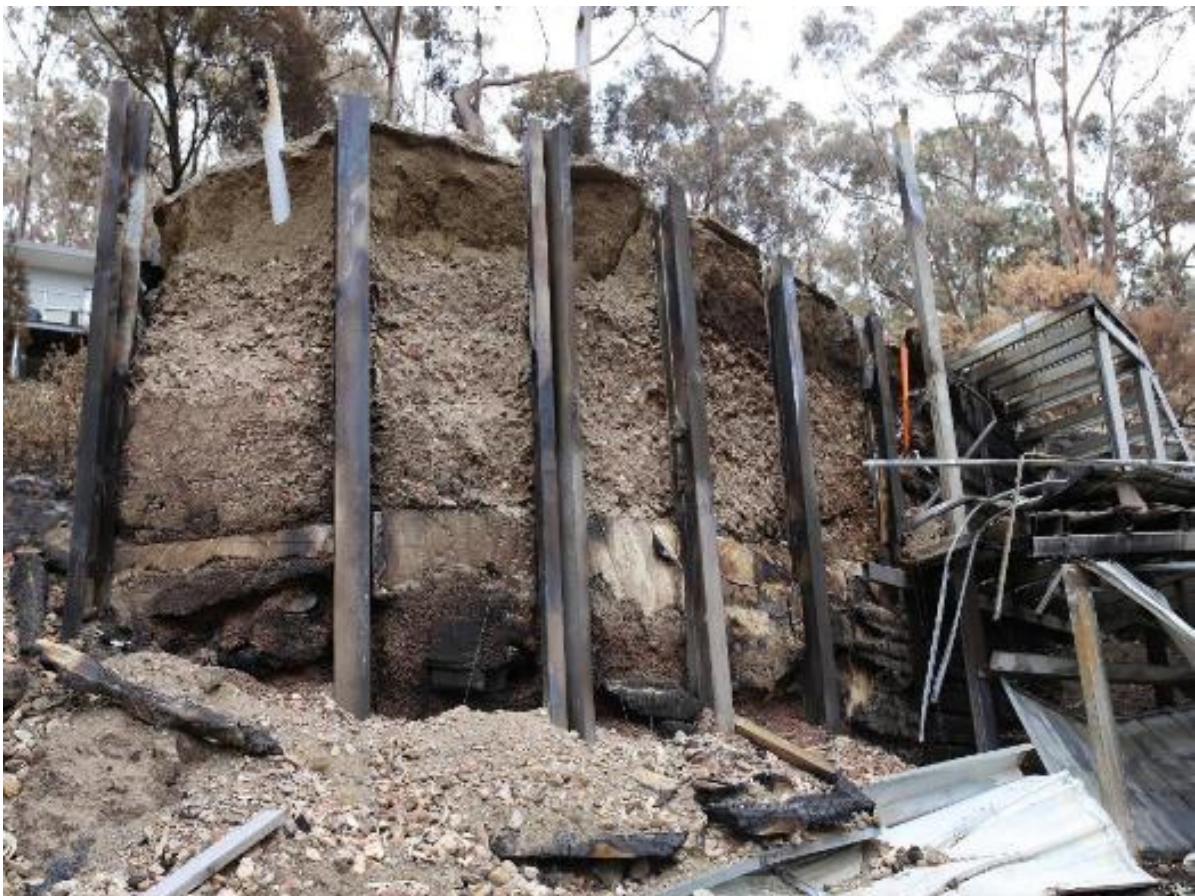
Many examples of destroyed timber retaining walls surrounded impacted houses (Figure 30). Combustible materials were an obvious factor in their low survival rate, as were the low soil moisture levels described in Section 2. It is likely that combustible retaining wall elements in contact with soils were also low in moisture content at the time of fire arrival, leading to a higher likelihood of ignition, more severe combustion and more extensive timber burn out.

Where timber (in particular treated pine) retaining walls were in contact with or within a few metres of a building, their combustion is likely to have contributed to house loss. Figure 30 provides an example of a large timber retaining wall that was burnt out.

Figure 30: Driveway off Karingal Drive, Wye River. An example of burnt out timber retaining wall sleepers.

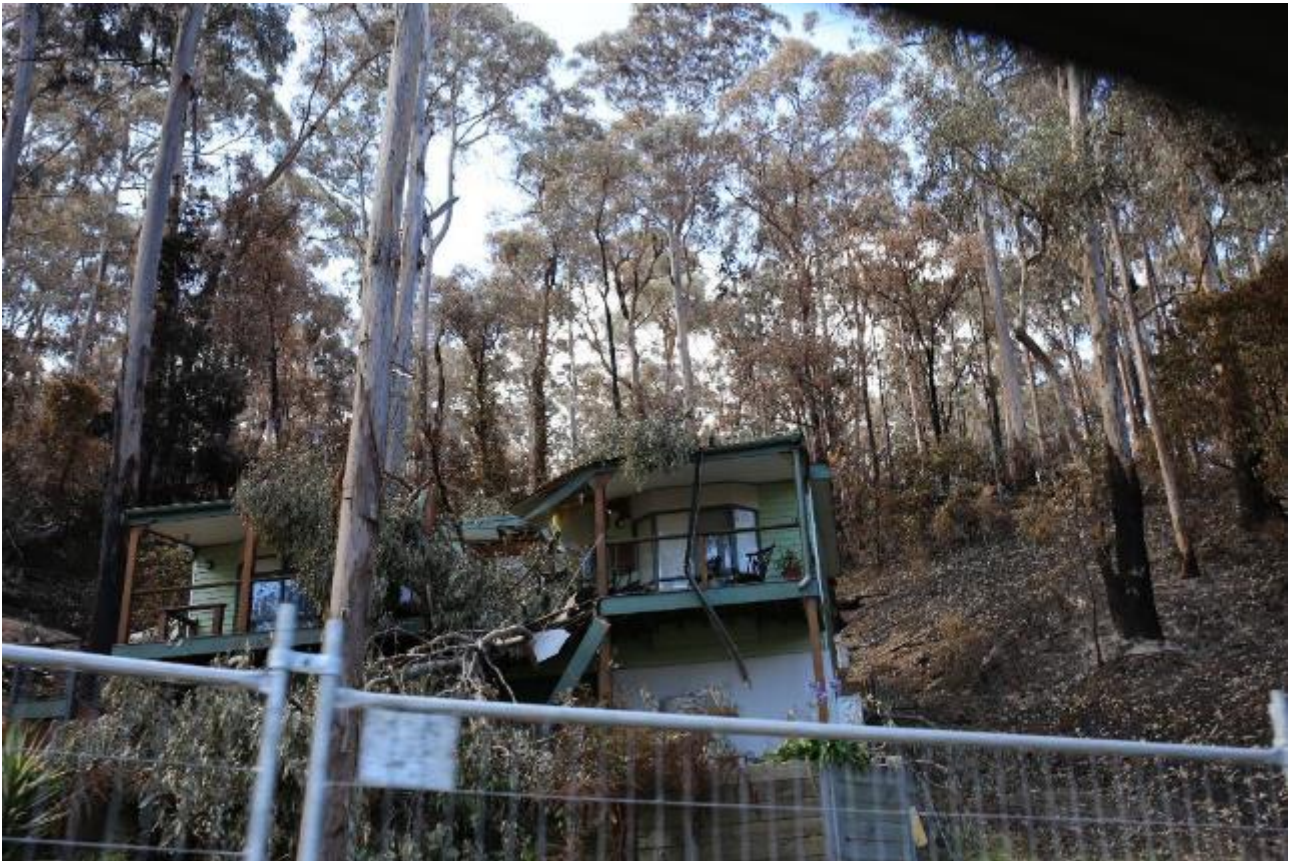
The interaction of fire with established tall trees also increased the risk of tree and branch strike because fire weakens knots and flaws in trees. Branch or tree strike, either on buildings or across roadways, is a common risk during and after bushfire arrival. While there was no direct evidence of tree strike onto houses subject to recent regulatory standards, evidence of direct tree strike either during or in the days following the fire event were apparent with some houses (Figure 31).

Figure 31: A house on Wallace St Wye River, subject to tree strike cause by fire interaction at the base of a tree.

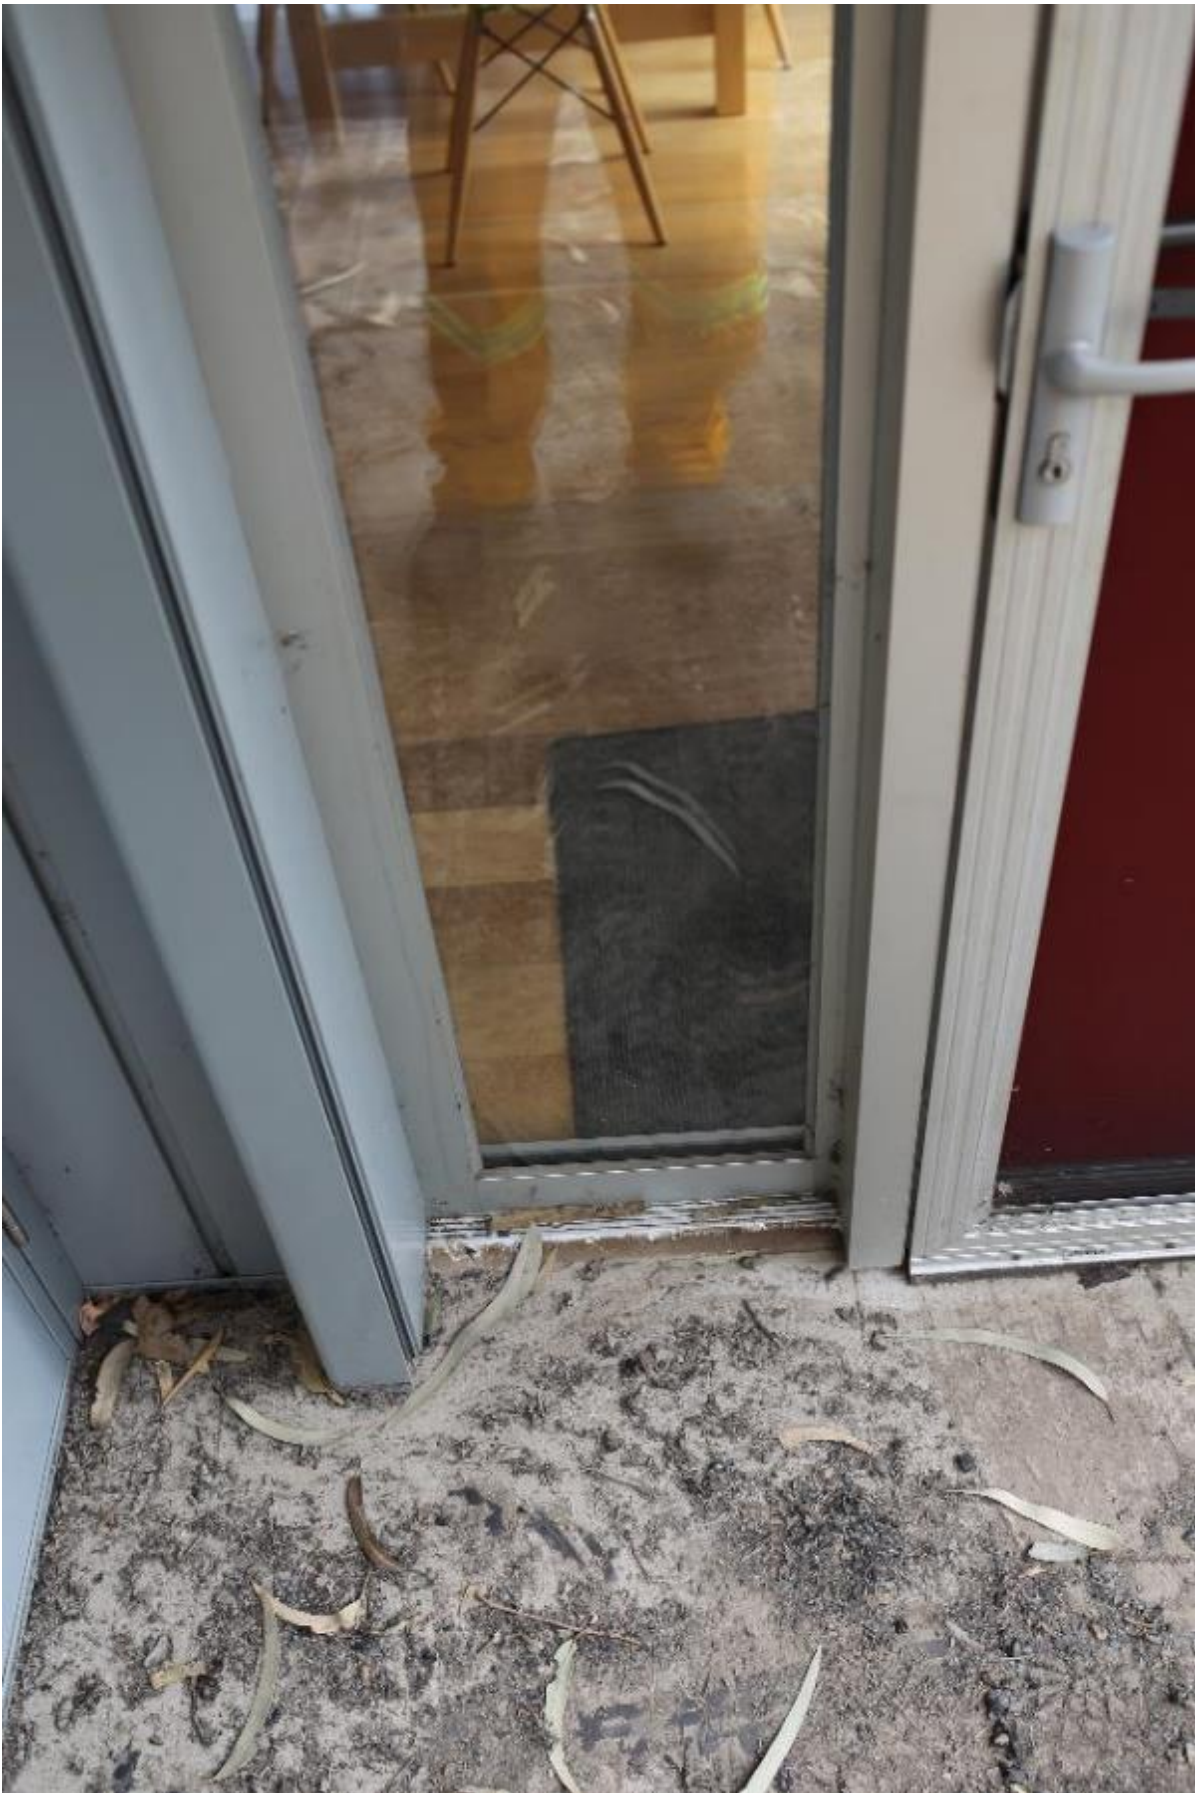
There was also evidence of extensive aerial water bombing activity throughout the affected areas. Indications included water wash marks (Figure 33 and Figure 34) on the landscape surrounding the houses and limited examples of house gutter deflection and other minor roof damage due to a sudden deluge of water.

Figure 33: Silt washed onto decking from an adjacent water drop

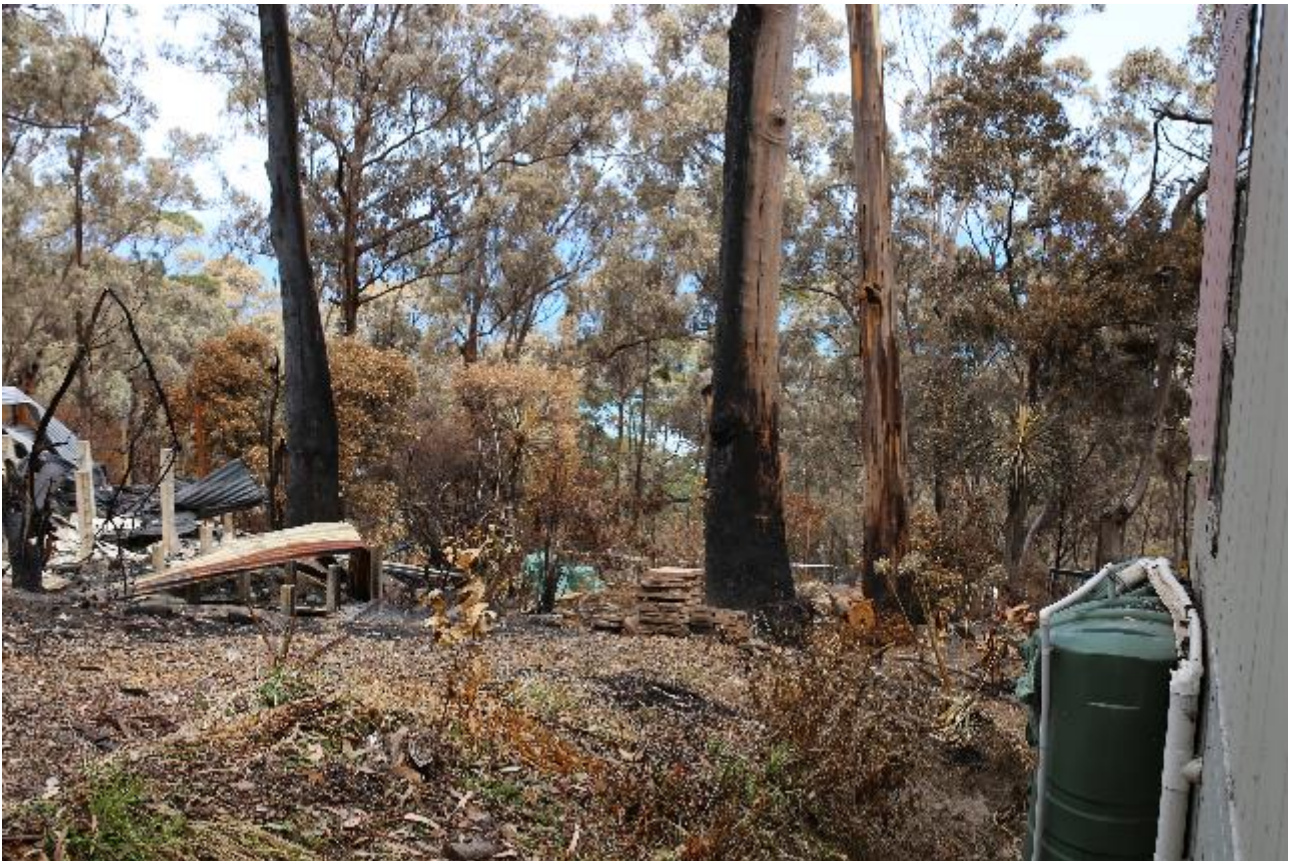
Figure 34: Vegetation between houses showing signs of water impact from water bombing

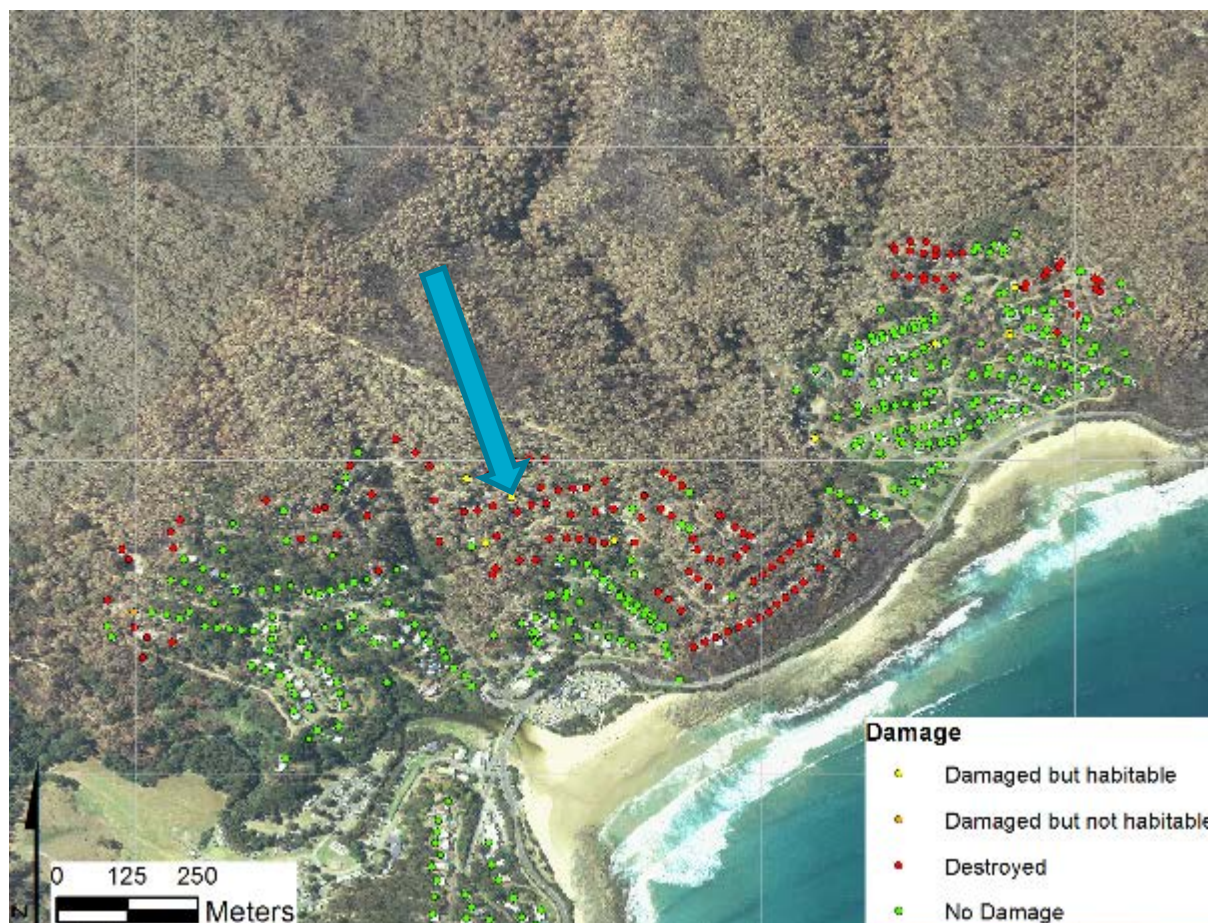
Figure 35: House on Karingal Drive, Wye River.

This house on Karingal Drive was completed in February 2013 to BAL-40 construction requirements. It survived with damage to its decking and decking support structure. The main threat to the house and decking was from the combustion of treated pine retaining walls adjacent to and below the structure and deck. The house’s steel support structure and non-combustible subfloor, cladding, window frames and doors were effective in resisting ignition in combination with aerial suppression activities.

Even though the fire arrival context was far below the worst-case exposure scenario assumed for BAL-40 construction, the fuel elements adjacent to the building may have been sufficient to cause building loss if aerial suppression did not occur.

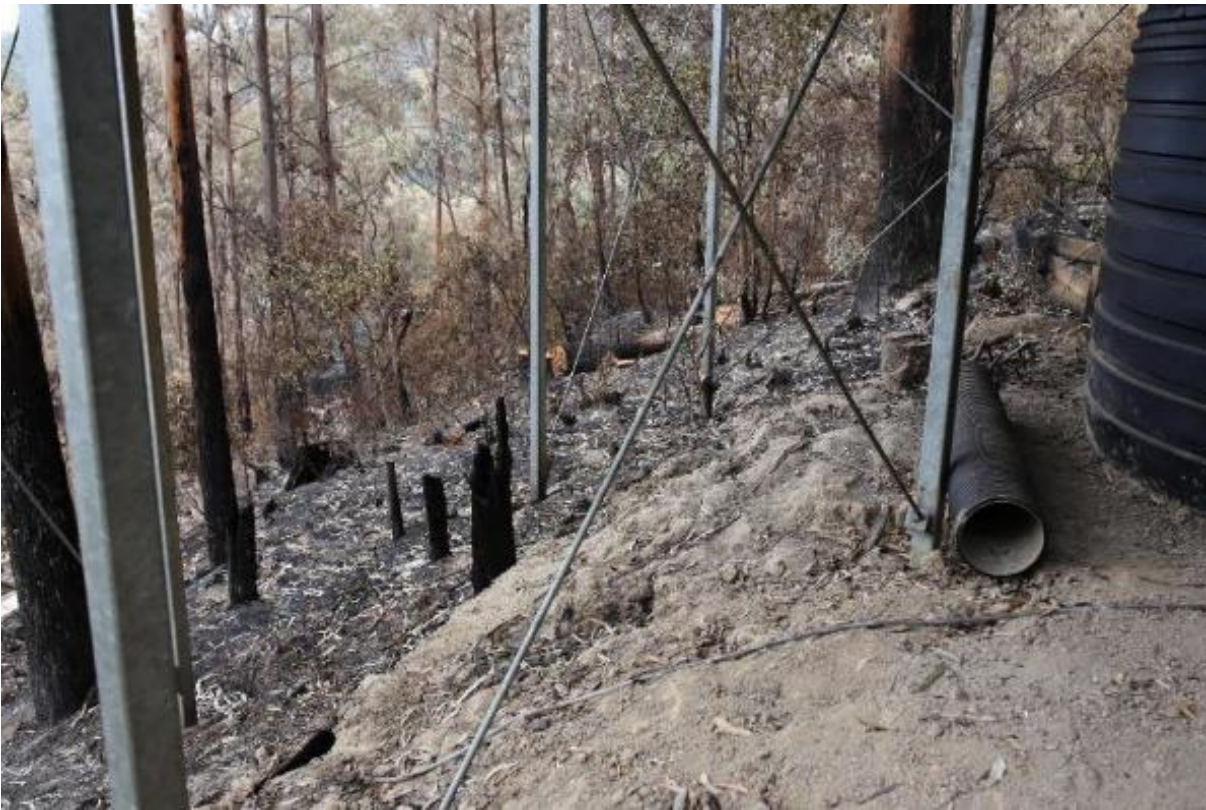
This house was exposed to a low-level surface fire, which followed the slope moving up to and past the building (Figure 37). This location was impacted between 15:30 and 16:45 by a fine fuel burn through.

Figure 37: Fire arrival upslope, involving some dead tree stumps.

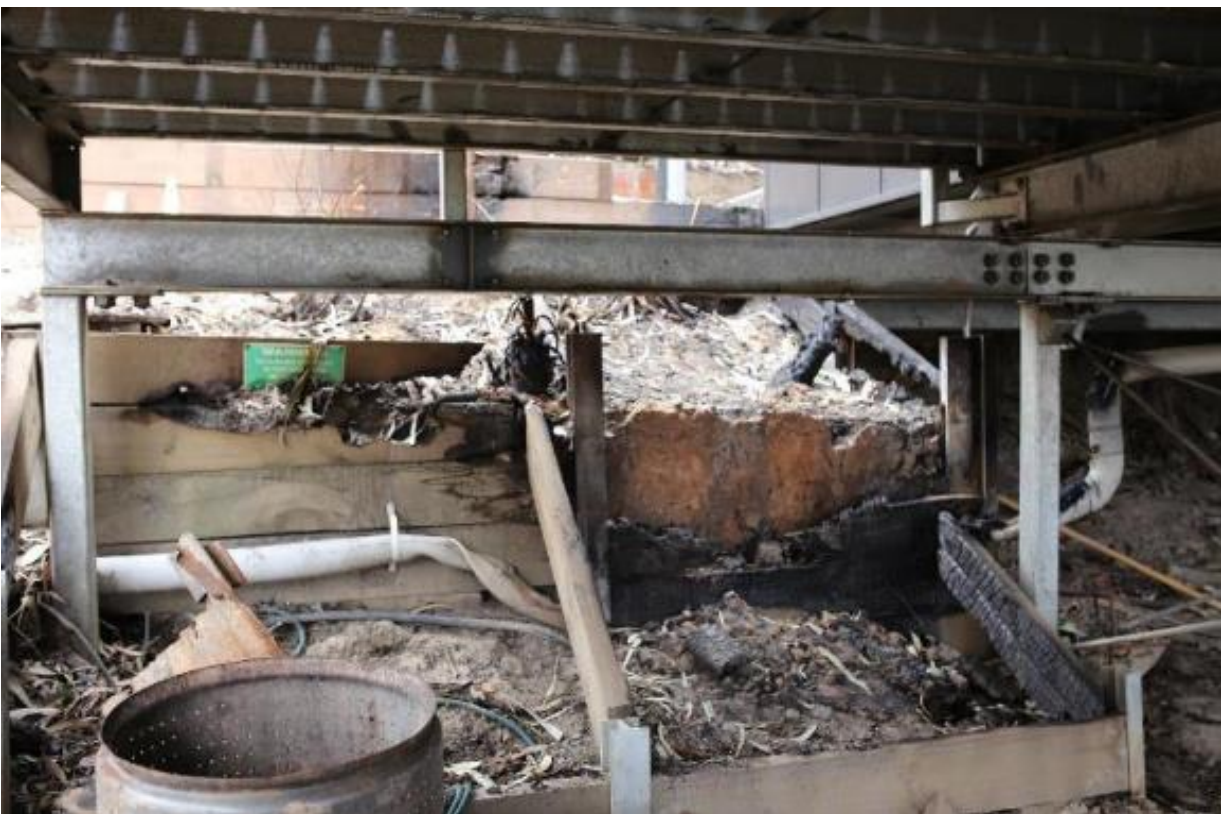
Figure 38: Retaining wall combustion below the deck.

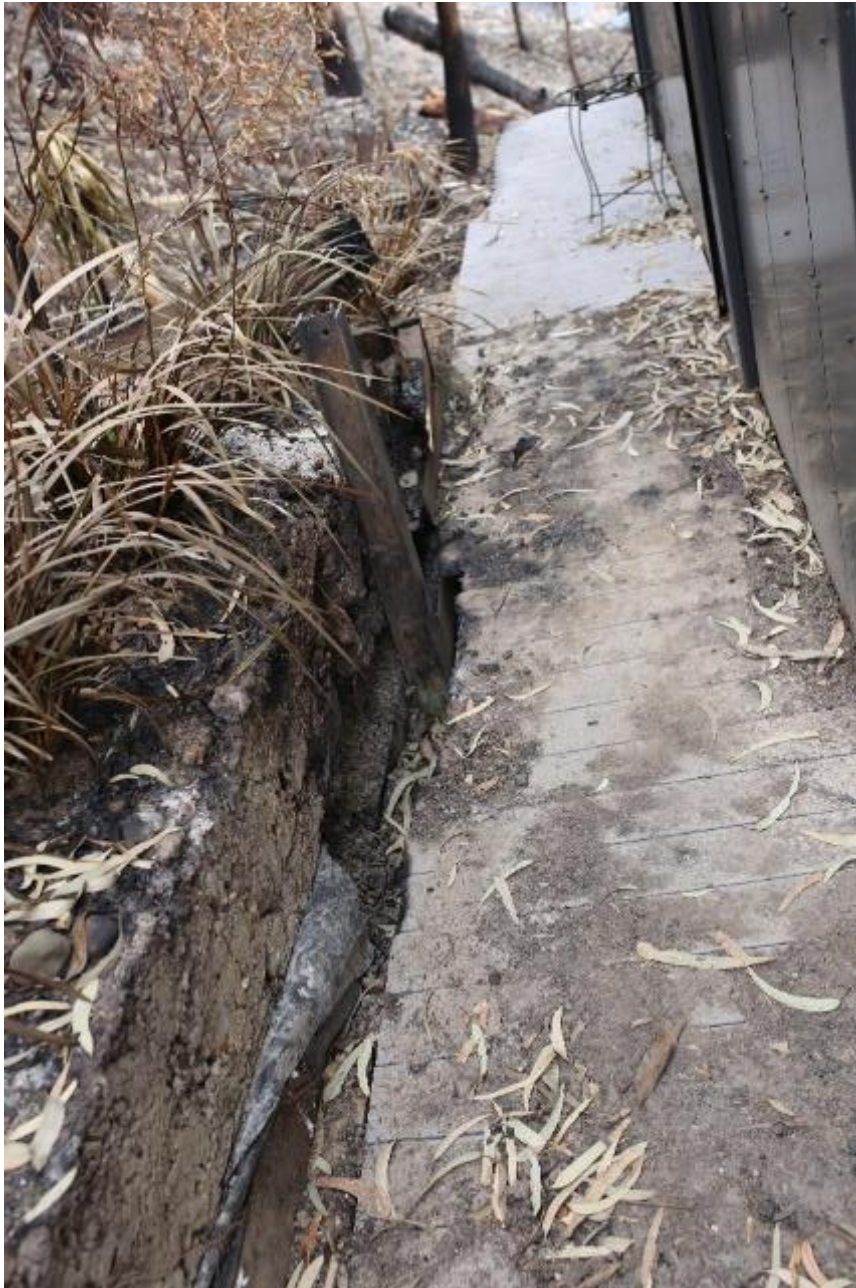
During active burning of these retaining walls, aerial water bombing drops washed down over the retaining walls and under the building. This water bombing appeared to be effective at suppressing the burning of the retaining walls and limiting the duration and intensity of flame exposure on the buildings and attached deck (Figure 39).

Figure 39: Deck-retaining wall interaction with evidence of water wash from aerial suppression.

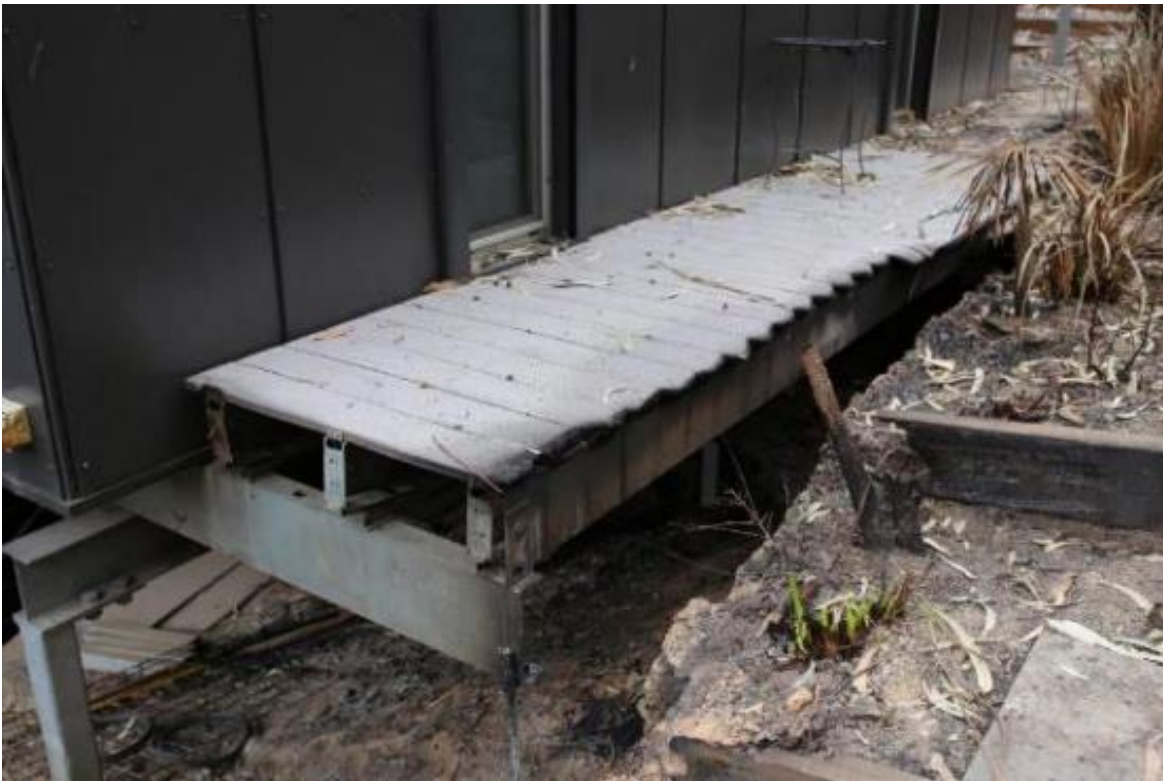
Figure 40: Impacted decking and support structure.

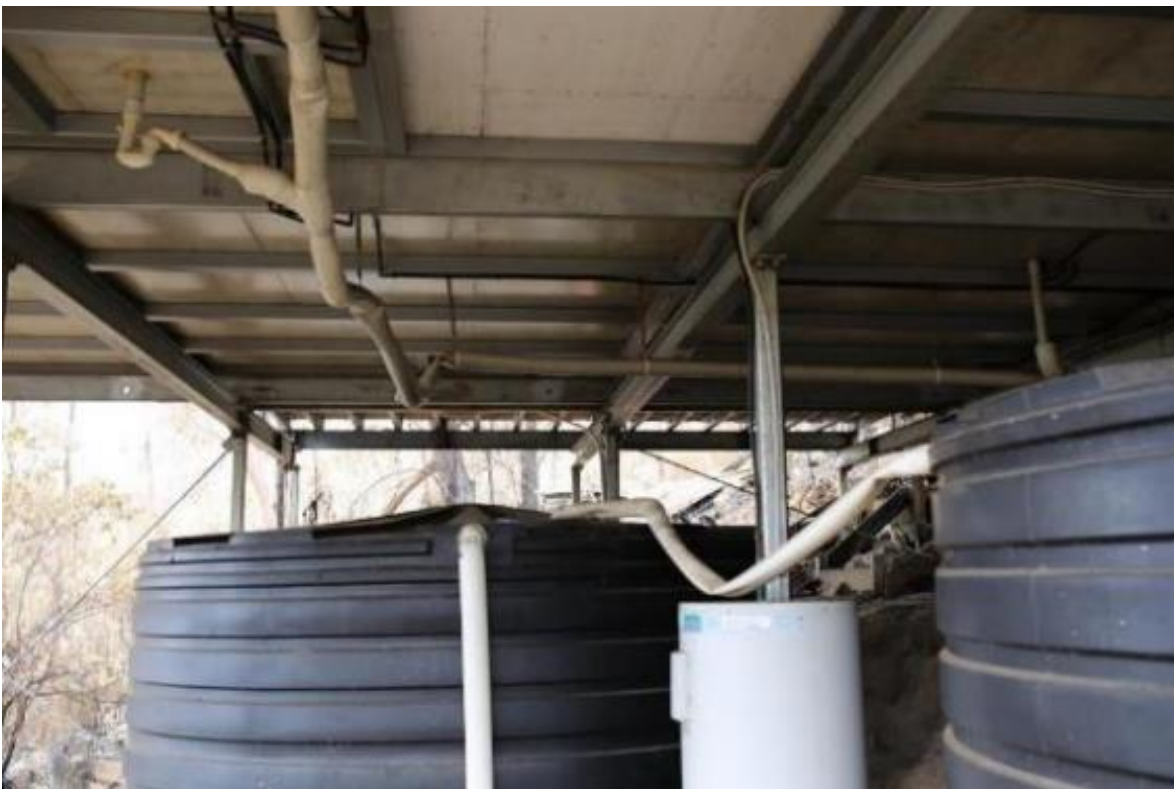
Other than the retaining walls, the only other significant combustible materials found under the house were two full polyethylene water tanks (Figure 41). While the PVC piping that was not full of water suffering some deformation, the polyethylene tanks were not sufficiently close to other stored materials or the combustible retaining wall to receive direct flame contact.

Figure 41: Water tanks and piping in subfloor area.

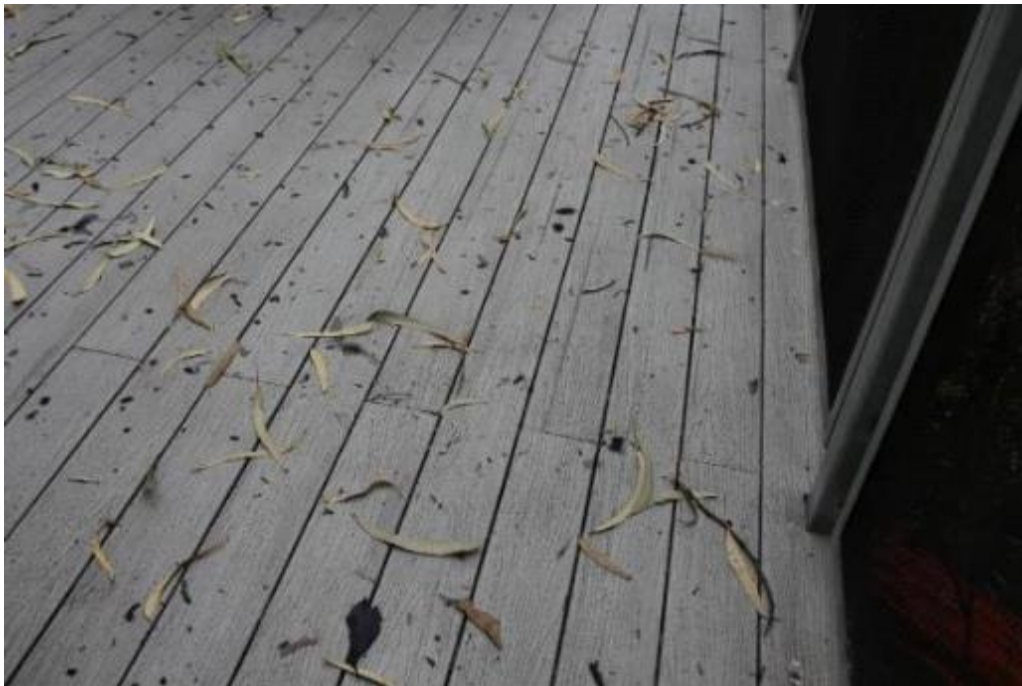
Figure 42: Ember scorch marks on plastic-wood composite decking.

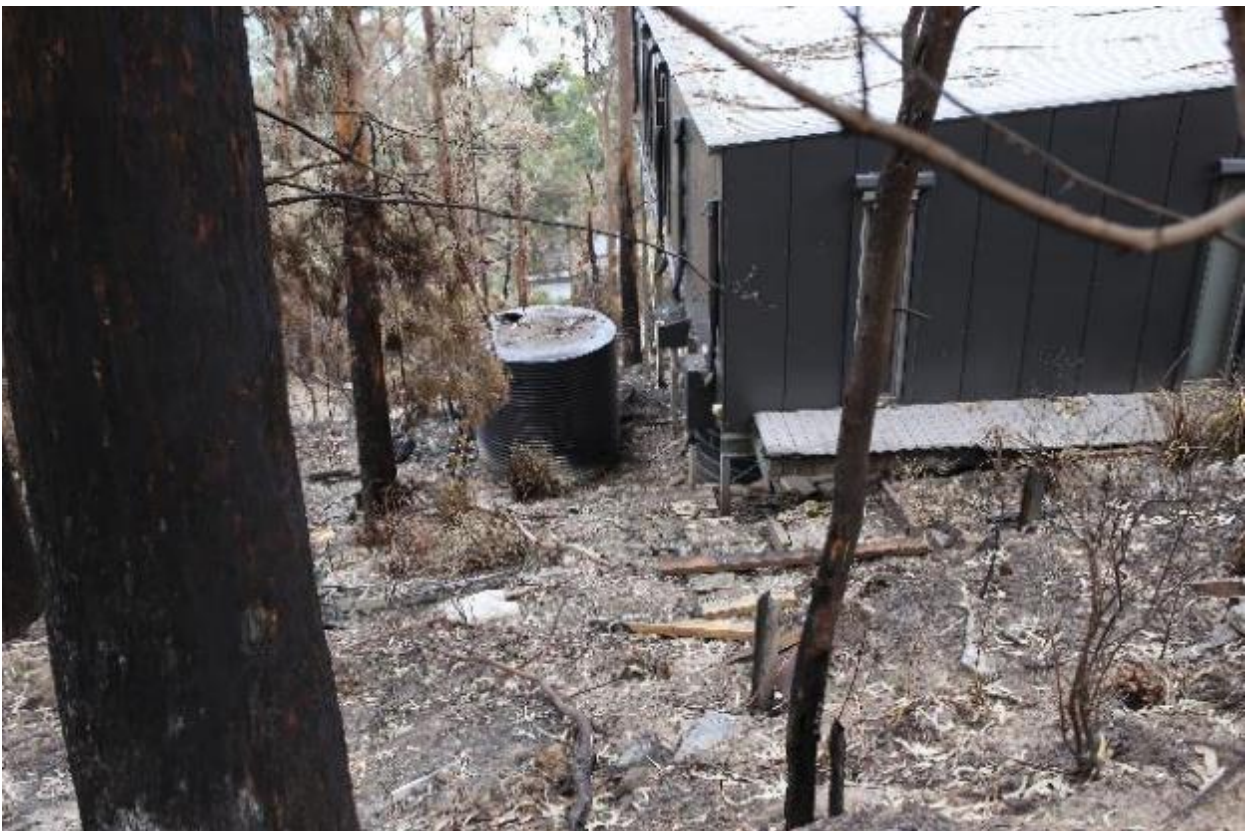
Figure 45: Side exposure on East facing wall

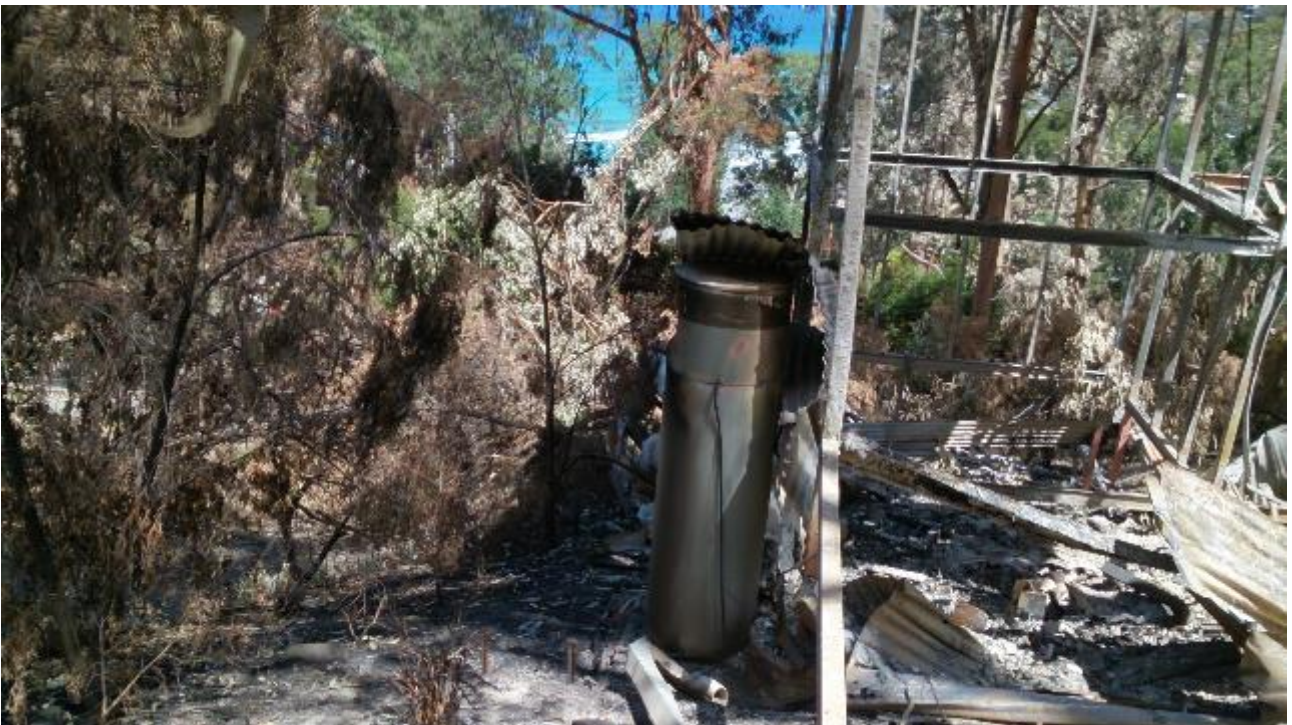
Figure 49: House on Durimbil Avenue showing adjacent vegetation scorch.

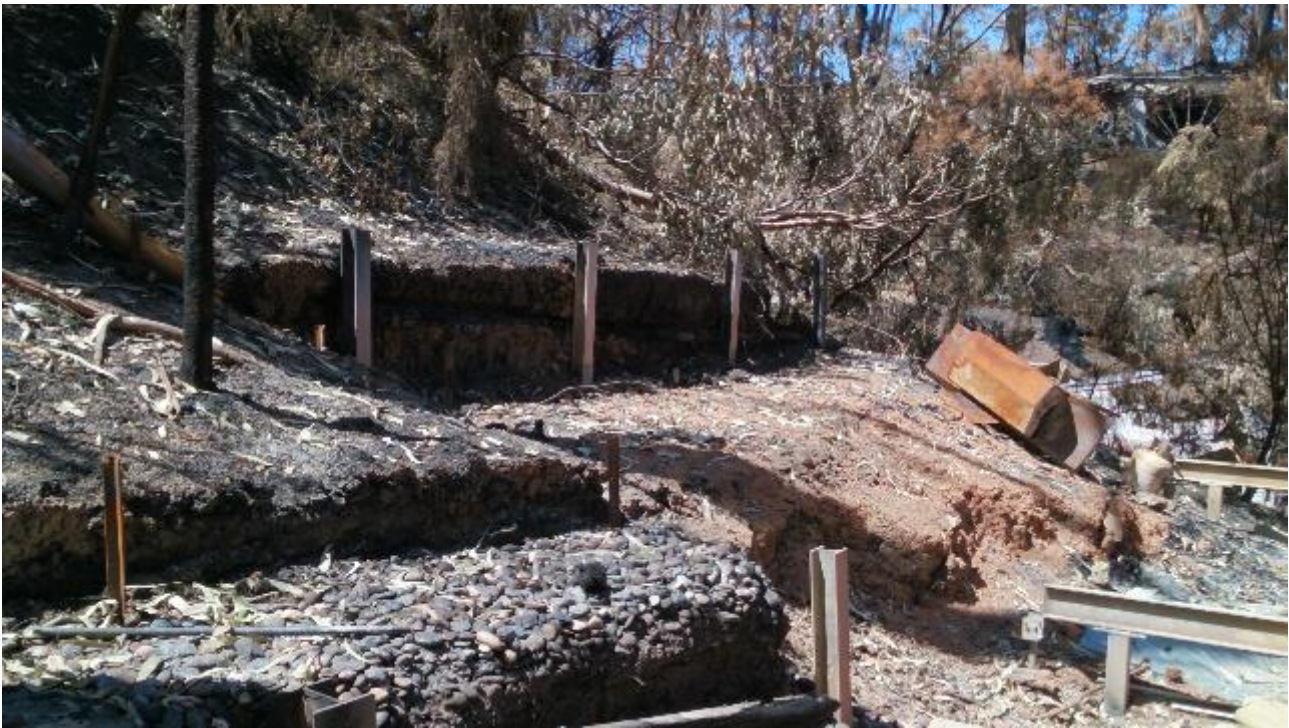
This fine fuel burn through appears to have ignited treated pine retaining walls and timber decking elements adjacent to the house (Figure 50).

Figure 50: Burnt retaining walls adjacent to house.

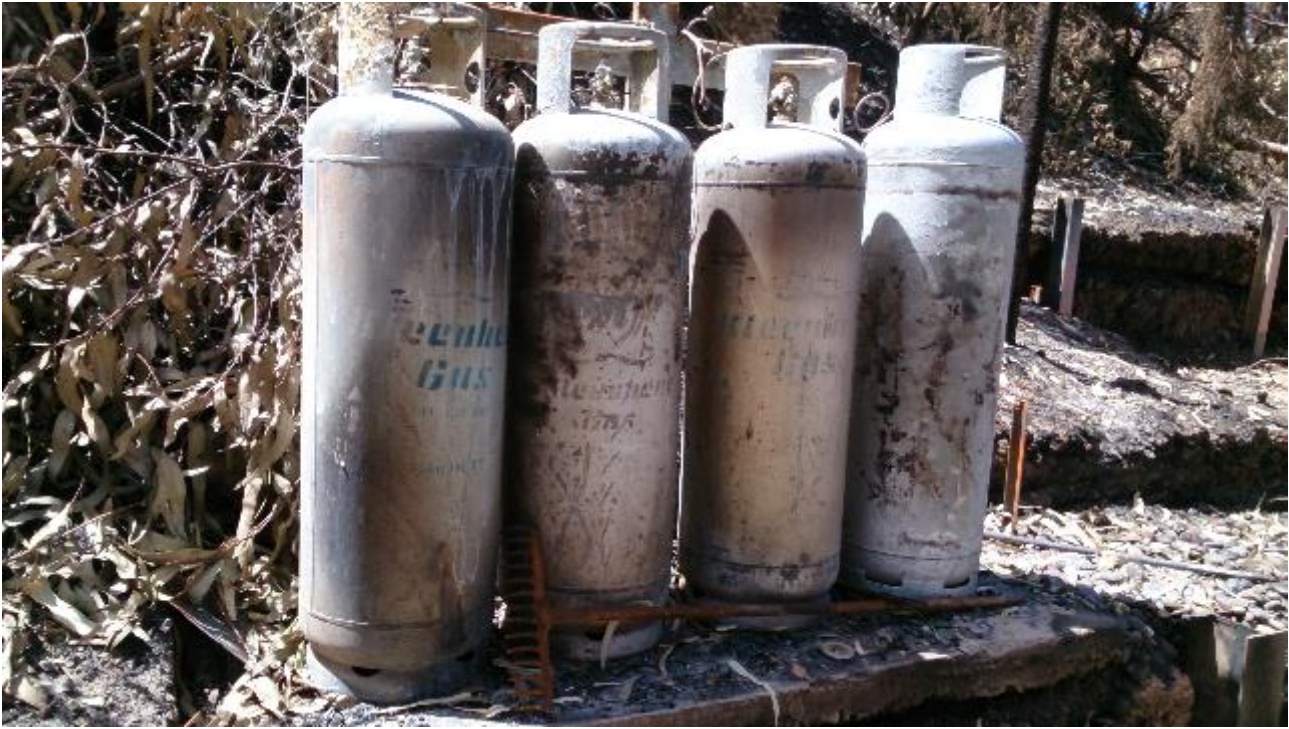
Figure 51: LPG pressure vessels adjacent to house.

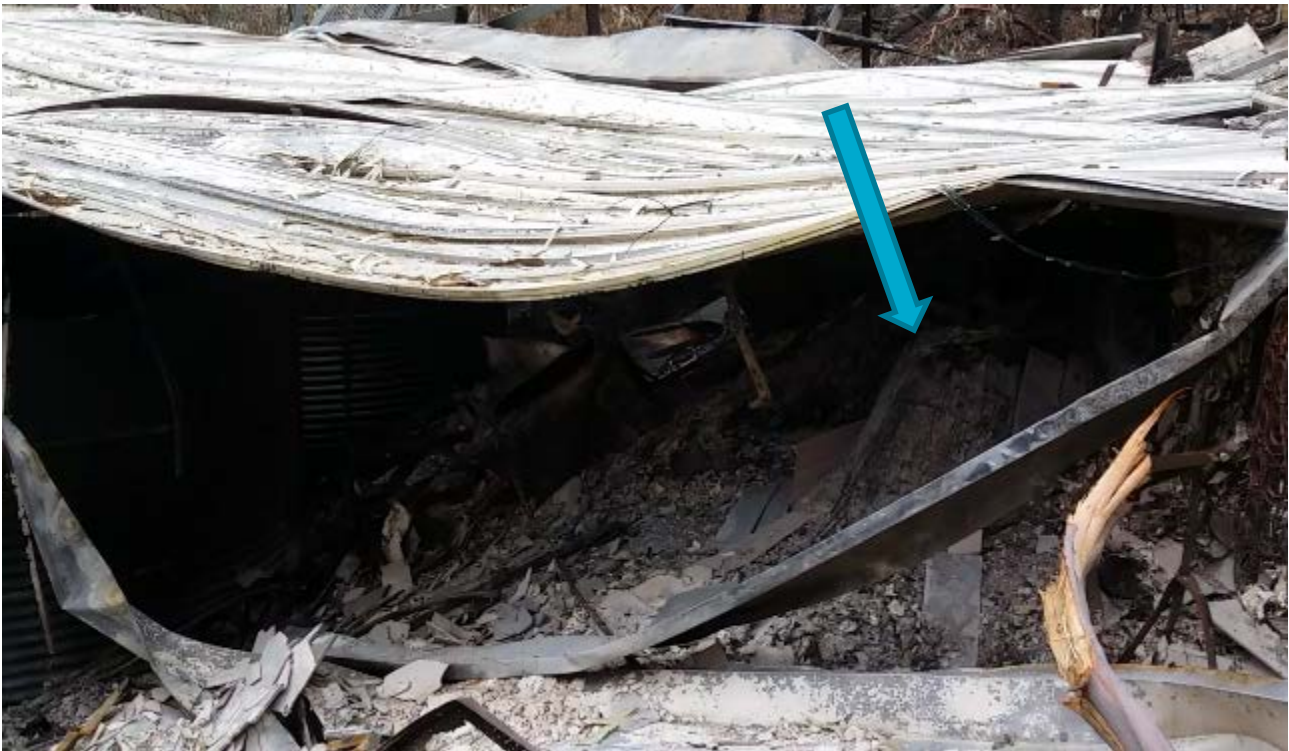
Figure 54: House on Koonya Avenue showing an old tree stump under the floor on the right of the picture.

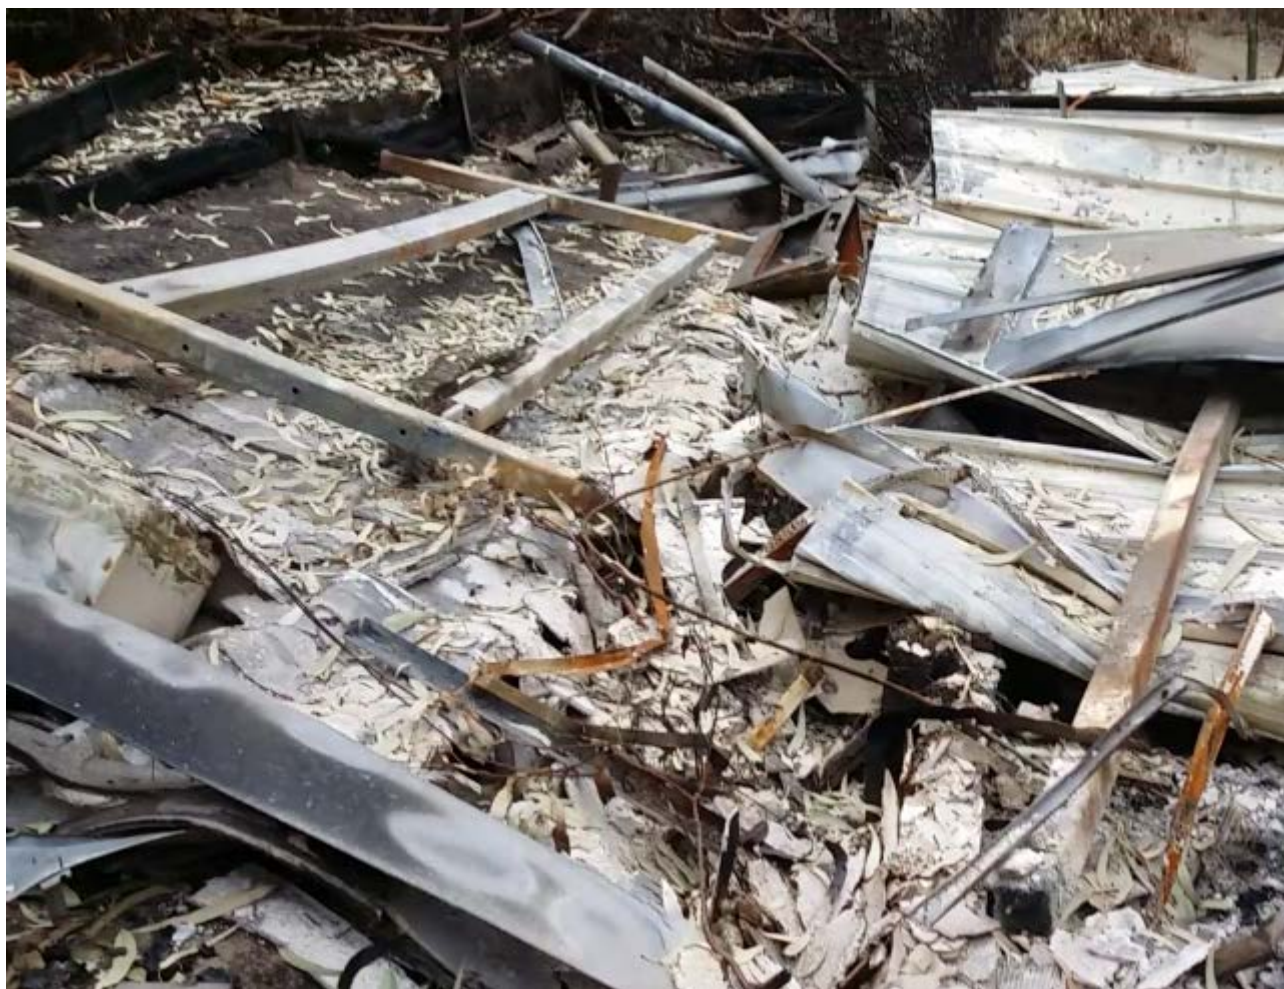
Figure 56: Ground to wall interface after the fire.

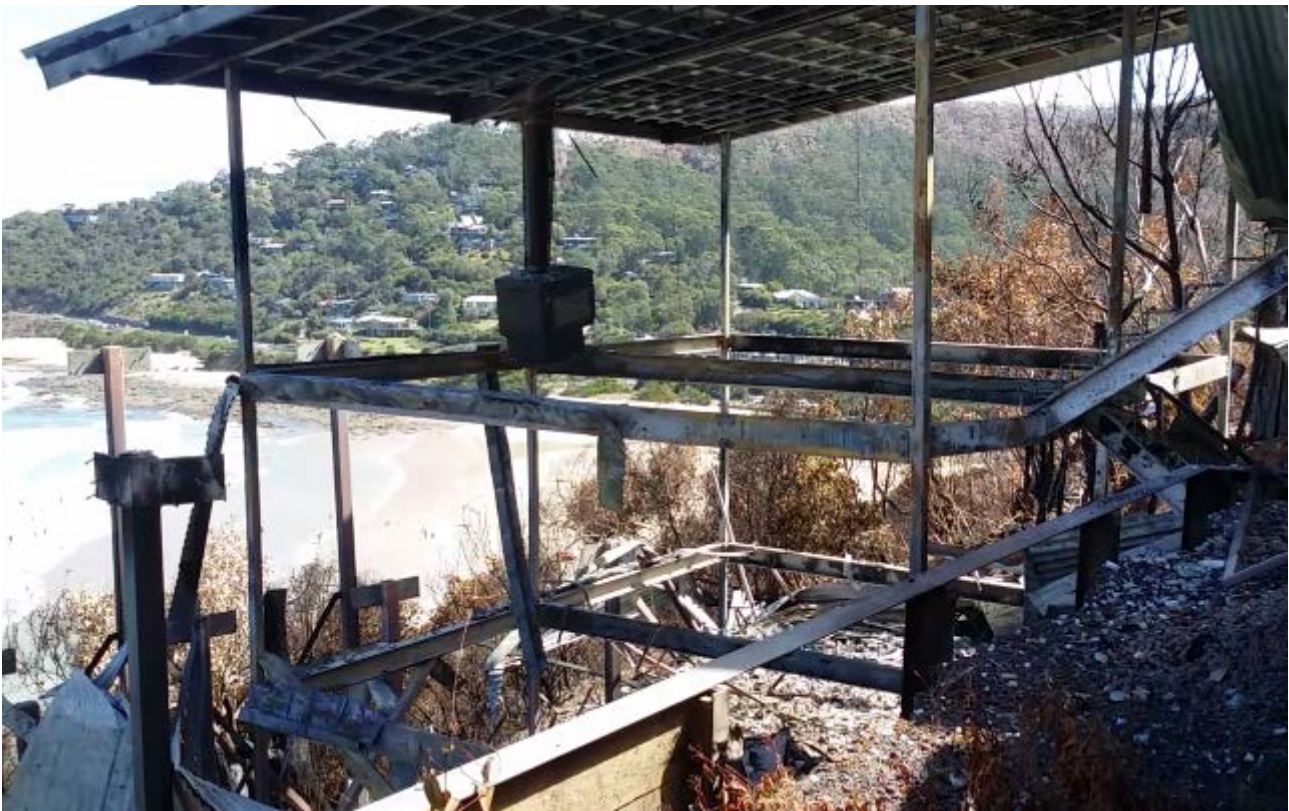
Figure 58: House on Iluka Avenue Wye River, showing vegetation condition below structure
