Wye River / Separation Creek

Post-bushfire building survey findings

Report EP16924

Report to the Victorian Country Fire Authority

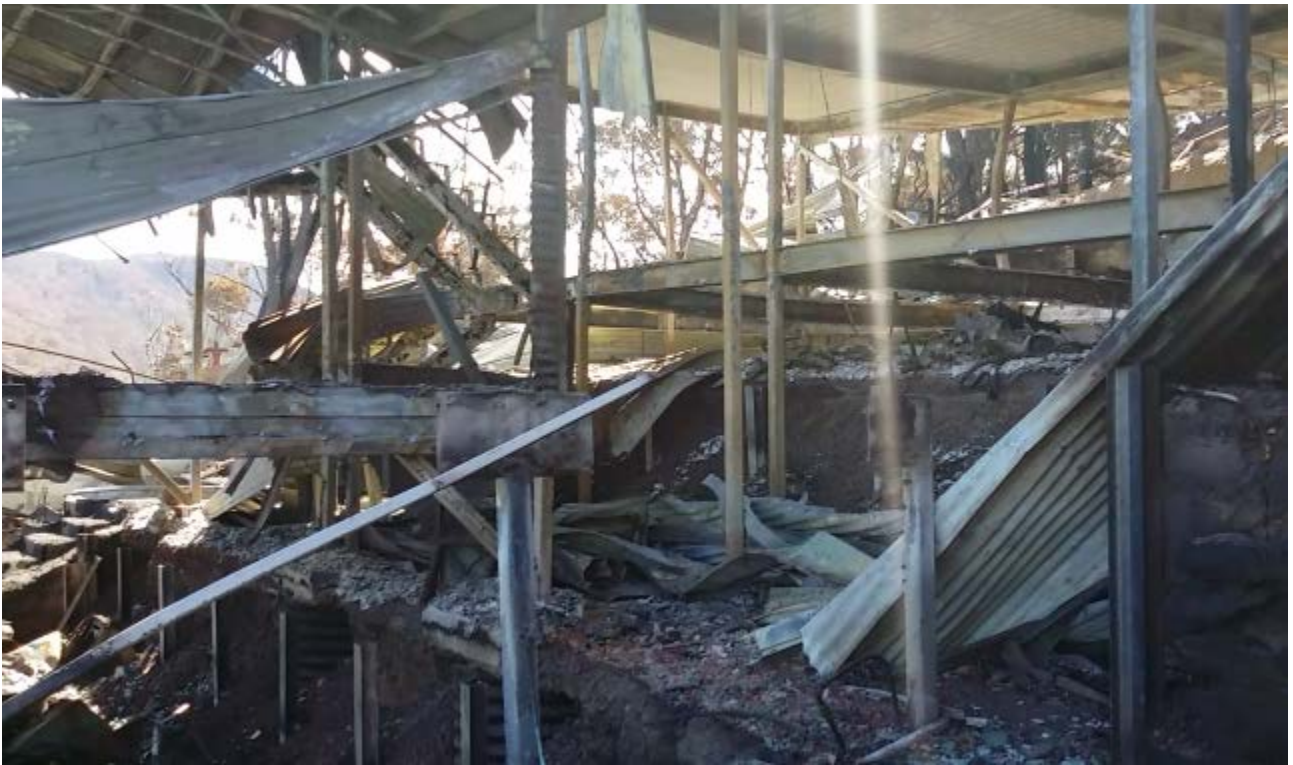
Figure 59: 23 Location of burnt out timber retaining walls below and beside structure

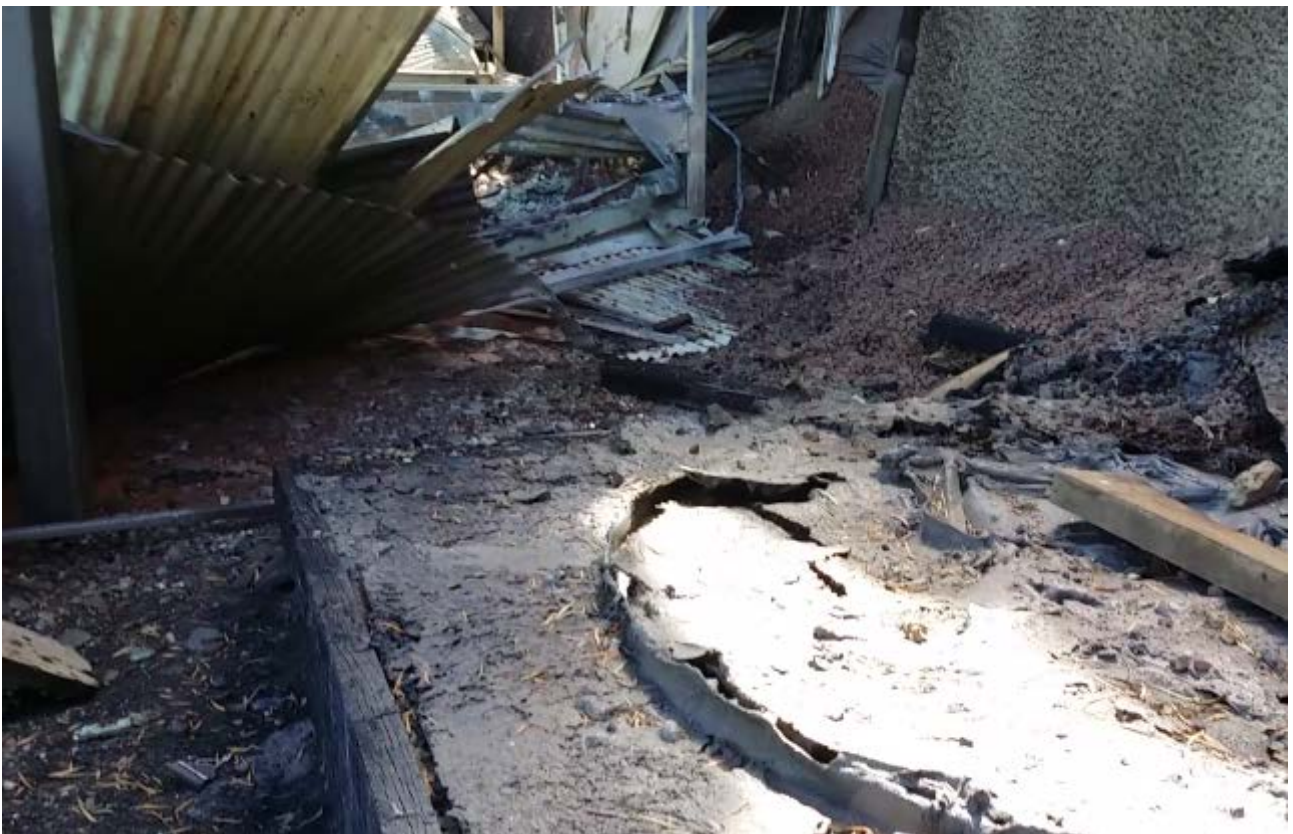
Figure 60: 23 Burnt out retaining walls and tank adjacent to house.

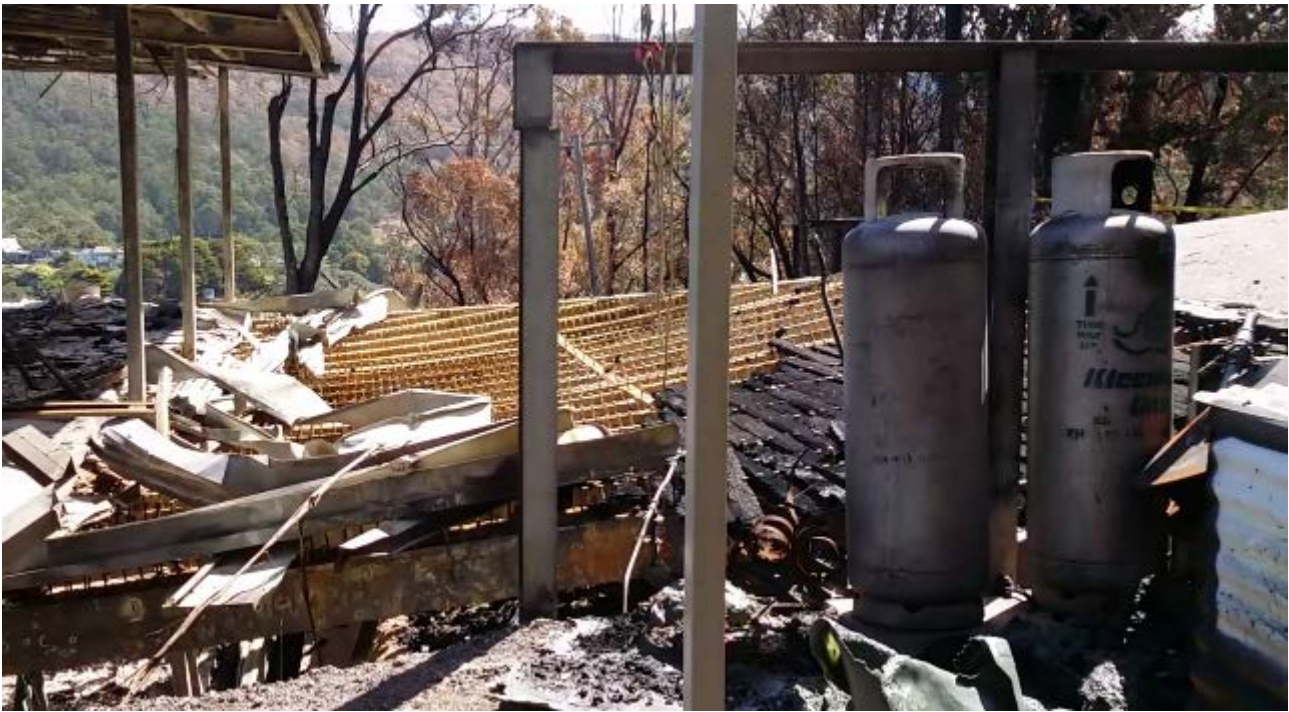
Figure 61: Rear deck combustion at driveway entrance

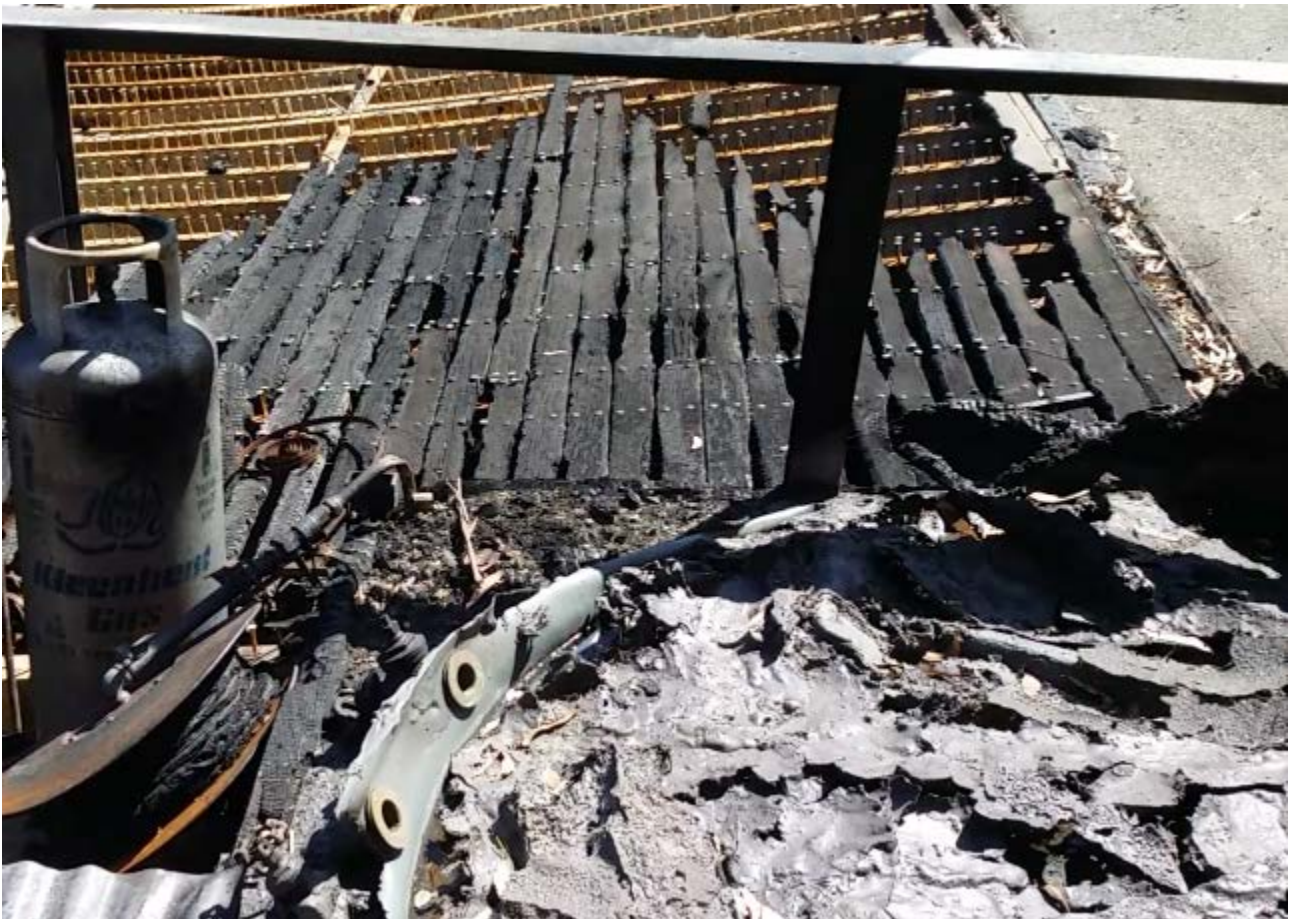
Figure 62: 23 Interaction between the timber driveway deck and a polyethylene water tank. It is possible that the ruptured water tank split out over the timber driveway and prevent the complete combustion of the deck.

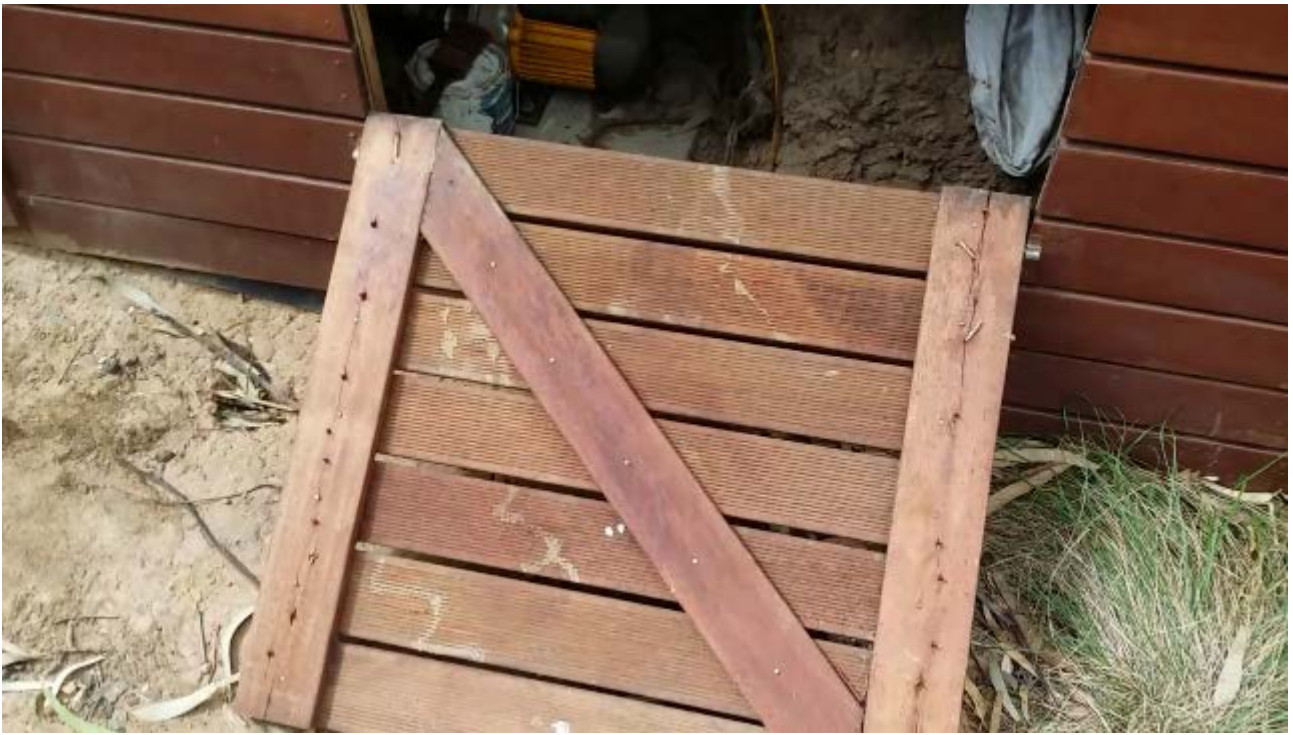
Figure 67: Subfloor area and material stored within.

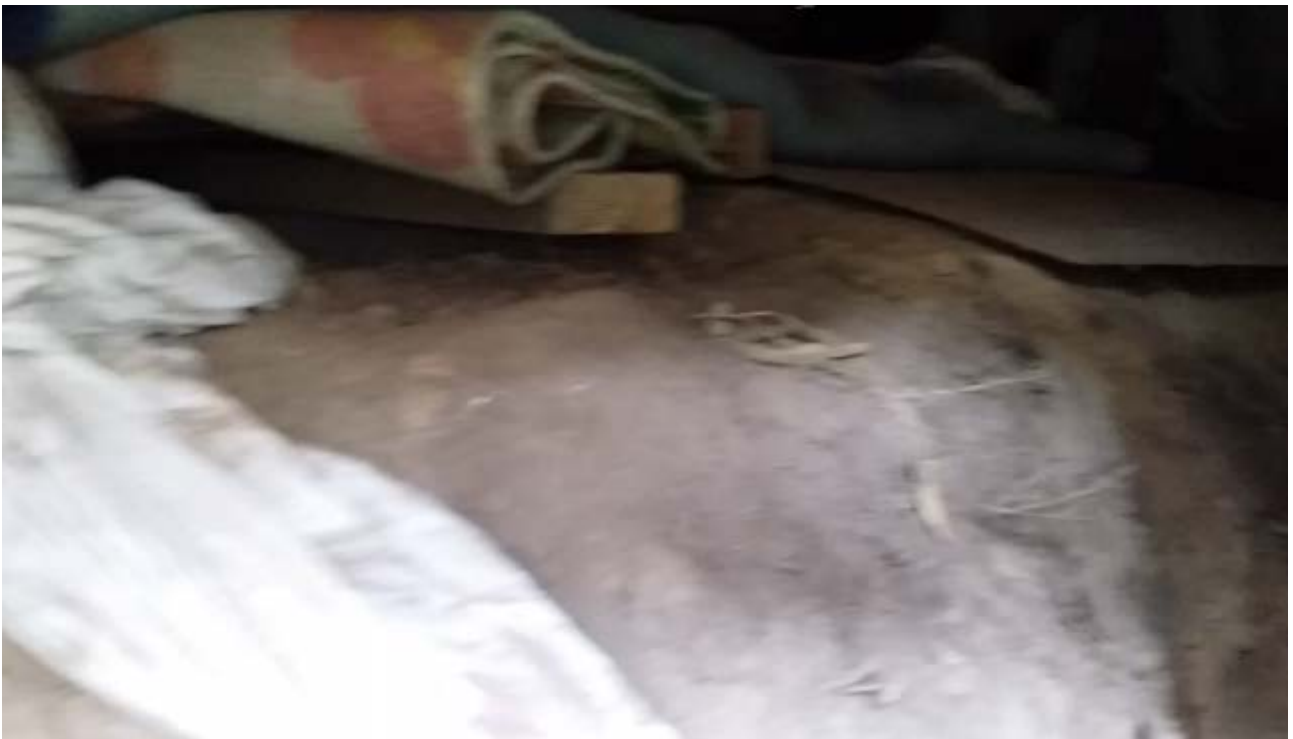
Figure 68: Extensive combustible objects in sub-floor area

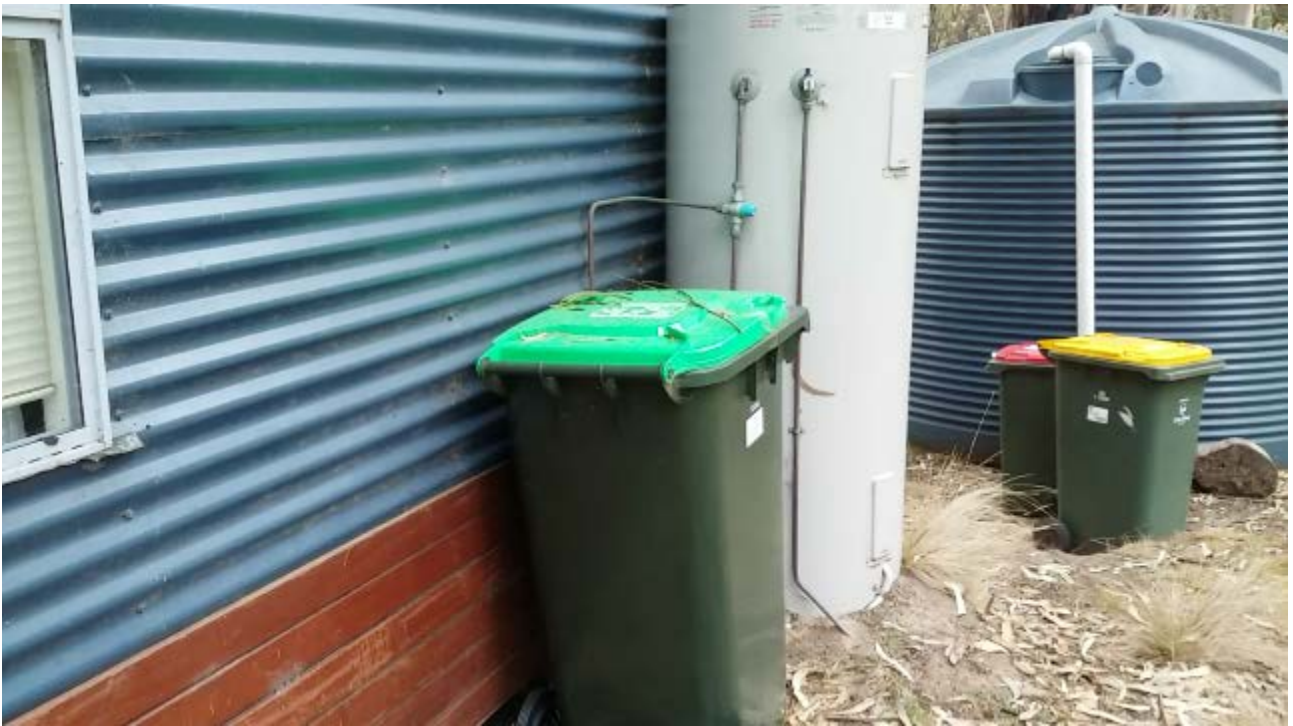
Figure 69: House to tank proximity and adjacent combustible elements including rubbish bins and firewood.

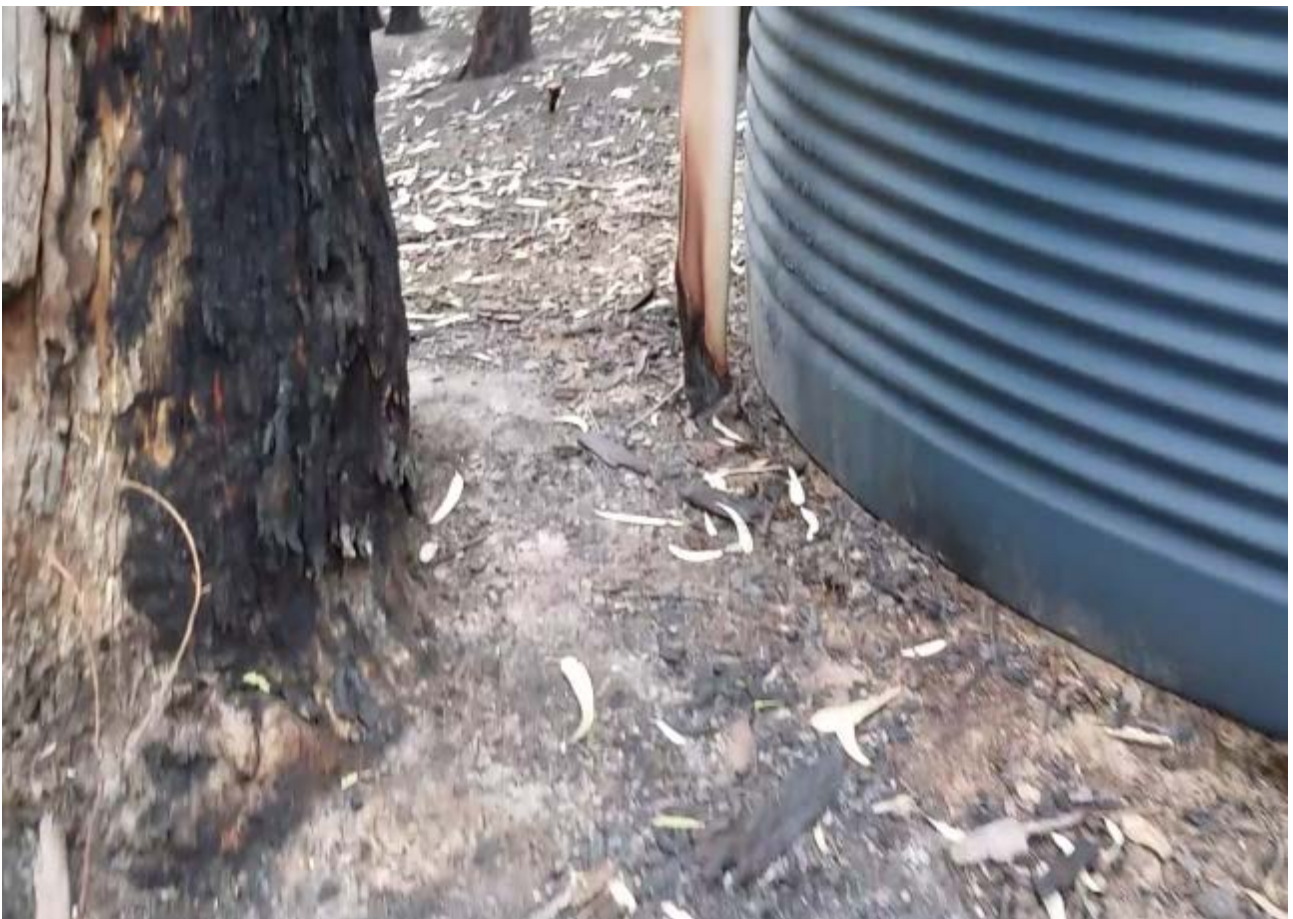
Figure 70: Some fire interaction between a burning tree trunk and an adjacent polyethylene water tank. The ground surface and tree bark condition indicate the suppression had occurred in this area.

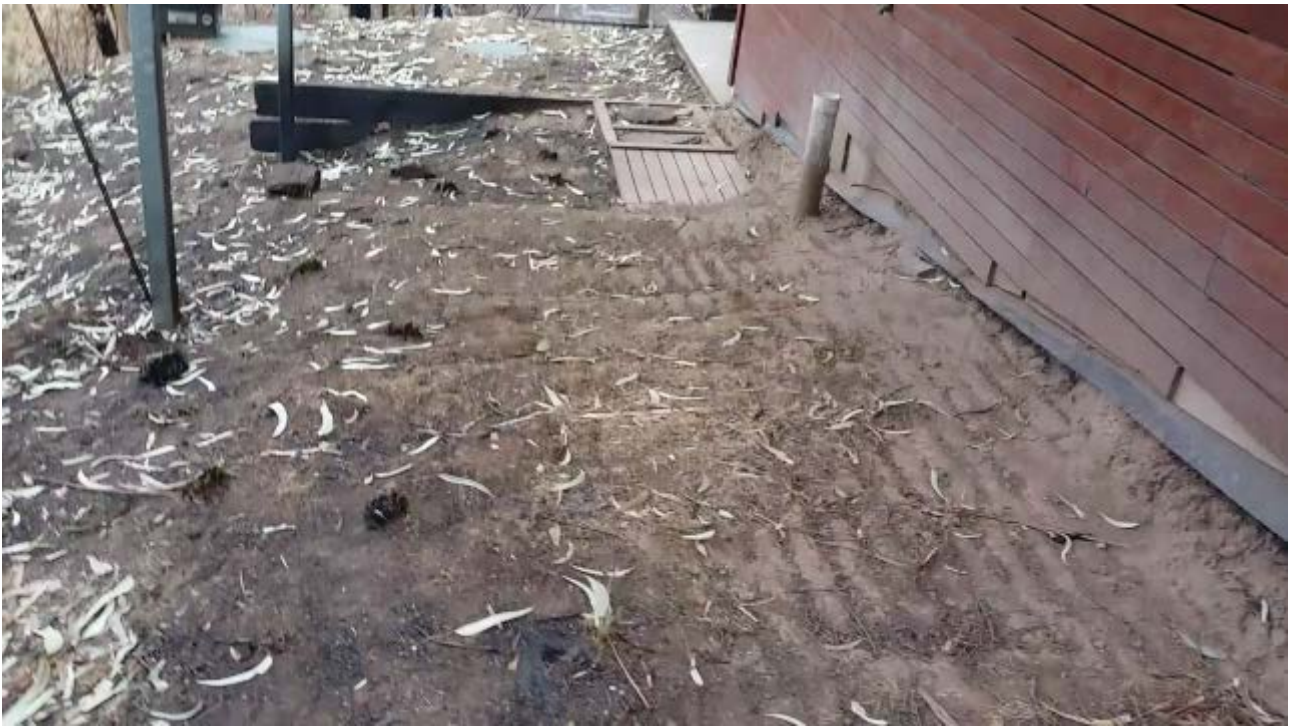
Figure 71: 33 Bare earth interface adjacent to sub-floor area. The dried earth on the sub-floor boards indicate water suppression in the area.

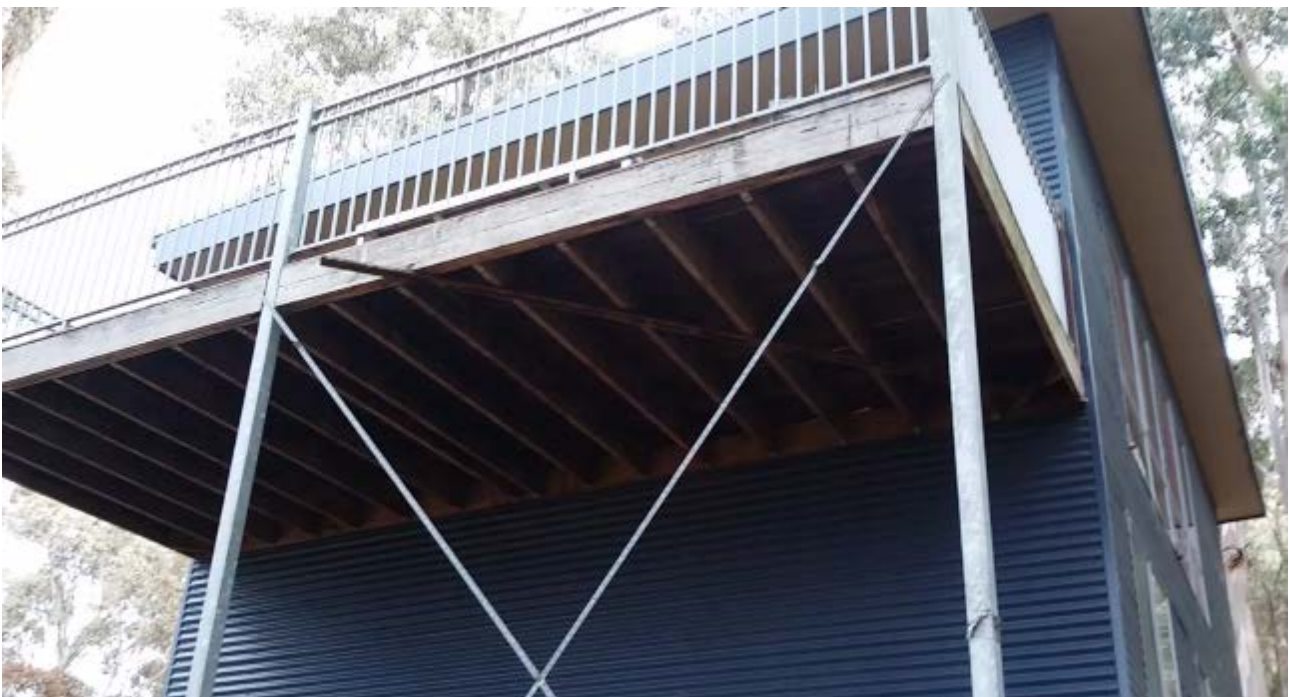
Figure 72: 33 Elevated deck with no clear signs of radiation or ember attack.
