**Wye River and Separation Creek -
Geotechnical, Land Capability and
Wastewater Solutions**

Geotechnical Assessment

31 March 2016

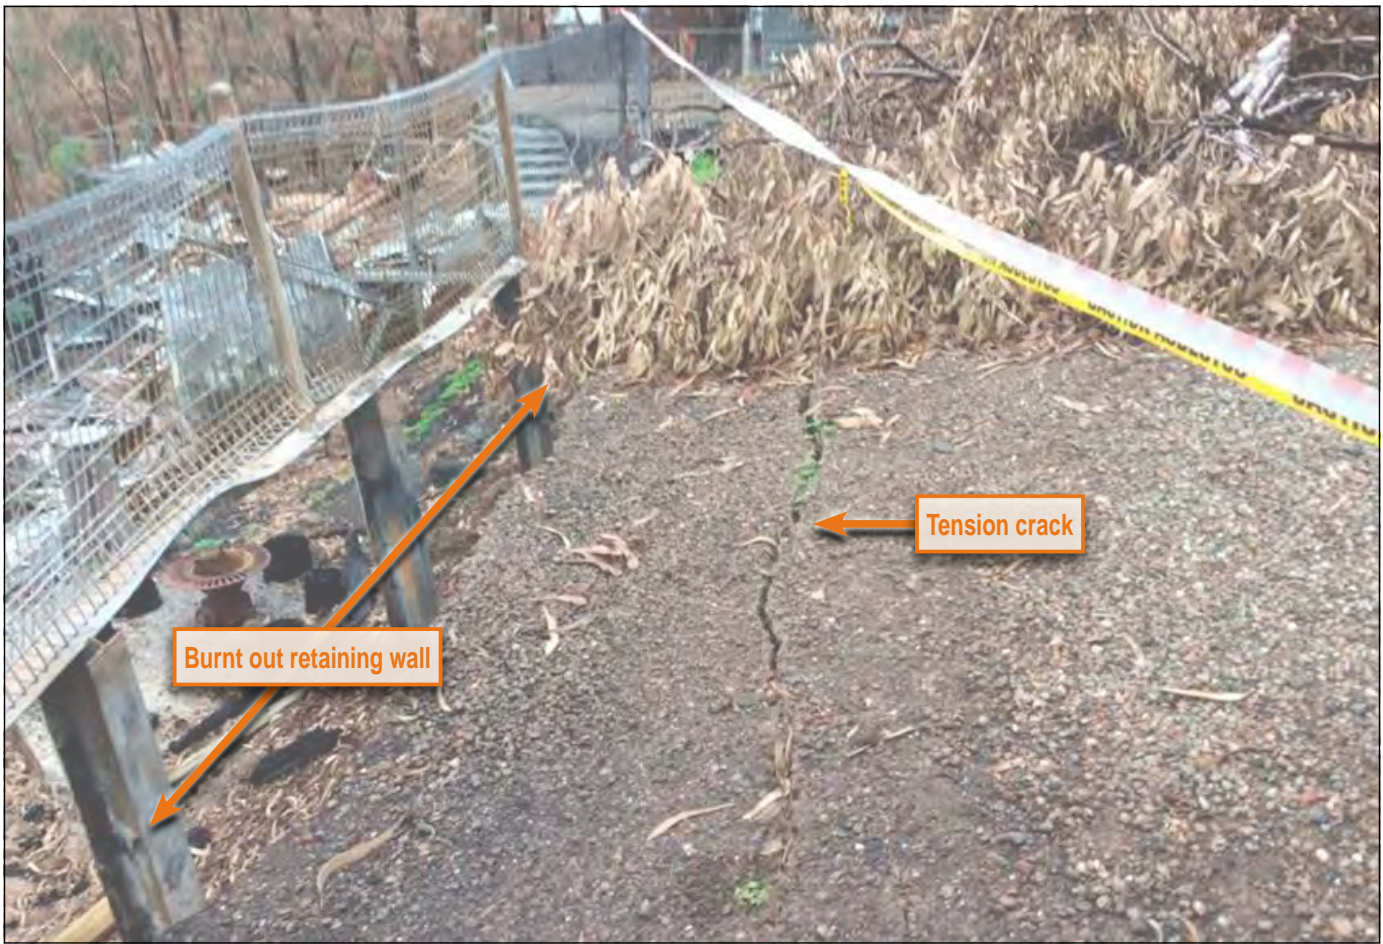
Photograph 1
Tension crack in carport adjacent to burnt out retaining wall

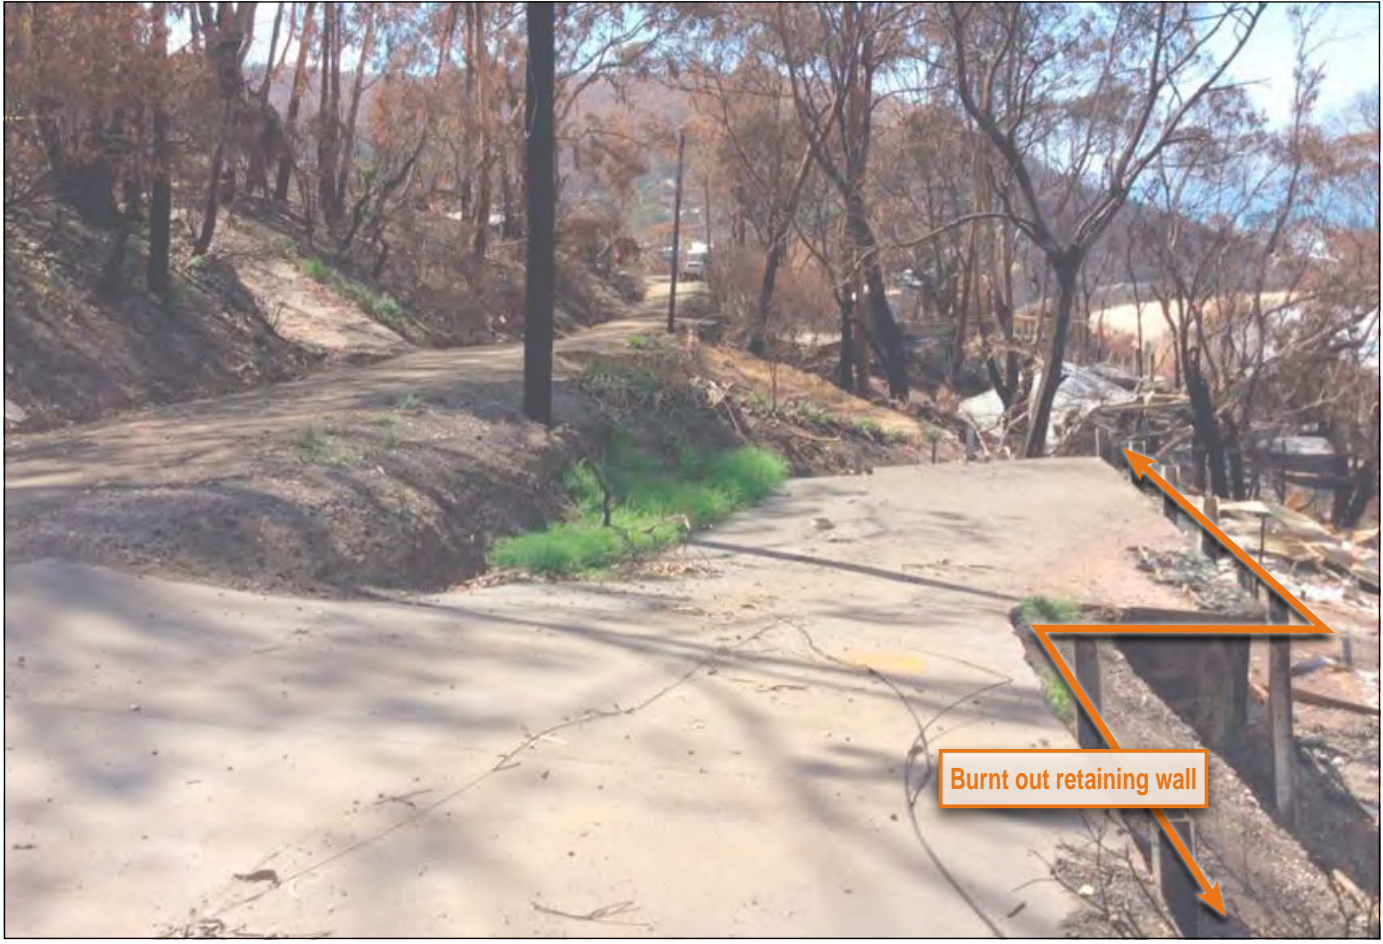
There is a risk to loss of life associated with unsupported soil adjacent to burnt-out retaining walls. These are structures are clearly dangerous in their present form and must be avoided until they are reconstructed using good engineering practice.

Photograph 2
Burnt out retaining wall

Many timber retaining walls were destroyed by the bushfires and the previously retained soil was observed to be failing at a number of locations. The damaged retaining walls need to be reconstructed. Where the retaining walls were constructed with metal I-beams and timber lagging, and the metal I beams remain in place, we recommend that a suitable experienced structural engineer inspects and approves the I-beams before re-using them in the retaining wall re-construction. A suitably experienced structural engineer should also be consulted if any other structural elements that were damaged during the bushfires are proposed for re-use.

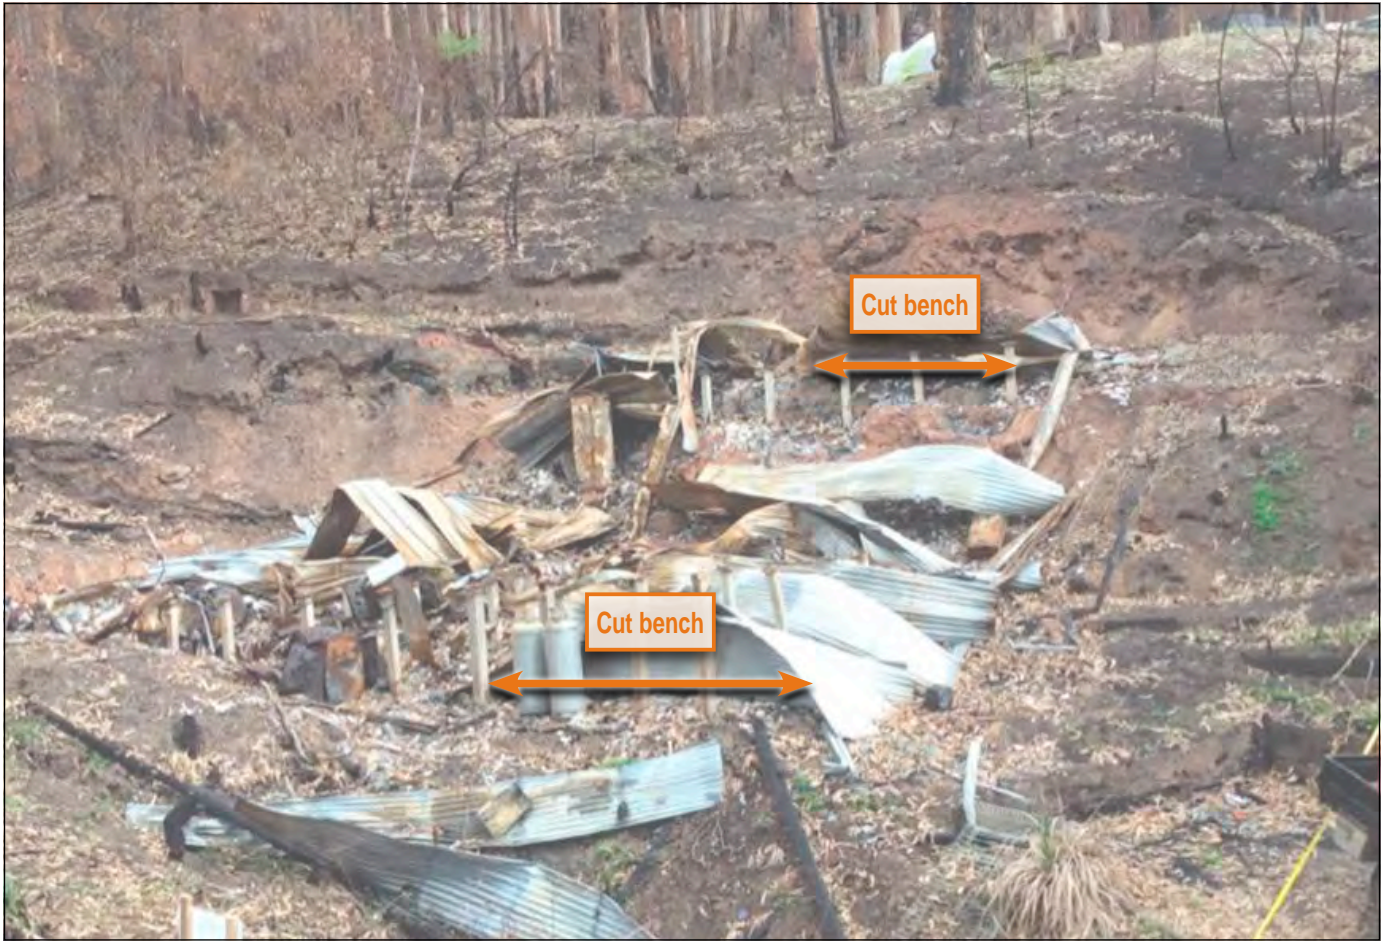
Photograph 3
"Upslope" property showing cut benches

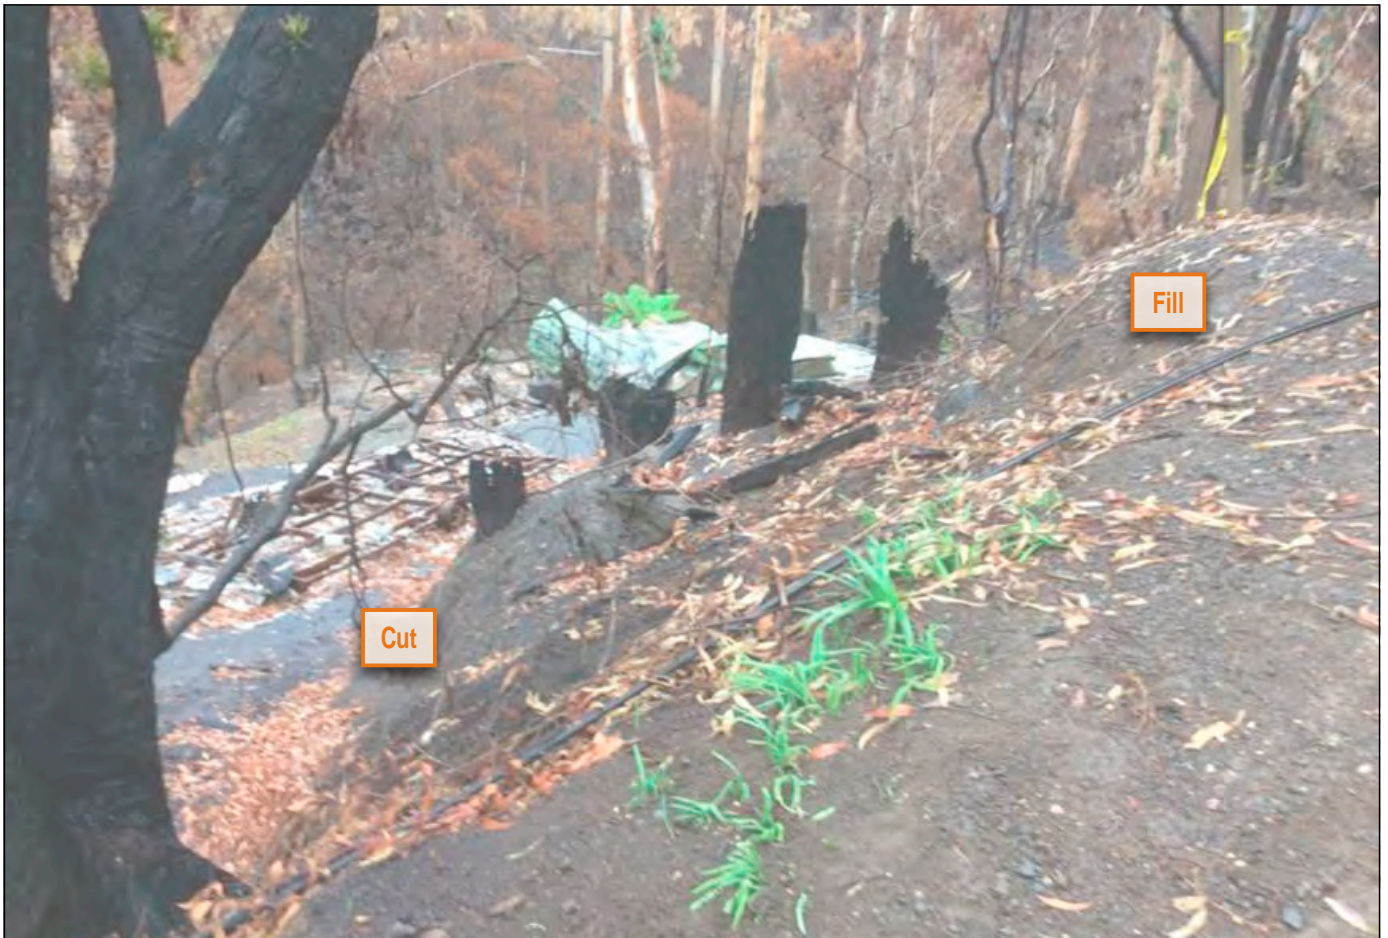
Photograph 4
"Downslope" property showing both cut and fill
