Apollo Bay, Skenes Creek & Marengo CIP

Issues and Opportunities Paper: Coastal

Tract Consultants Pty Ltd

23 June 2019

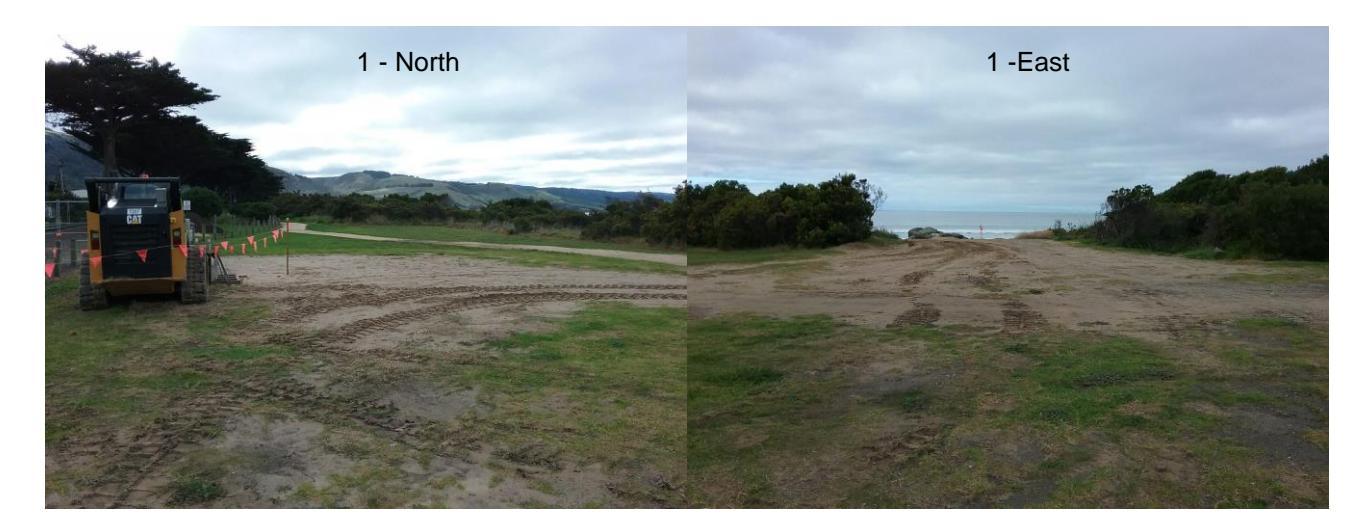
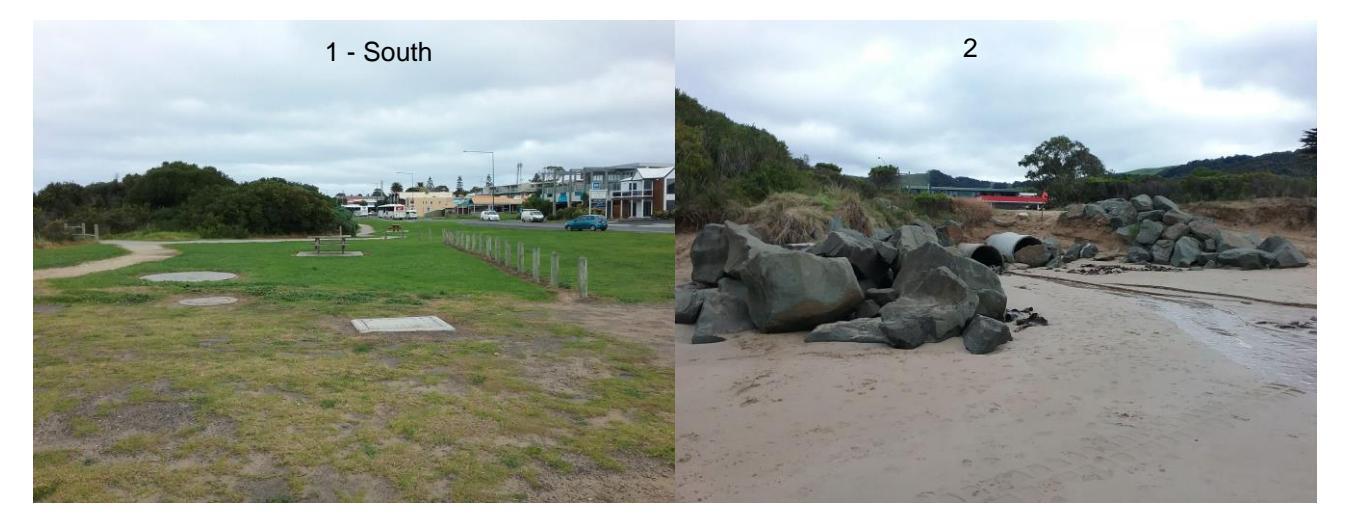
FIGURE 3-3 PHOTO POINTS AT THOMSON ST. LABELS ARE CORRESPONDING NUMBERS ON FIGURE 3-2 (PHOTO POINTS 1 & 2).

- The coastline at Thomson street, whilst quite flat and low-lying, is above the inundation extents produced by Water Technology in 2012 (Photo 1). This location is suitable for coastal infrastructure from an inundation perspective.
- Erosion was observed adjacent to the beach access track, and stormwater discharge (Photo 2).
- Boulders have been placed on the beach, although these are haphazard and would require additional works to provide sufficient erosion protection. At present these rocks could potentially be exacerbating the erosion.

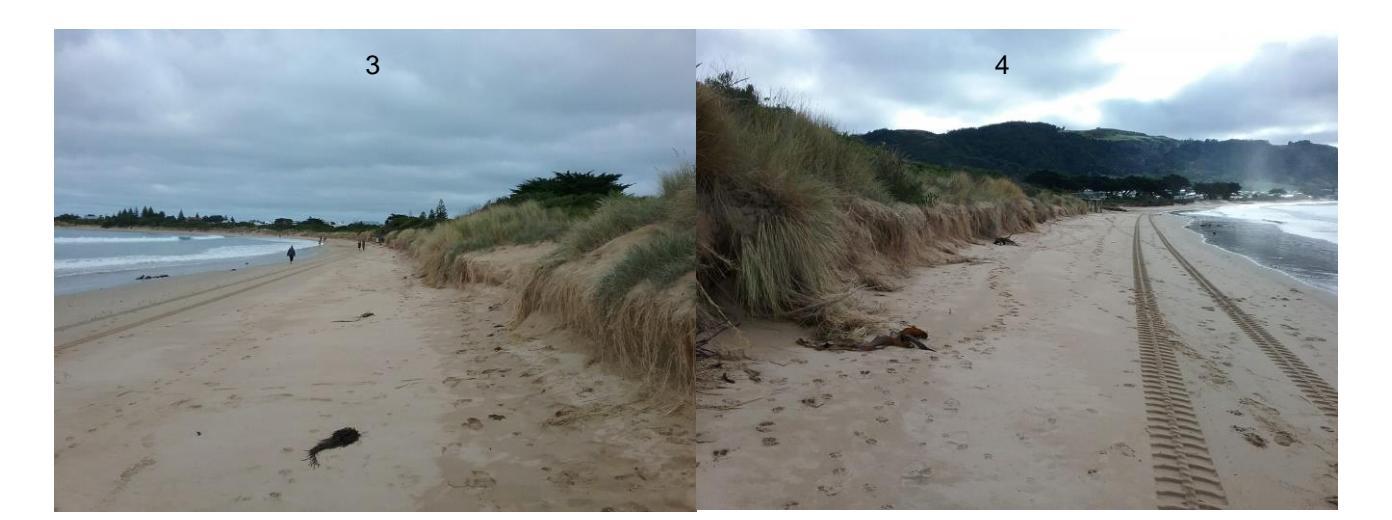
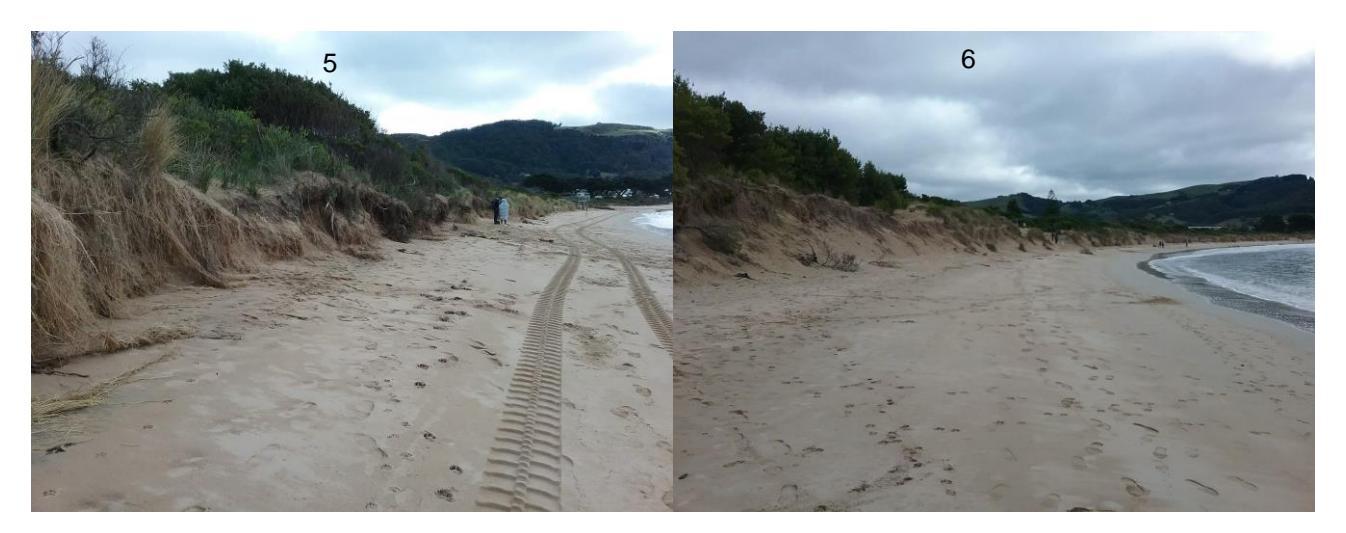
FIGURE 3-4 SCOURING OF THE APOLLO BAY FOREDUNE

- The foredune at Apollo Bay is scoured at its toe along most of its length (photos 3-6).
- This scouring should be monitored to pre-empt any loss of protection afforded by the dunes. Vulnerability of developments within the Apollo Bay Foreshore Reserve would increase significantly if the dunes were compromised.

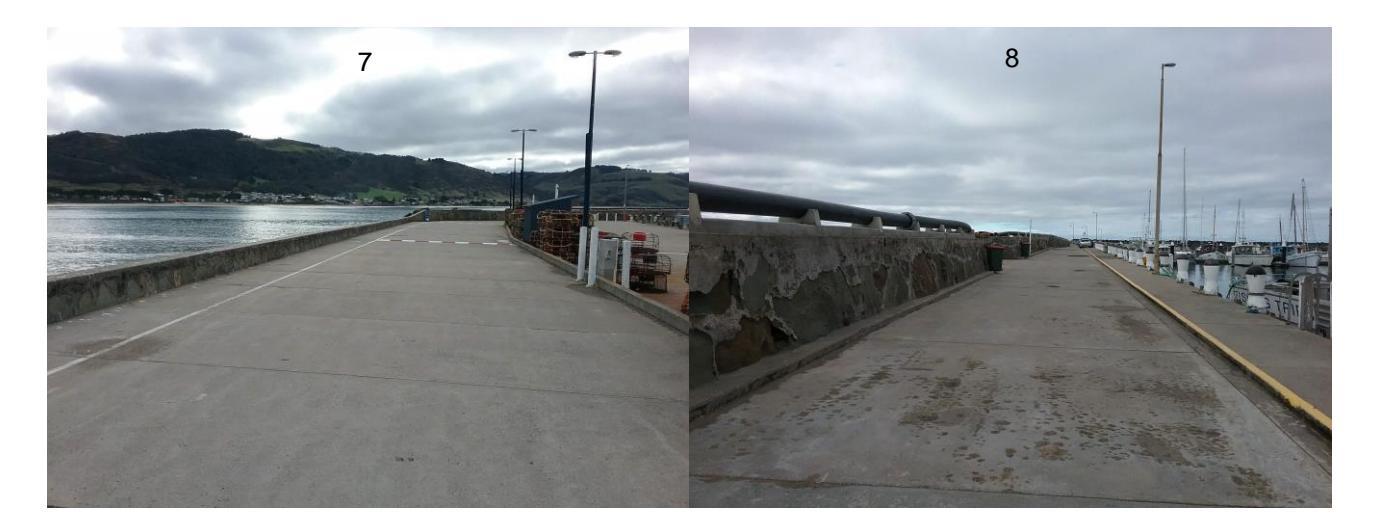
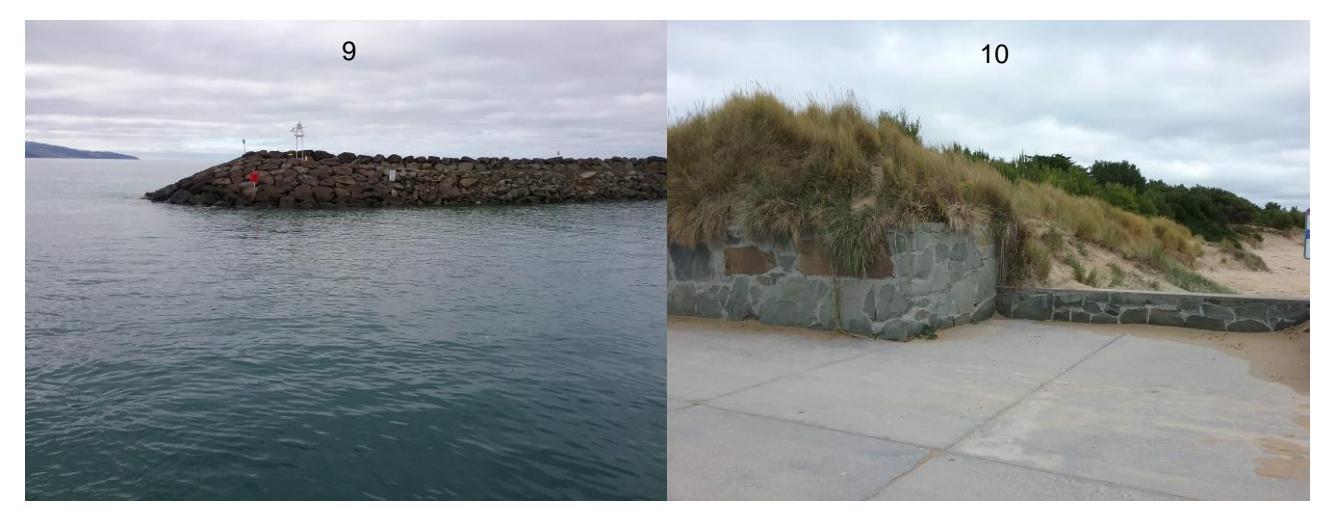
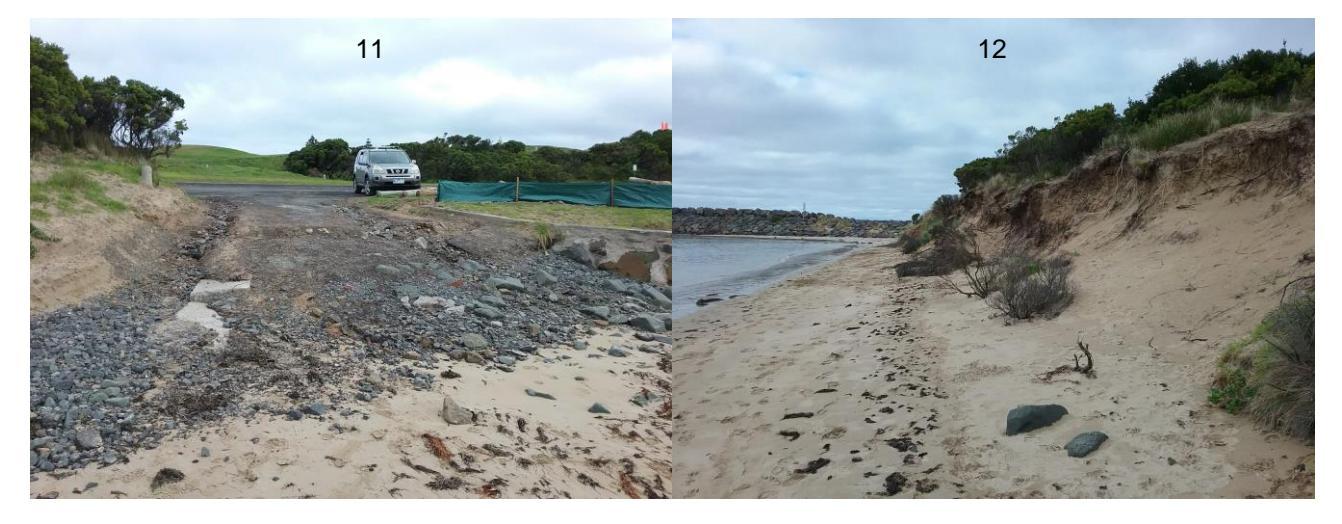
FIGURE 3-6 APOLLO BAY HARBOUR (PHOTO POINTS 7-12)

- The Harbour Breakwaters are generally in good condition (photos 7-9). The inner face of the eastern breakwater was assessed by Water Technology in 2018 (Water Technology, 2018) and found to have fretting of the road edge and slumping of the rear face due to wave overtopping. Repair of the inner face was recommended and should be conducted before further development of the area.

- Areas near to the dunes are protected by narrow stone walls. These walls may not have been picked up by the LiDAR, and thus the inundation mapping may be conservative in this area. We recommend *in-situ* survey/review of final design drawings of the Harbour to rectify storm tide and wave runup barriers within and around the Harbour (photo 10).

- There is erosion to the inner Harbour access ramp to the beach, and to the dunes at the Harbour's southeastern beach (photos 11 & 12). Considering the protection afforded by the Harbour walls, this is most likely due to carpark runoff (access ramp) and storm tides/loss of vegetation/wind erosion/currents due to seiching (dune). The dune to the west of the inner-boat ramp is well vegetated and showing no signs of erosion.

- WATER TECHNOLOGY WATER, COASTAL & ENVIRONMENTAL CONSULTANTS
- This area would benefit from some targeted coastal management, that would provide the dual function of improving the amenity and minimising the erosion issue.

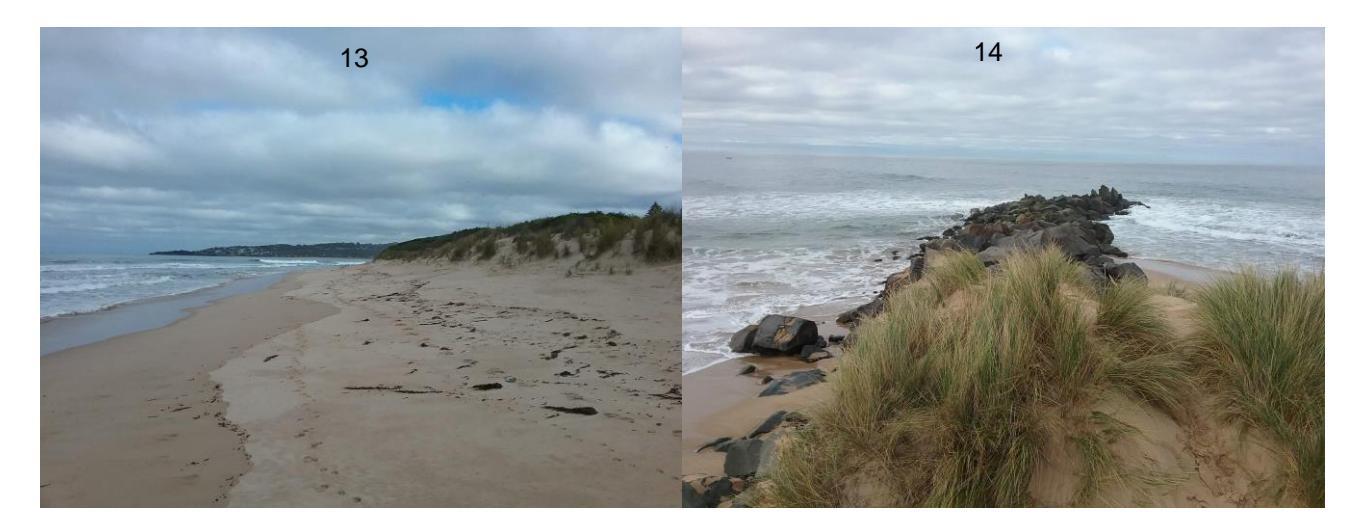
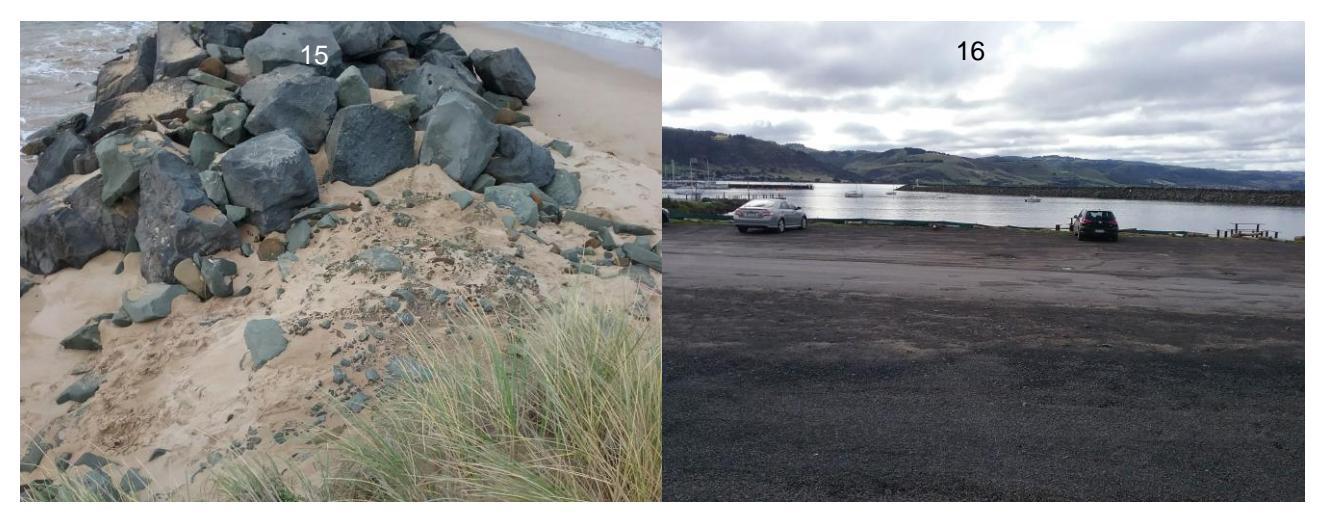
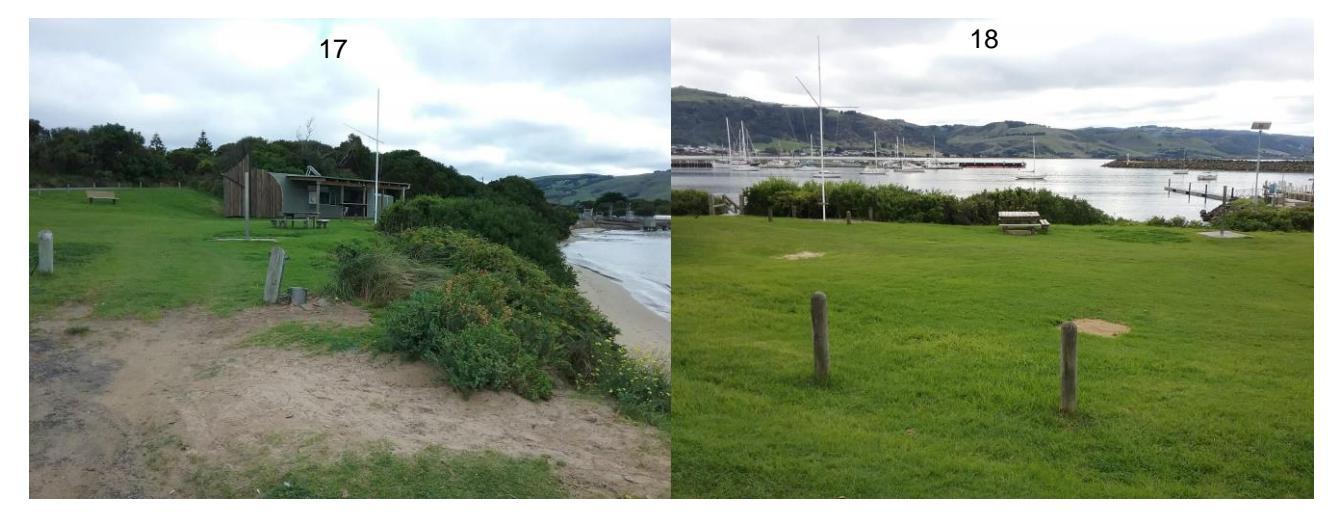
FIGURE 3-7 BUNBURY POINT AND CAR PARK

- The beach at the northern end of Mounts Bay (Bunbury Point) is stable, with no indication of erosion (photo 13)
- The Bunbury Point Groyne is currently holding sand, with one section close to shore that is in need of urgent repair (photos 14 & 15). At present, the structure could be outflanked during a storm event. The groyne was originally designed as a sand trap for later sand bypassing to prevent sand build-up within the harbour. Although the groyne has not recently been used in this way, any development plan of the area should consider this function.

- The car park and grass area in front of the Apollo Bay Sailing Club both represent good development opportunities, lying above the predicted storm-tide levels up to 2010 (photos 16-18). Erosion risk is low here considering its protection by Harbour Breakwaters and its present condition.

- Erosion within the Harbour has not been considered in previous reports but with coastal processes affecting the south-eastern dune accelerated erosion is possible. An inner-harbour processes study is recommended.

The Bunbury Point Groyne has reached capacity and was originally designed to be used in sand bypassing operations for the Harbour. Development opportunities should consider this original purpose.

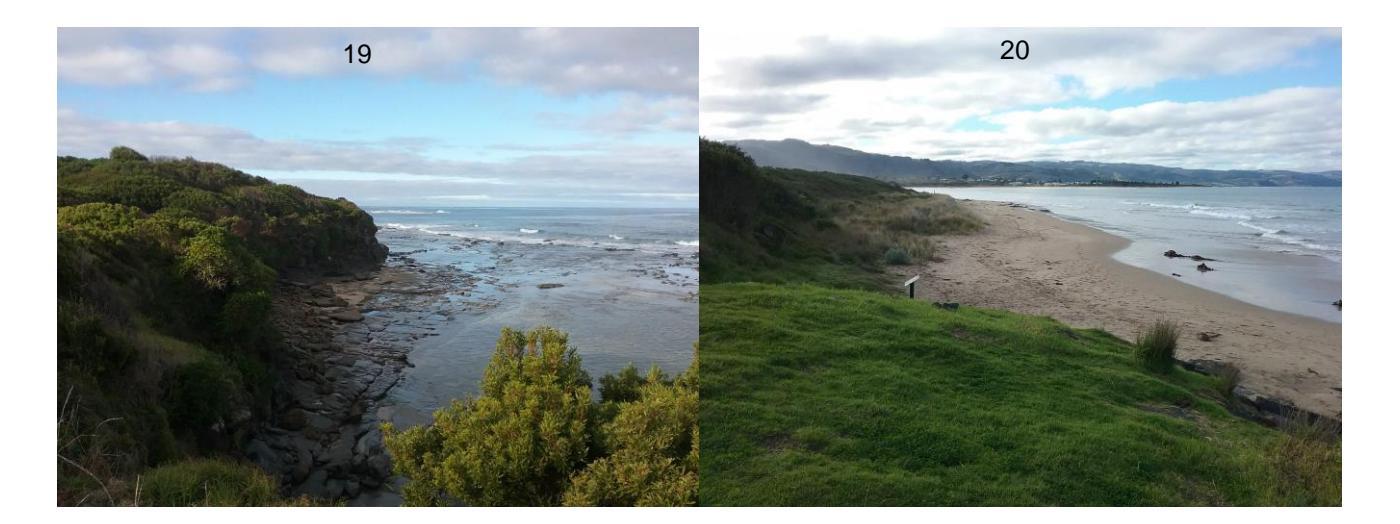
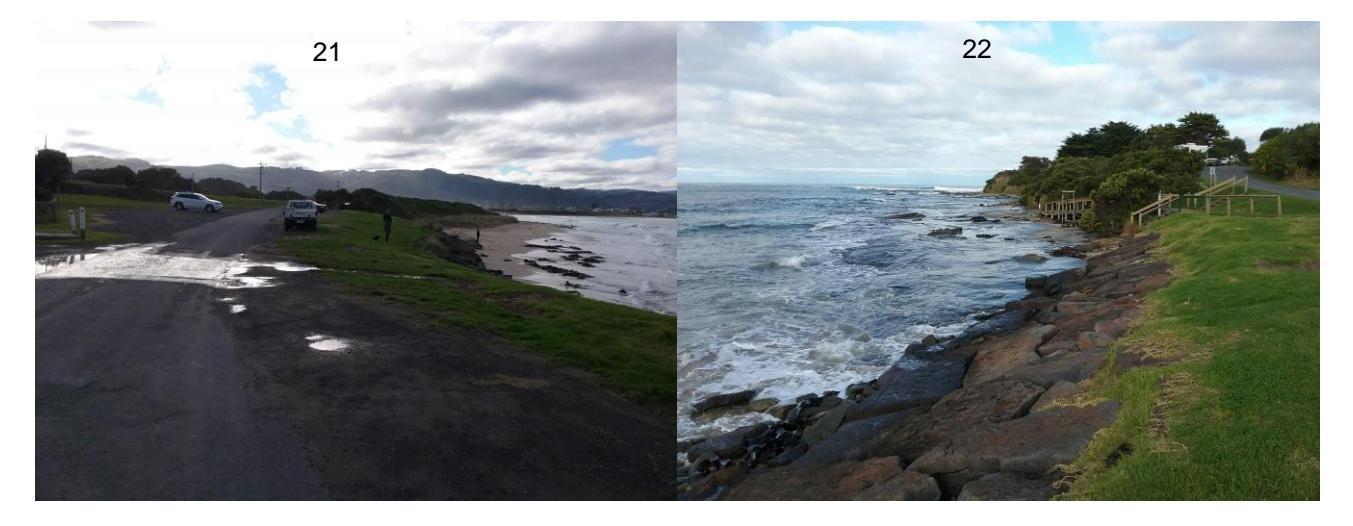
FIGURE 3-9 MARENGO PHOTO POINTS

- Coastal cliffs protect the Marengo headland (photo 19)
- The dune to the north of the carpark is currently stable, showing no signs of recent erosion (photo 20)
- The carpark slopes up away from the shoreline providing increased resilience (photo 21)
- The shoreline is protected by a revetment that is presently in good condition (photo 22)

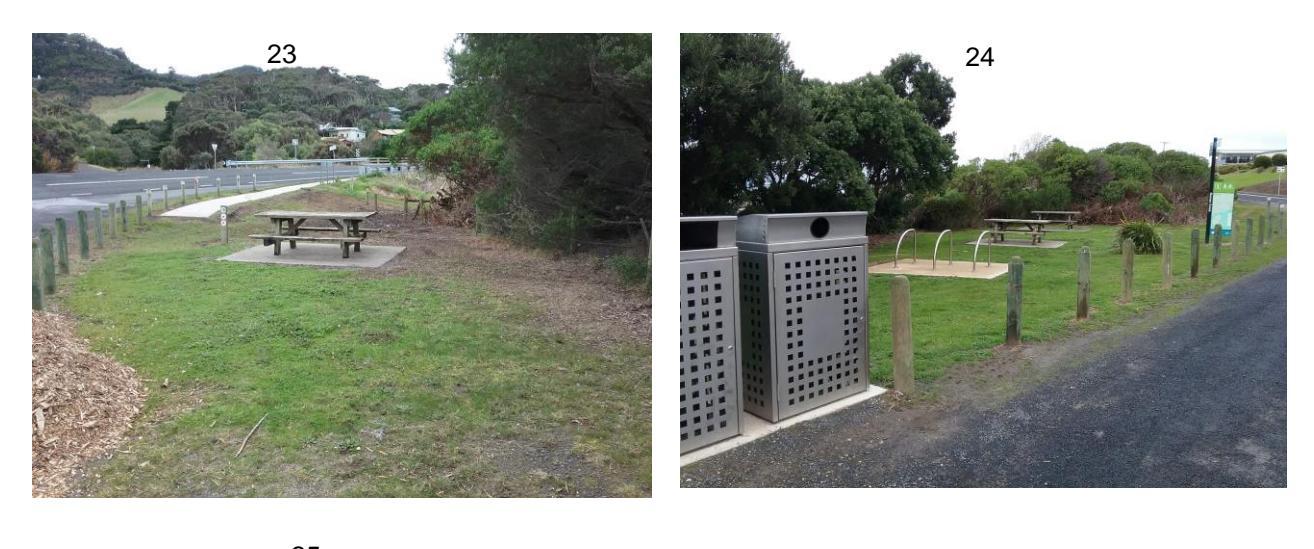
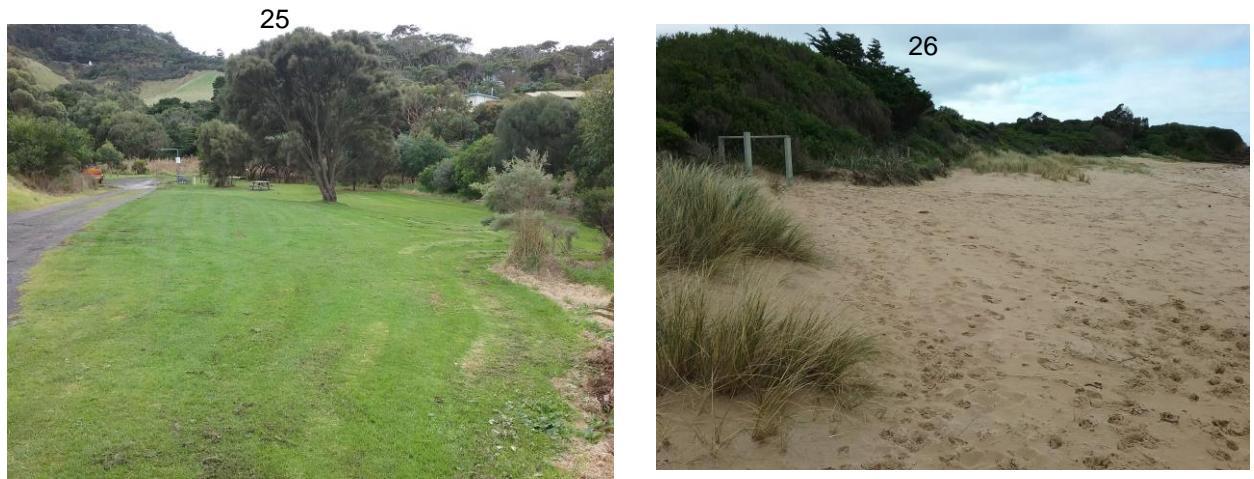
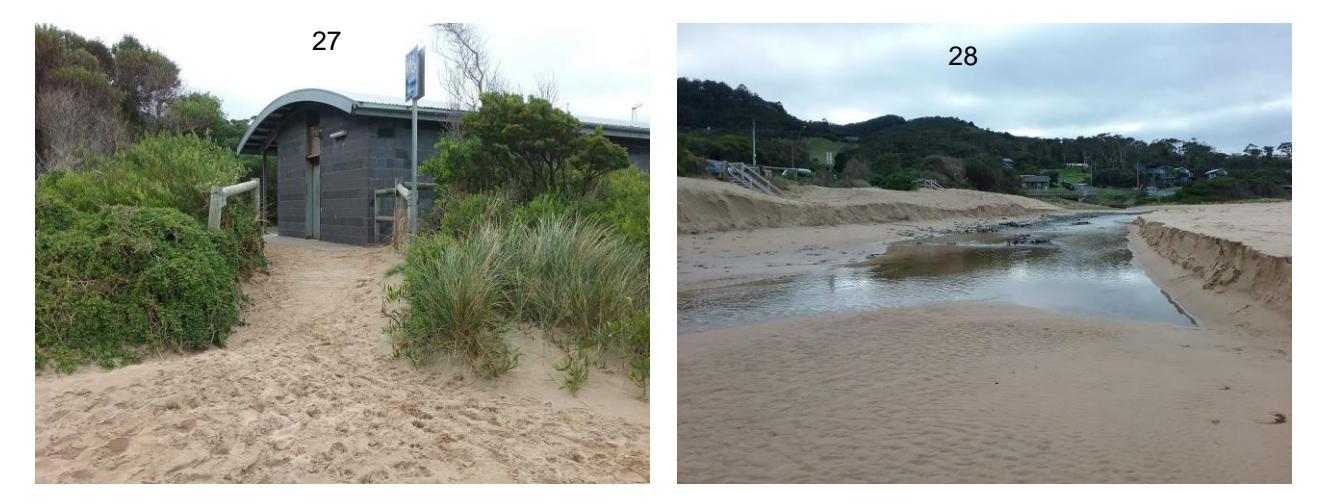
FIGURE 3-11 SKENES CREEK PHOTO POINTS CORRESPONDING TO NUMBERED LABELS IN FIGURE 3-10

- The car park is exposed to erosion risk and inundation risk from a combination of storm tide and wave runup. There are two picnic areas at each end of the carpark, with the ground sloping down towards the creek. The eastern picnic area is low-lying, while the western picnic area is at a higher elevation and could house infrastructure of greater value/lower resilience (photo 23 low-lying picnic area, photo 24 upper picnic area).

- The picnic area upstream of the bridge on the western bank of Skenes Creek slopes down, transitioning to higher risk at its far side towards the creek. The area closest to the bridge is elevated above the predicted 2100 storm tide levels (photo 25).

- The dune in front of the caravan park is stable at present, showing establishment of new vegetation (photo 26)
- The access path from the toilets to the beach is also in good condition (photo 27)

- The access paths and steps to the beach from the large car park area are subject to erosion and variability due to the Skenes Creek channel. Improvements to beach access would require a study into options with further consideration of the long-term coastal processes of the area (photo 28).

Consideration for coastal protection works are recommended at Thomson St, the Bunbury Point Groyne, and Skenes Creek access stairs if these areas are to remain long term. Additional survey/review of final design drawings are required in areas that are not well resolved by previous LiDAR surveys; these include:
