PP304/2017-1

14 Mitchell Grove SEPARATION CREEK

Construction of a dwelling and associated works

P.J. Yttrup & Associates Pty Ltd was commissioned to carry out a Land Capability Assessment at 14 Mitchell Grove, Separation Creek to assess the site's suitability for effluent disposal and to provide recommendations for the design of an on site waste water management system.

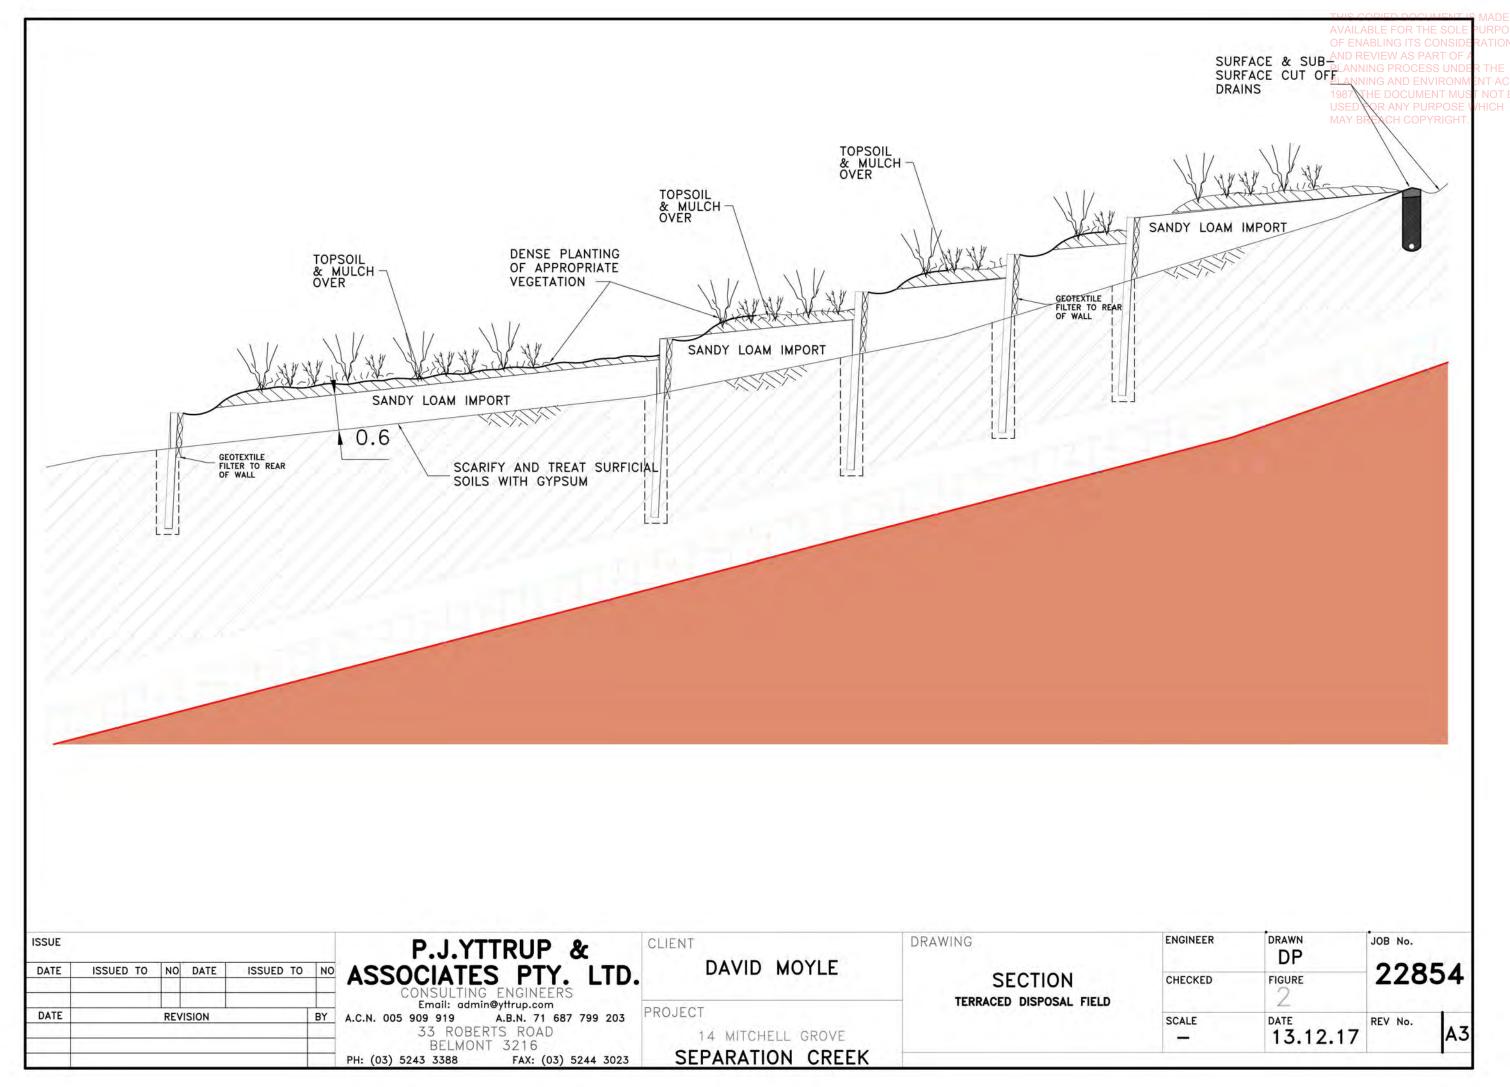
Disposal is recommended to be a terraced subsurface irrigation bed area, sized in accordance with EPA891.4. The area will need to be benched and terraced to provide suitable zone application. The disposal field will be required to be distributed across the full width of the block (less the required setbacks) to limit concentration of moisture in one location. Furthermore, imported FILL will be required to improve the application rates. Additional slope stabilisation will be required (ref. LRA 22854, 20 December 2017) in order to reduce the potential landslide risks, most likely in the form of subsurface and surface water cut off drains and engineered retaining walls (as required). Refer to Figure 2 for a concept design of the proposed terraced beds.

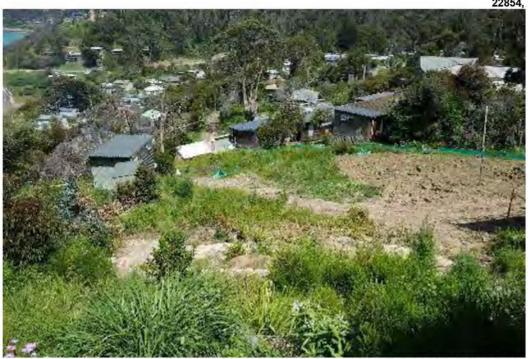
Photo 1 Disposal field looking south west with uncontrolled FILL and incorrect storm water drain construction at the time of inspection. .

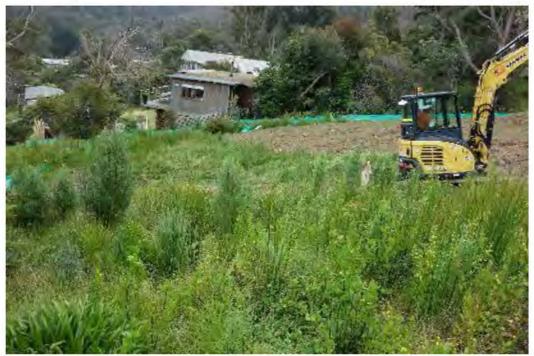
Photo 2 Disposal field looking west showing moderate slopes at the bottom of the property.

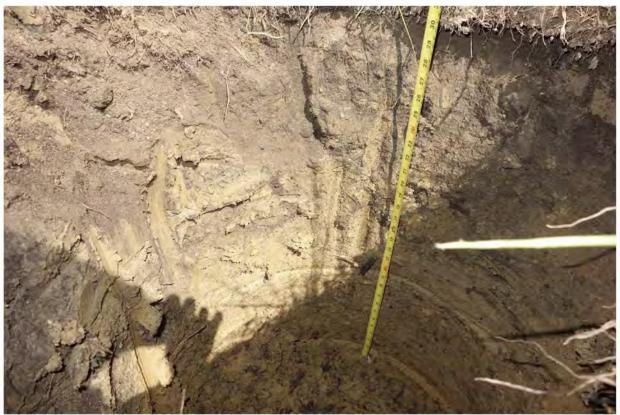
Photo 3 Typical sub-surface conditions at borehole BH3 with Sandy Clay LOAM overlying mottled Medium CLAY at depth.

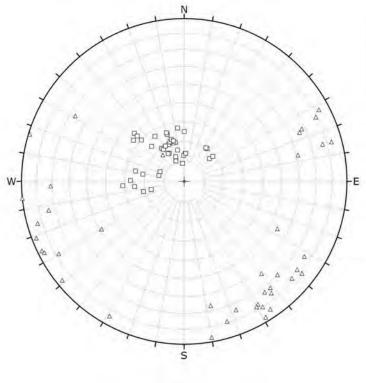
Symbol	DEFECT	Quan	tity
0	BG	42	
Δ	JN .	40	
	Plot Mode	Pole Vectors	_
	Vector Count	82 (82 Entries)	
	Hemisphere	Lower	
	Projection	Equal Area

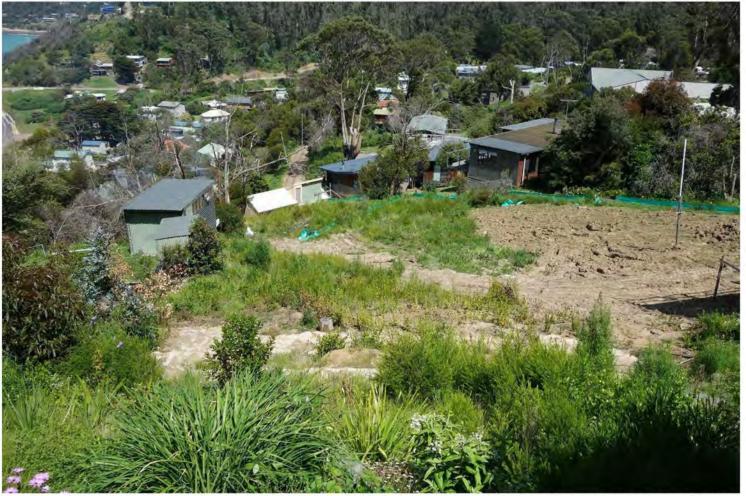
Photo 1 General overview looking south west with FILL and drainage works in lower half of property.

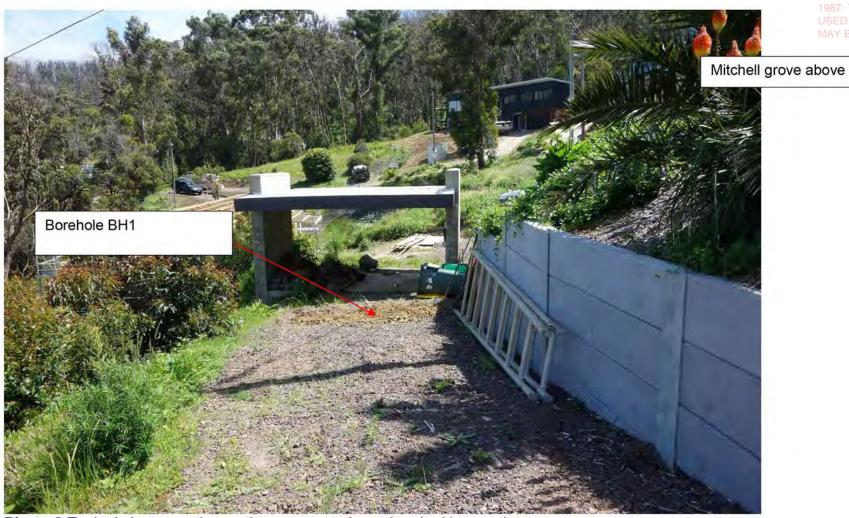
Photo 2 Typical slopes on the northern property boundary looking north west

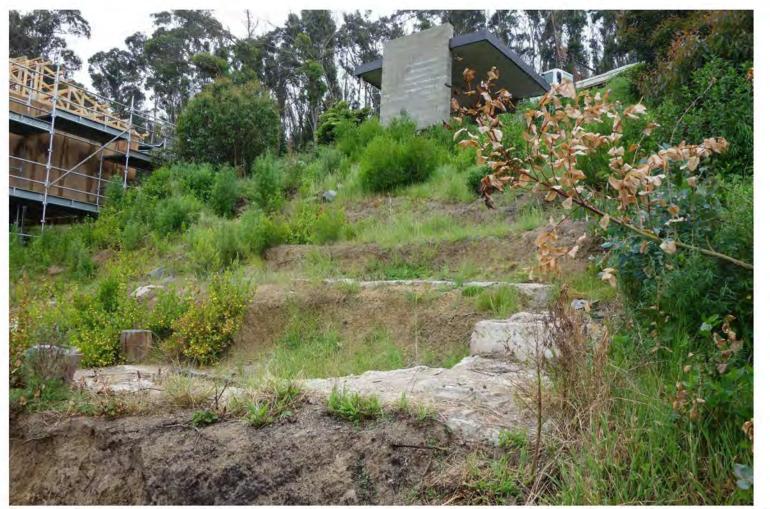
Photo 3 Typical small benches at the location of the previous dwelling looking north east. Note the recovering vegetation.

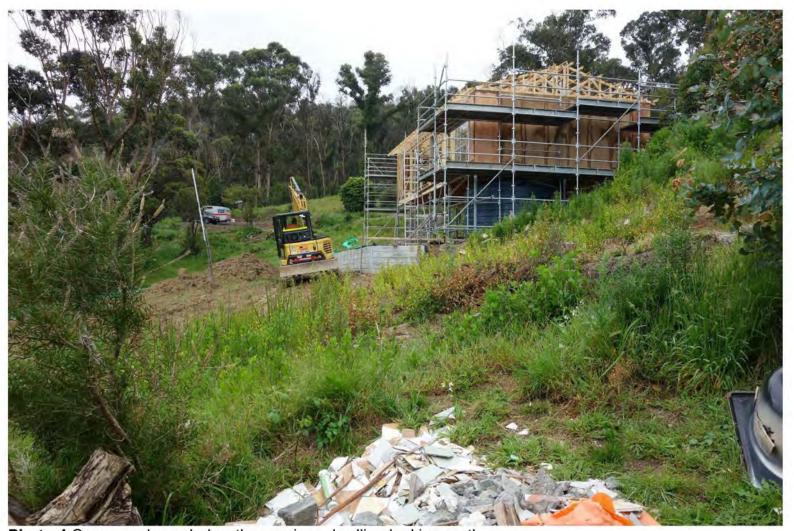
Photo 4 Concave slopes below the previous dwelling looking north.

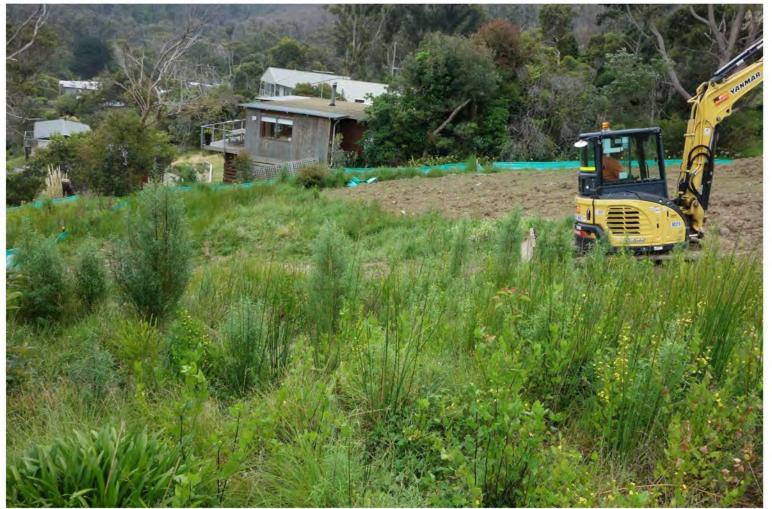
Photo 5 Moderate slopes in the area of the disposal field looking west. Note recovering vegetation.
