Infrastructure projects update

Wye River and Separation Creek

5 JULY 2018

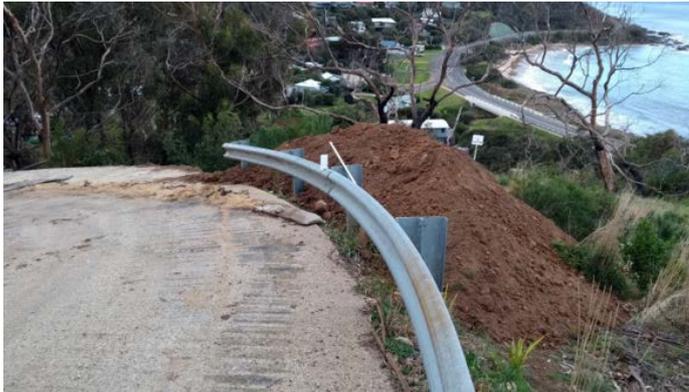
Iluka Extension looking towards Separation Creek below

The project involves constructing a 30m long, 2.2-metre-high new retaining wall to repair a landslide that has de-stabilized an important alternative emergency access connection for the Wye River and Separation Creek community.

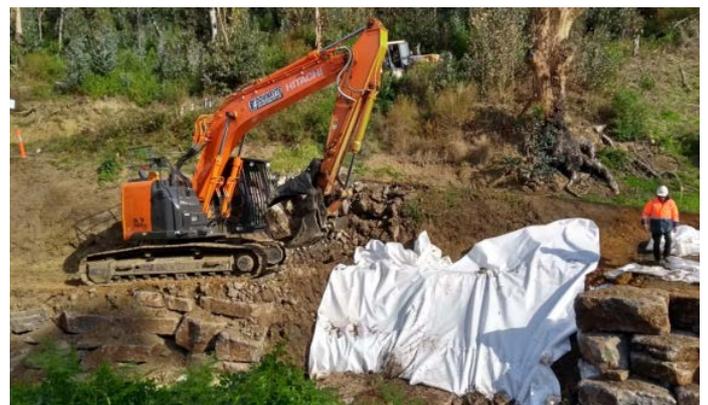
Rock Beaching on Creek Bank taking Shape

The laying of rock beaching and installing of soil nails will be ramped up over next two weeks, after which the creek bank will be close to completion. The bank stabilization work will then be repeated along the upper bank of Stanway drive.

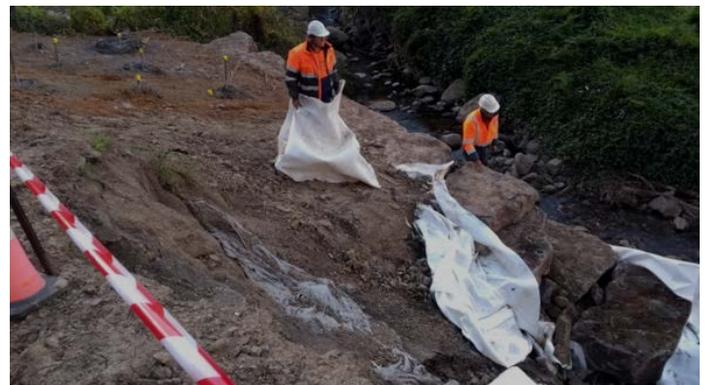
Soil nails behind the workers, drilled to 7.5m below surface

The stabilization work includes drilling 7.5 metres below ground to underlying rock layer and installing numerous steel bars. These bars are bolted at the ground surface to essentially sandwich the loose up ground and prevent future movement.

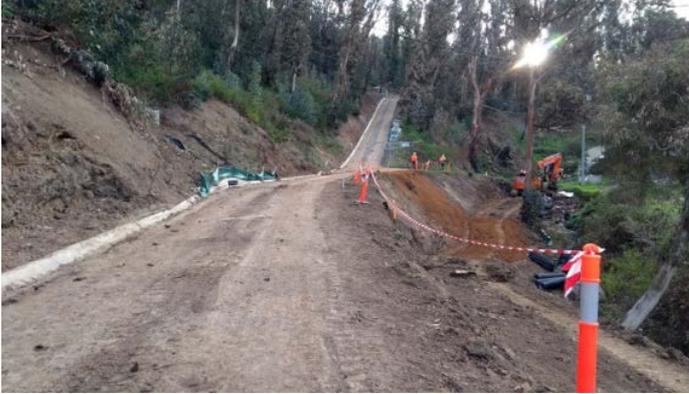
Stanway Drive. Beaching works on the upper left bank will begin after completion of the creek bank
