Department of Environment, Land, Water and Planning

**Wye River and Separation Creek -
Geotechnical, Land Capability and
Wastewater Solutions**

Land Capability Assessment

31 March 2016

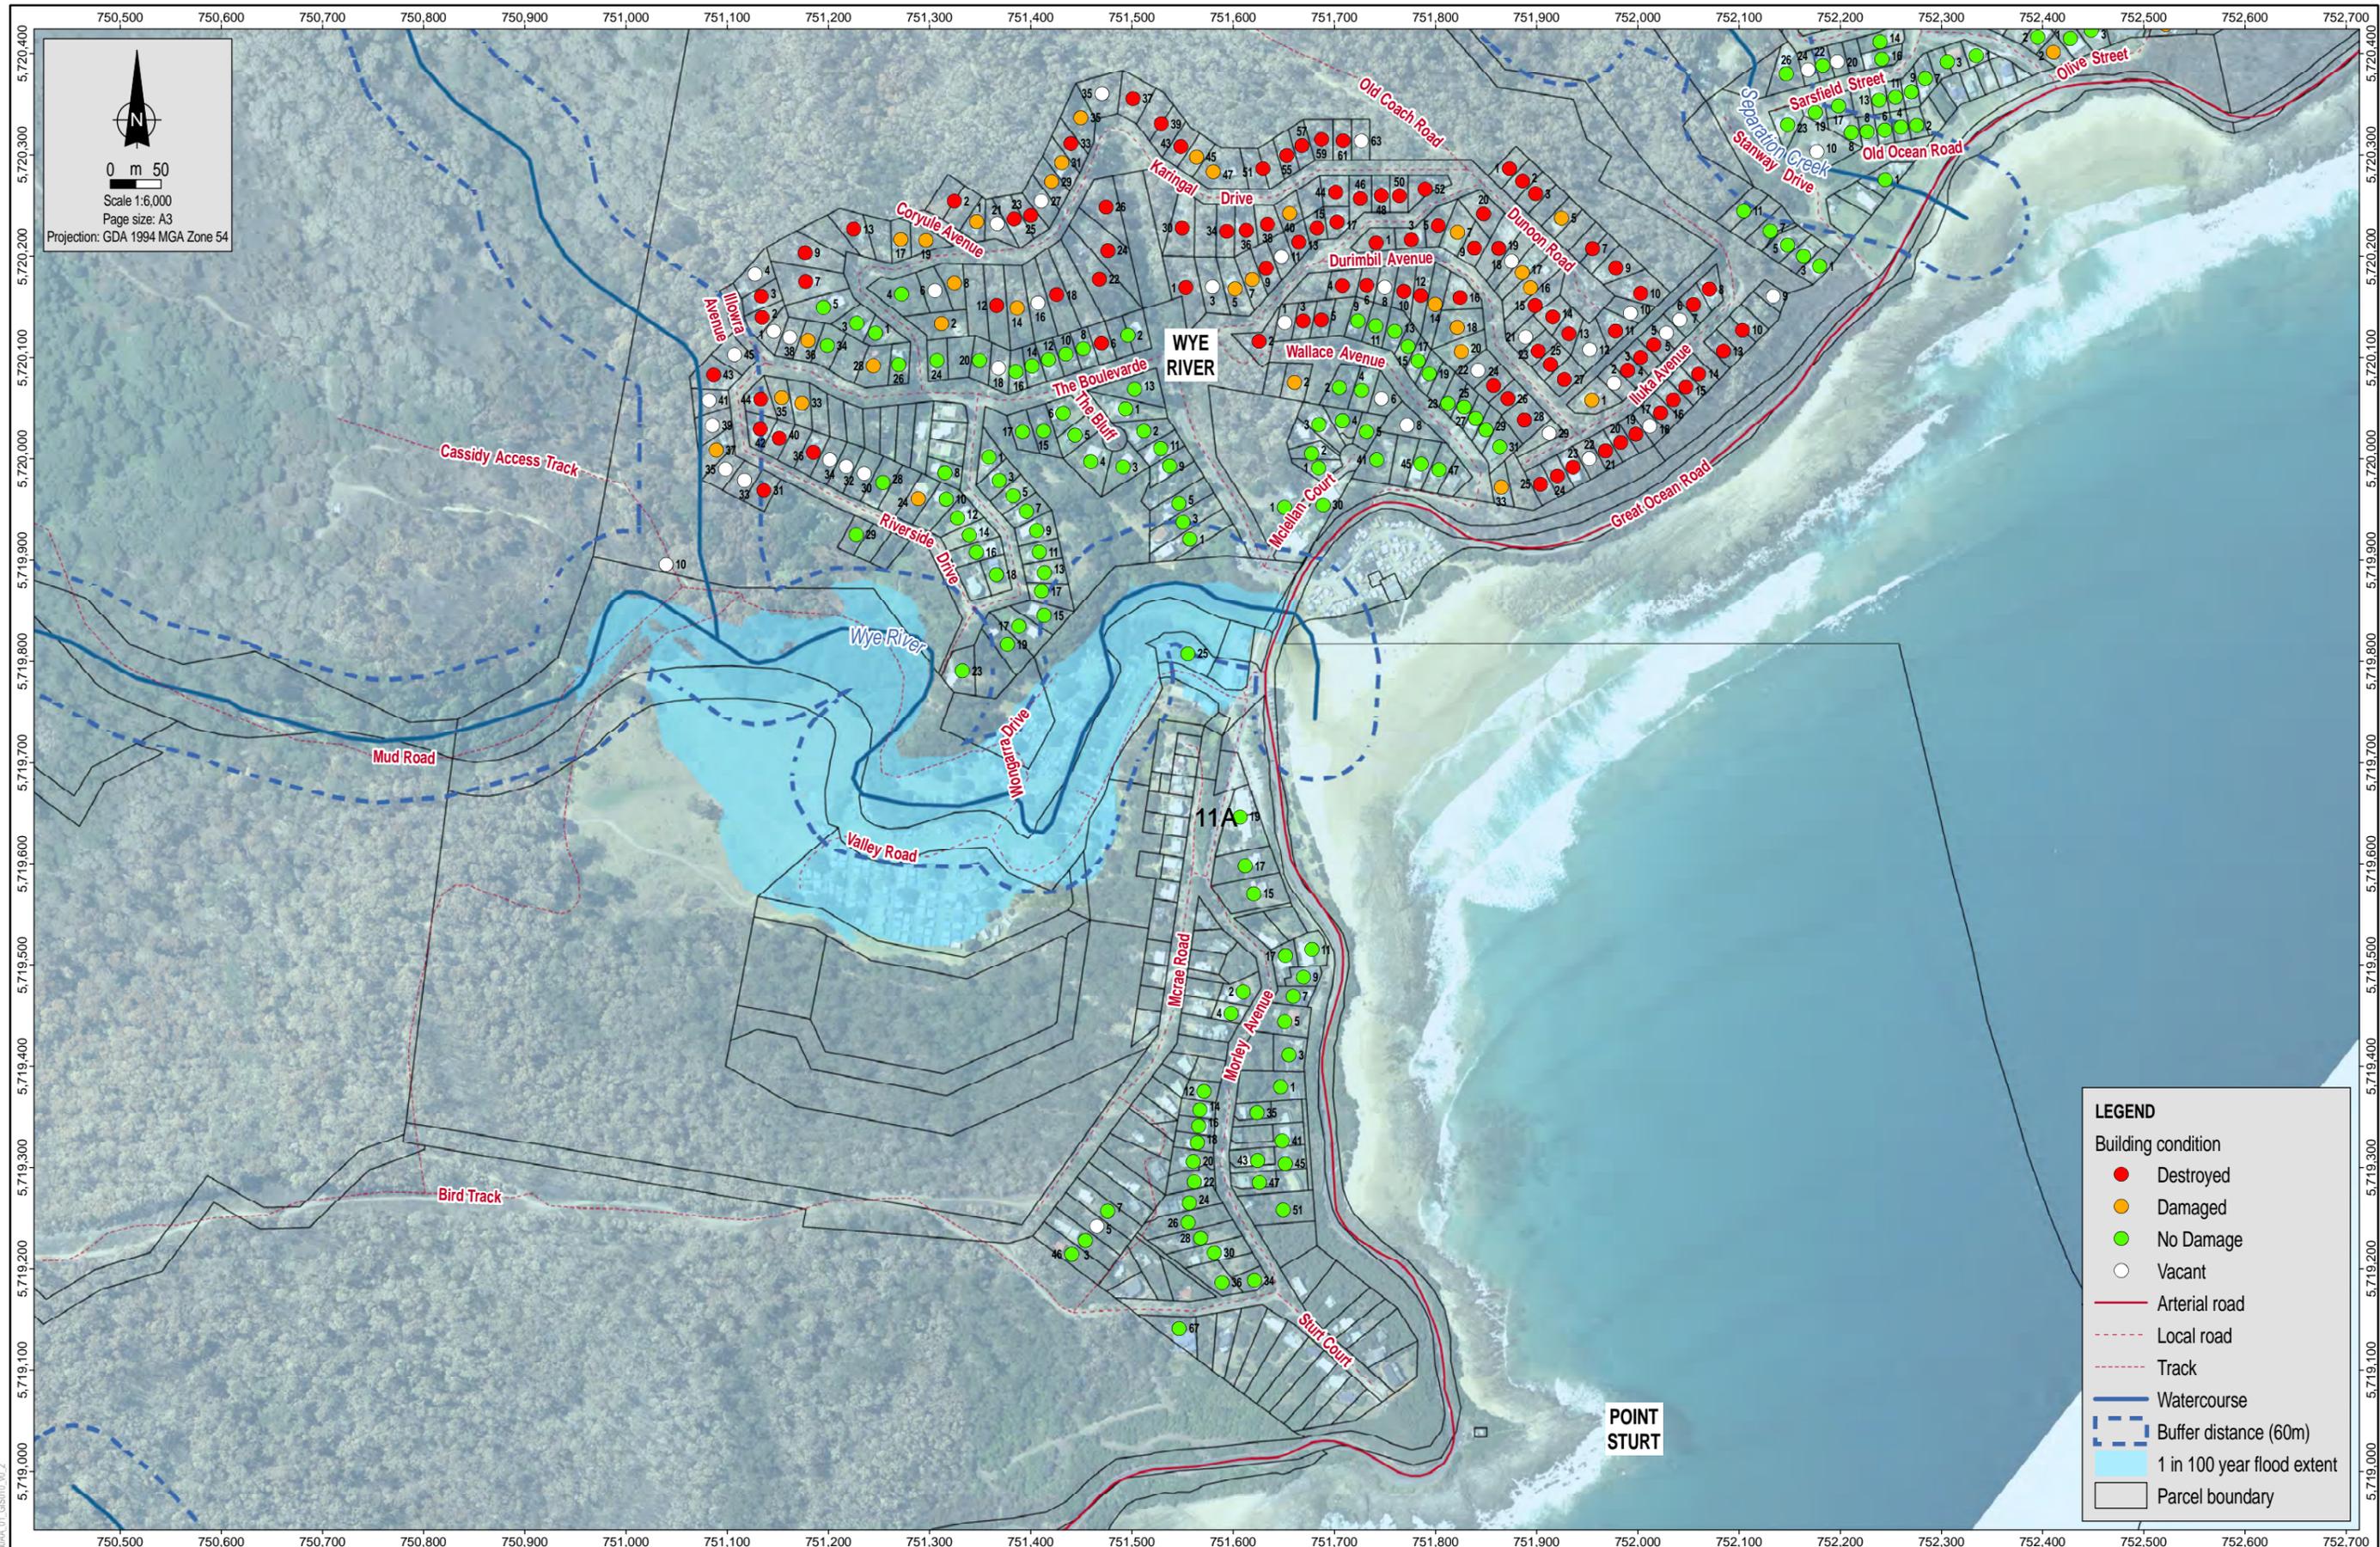
Figure No:
1A

Study area
Wye River

The study areas are shown on Figure 1a and 1b for Wye River and Separation Creek respectively.

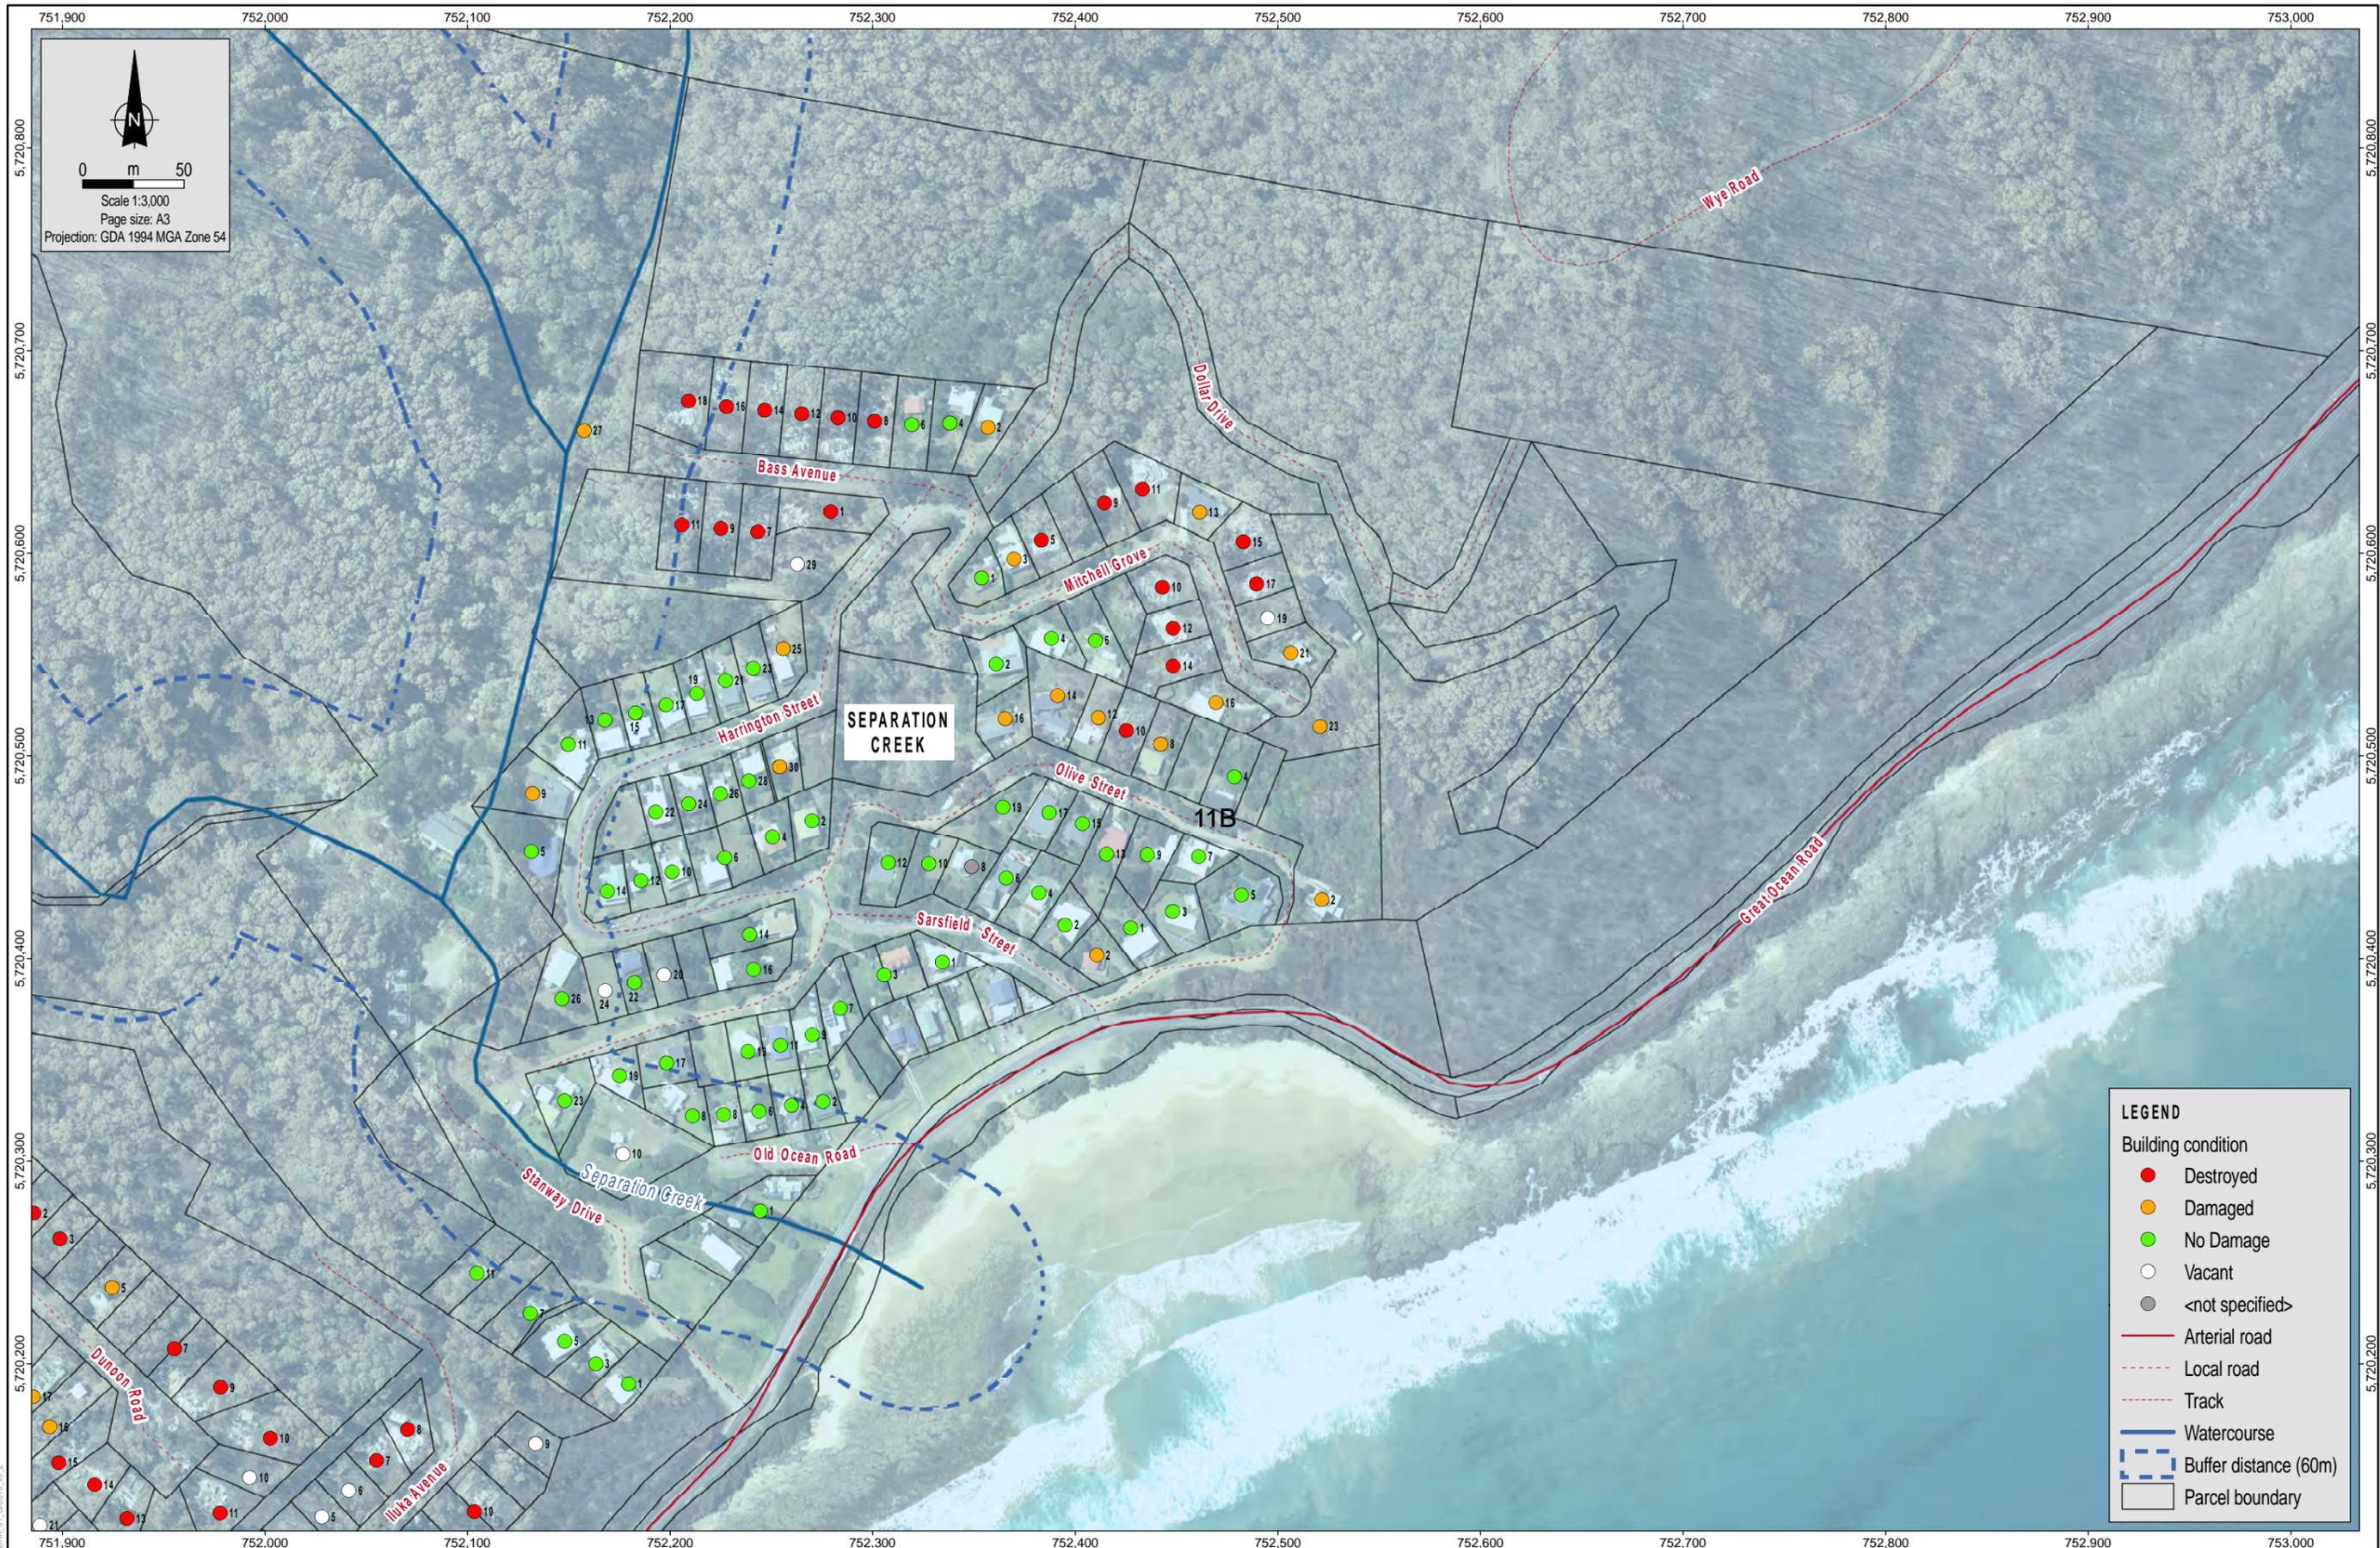
LEGEND

Building condition

- Destroyed
- Damaged
- No Damage
- Vacant
- <not specified>

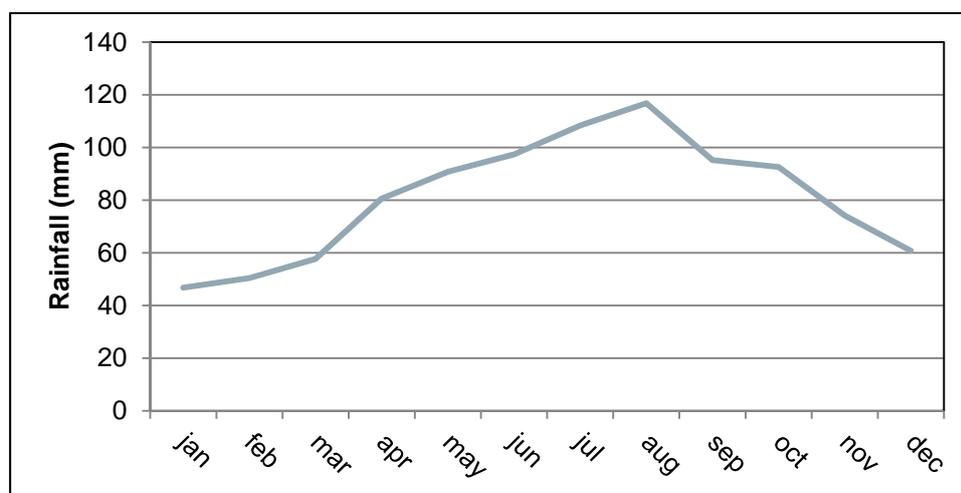
Chart 2.1 Wye River modelled rainfall

Month	Jan	Feb	Mar	Apr	May	Jun	Jul	Aug	Sep	Oct	Nov	Dec	Ann
Rainfall (mm)	46.8	50.4	57.7	80.6	90.8	97.4	108.4	116.7	95.2	92.6	74.2	60.8	971.6
Source: Dahlhaus (2002) cited in Dahlhaus and Miner (2003)

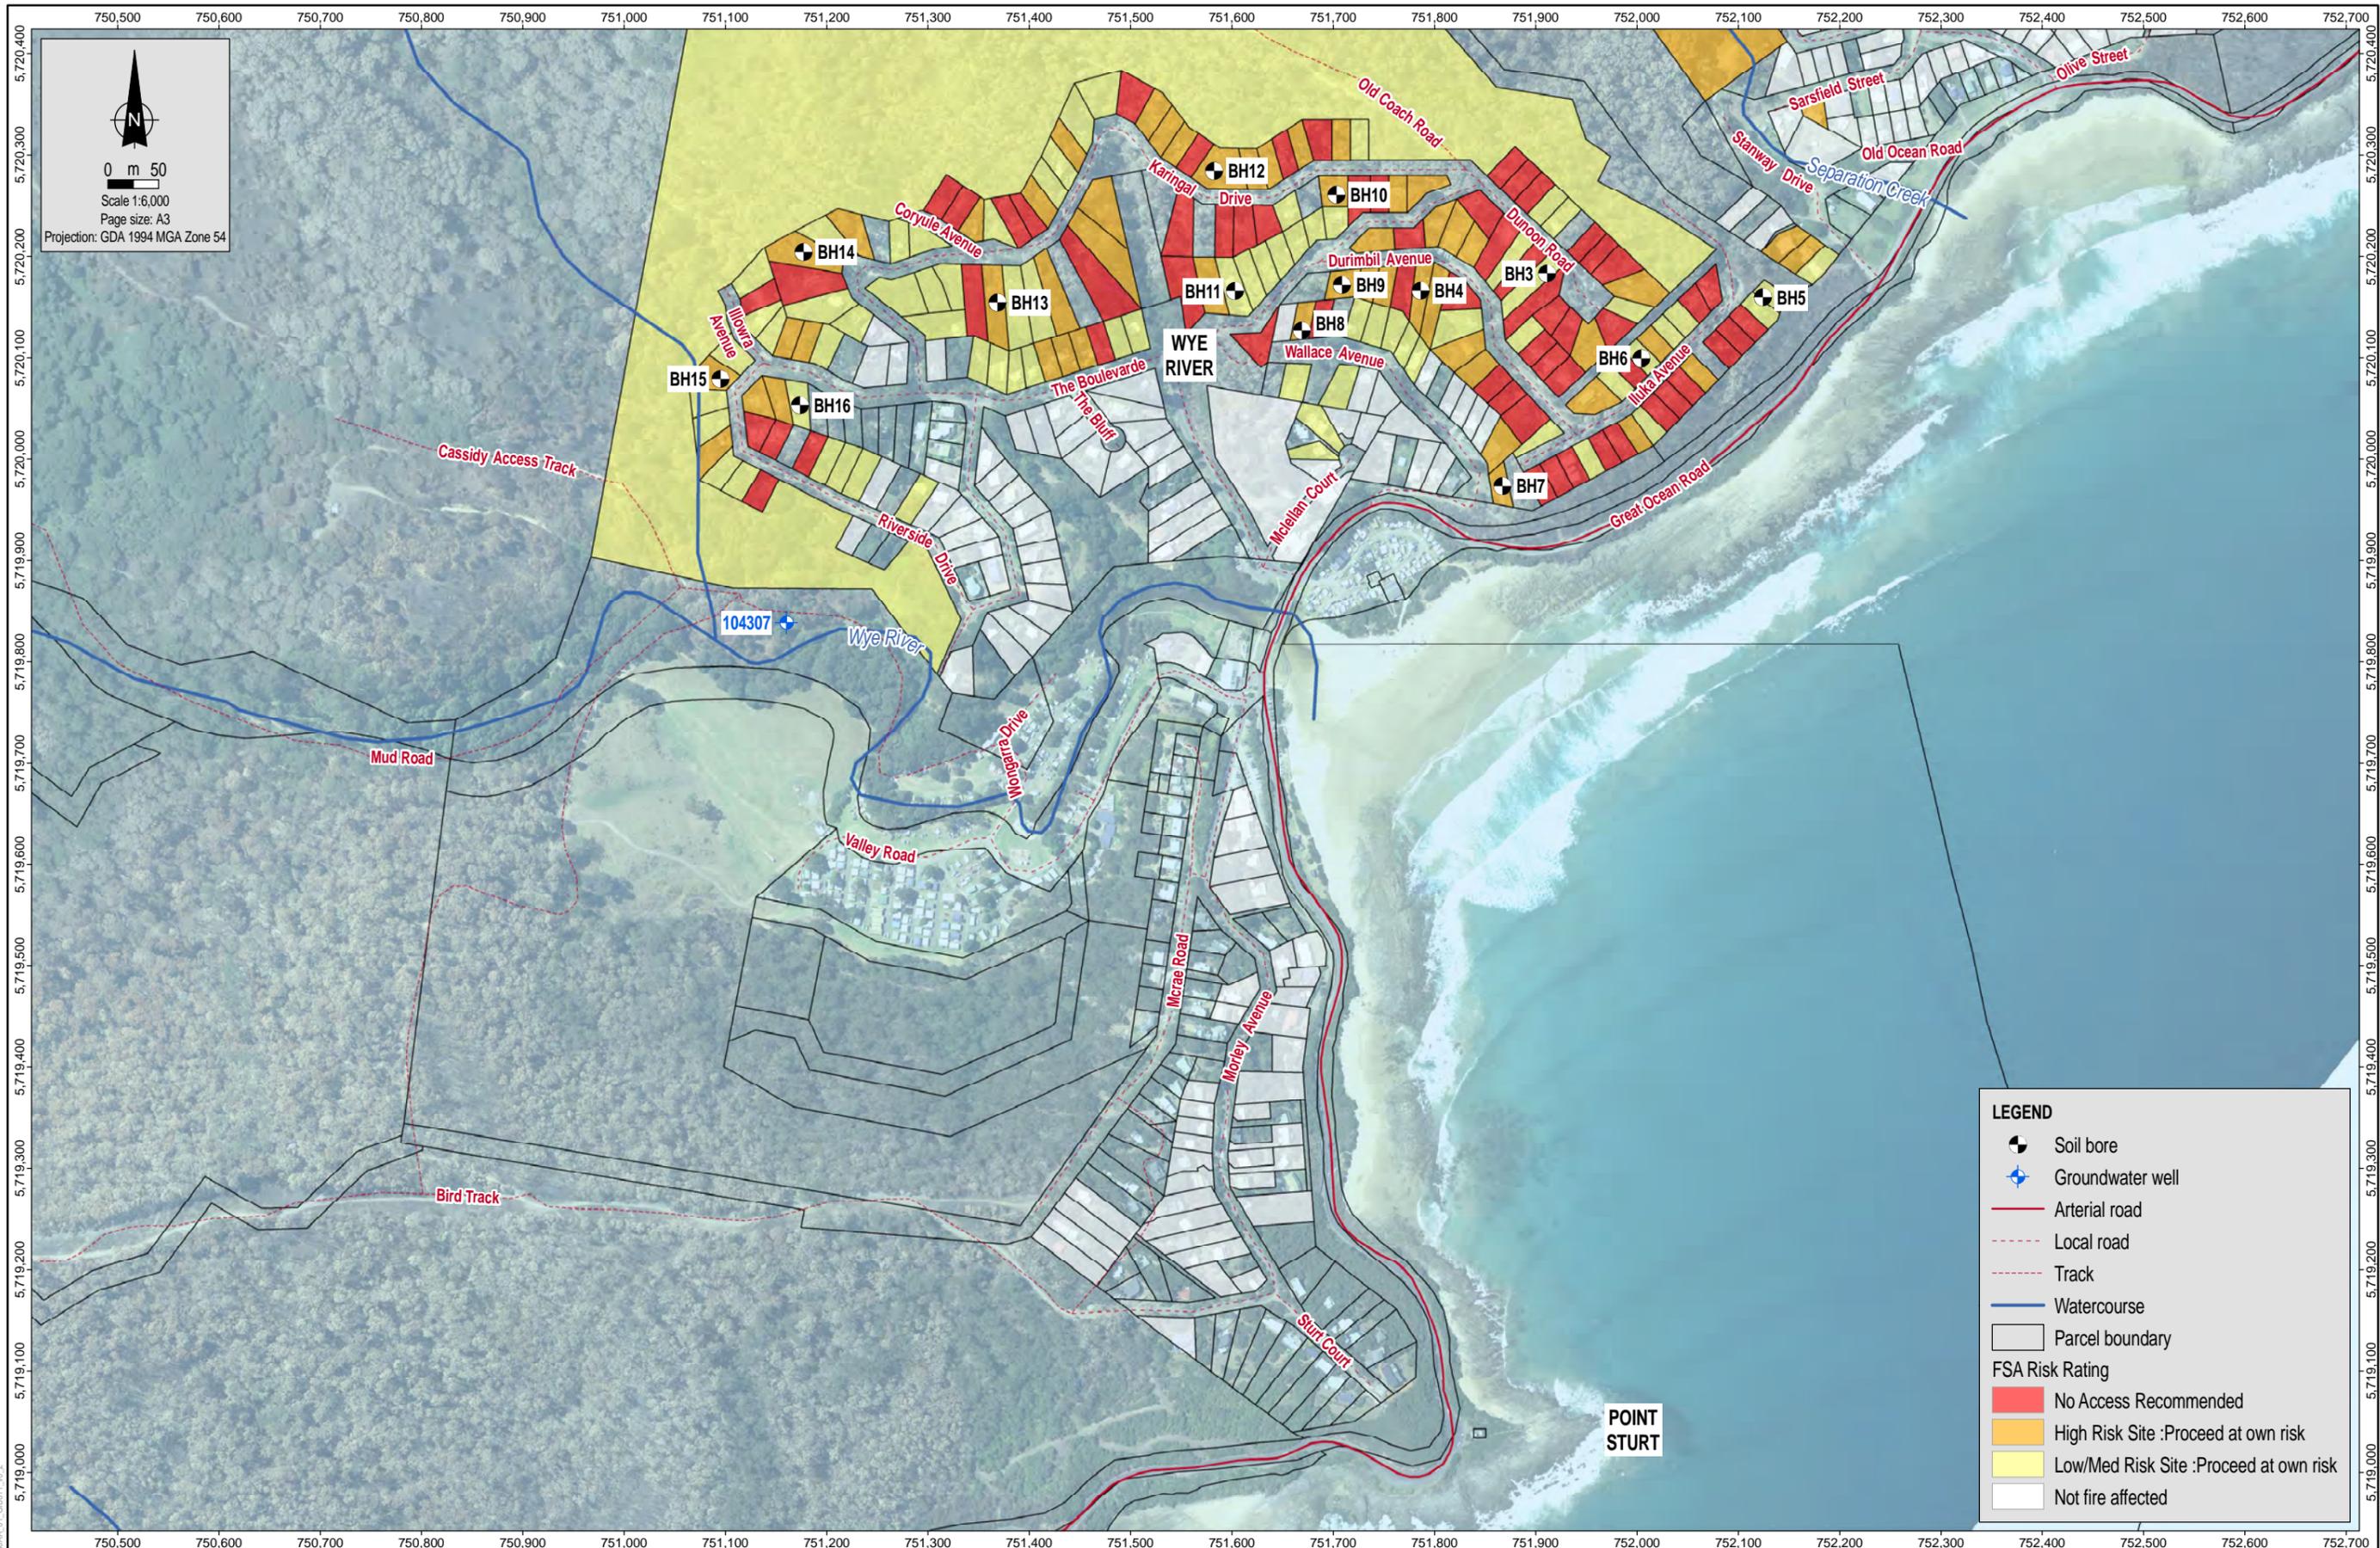
Figure No:
2A

**Soil bore locations
 Wye River**

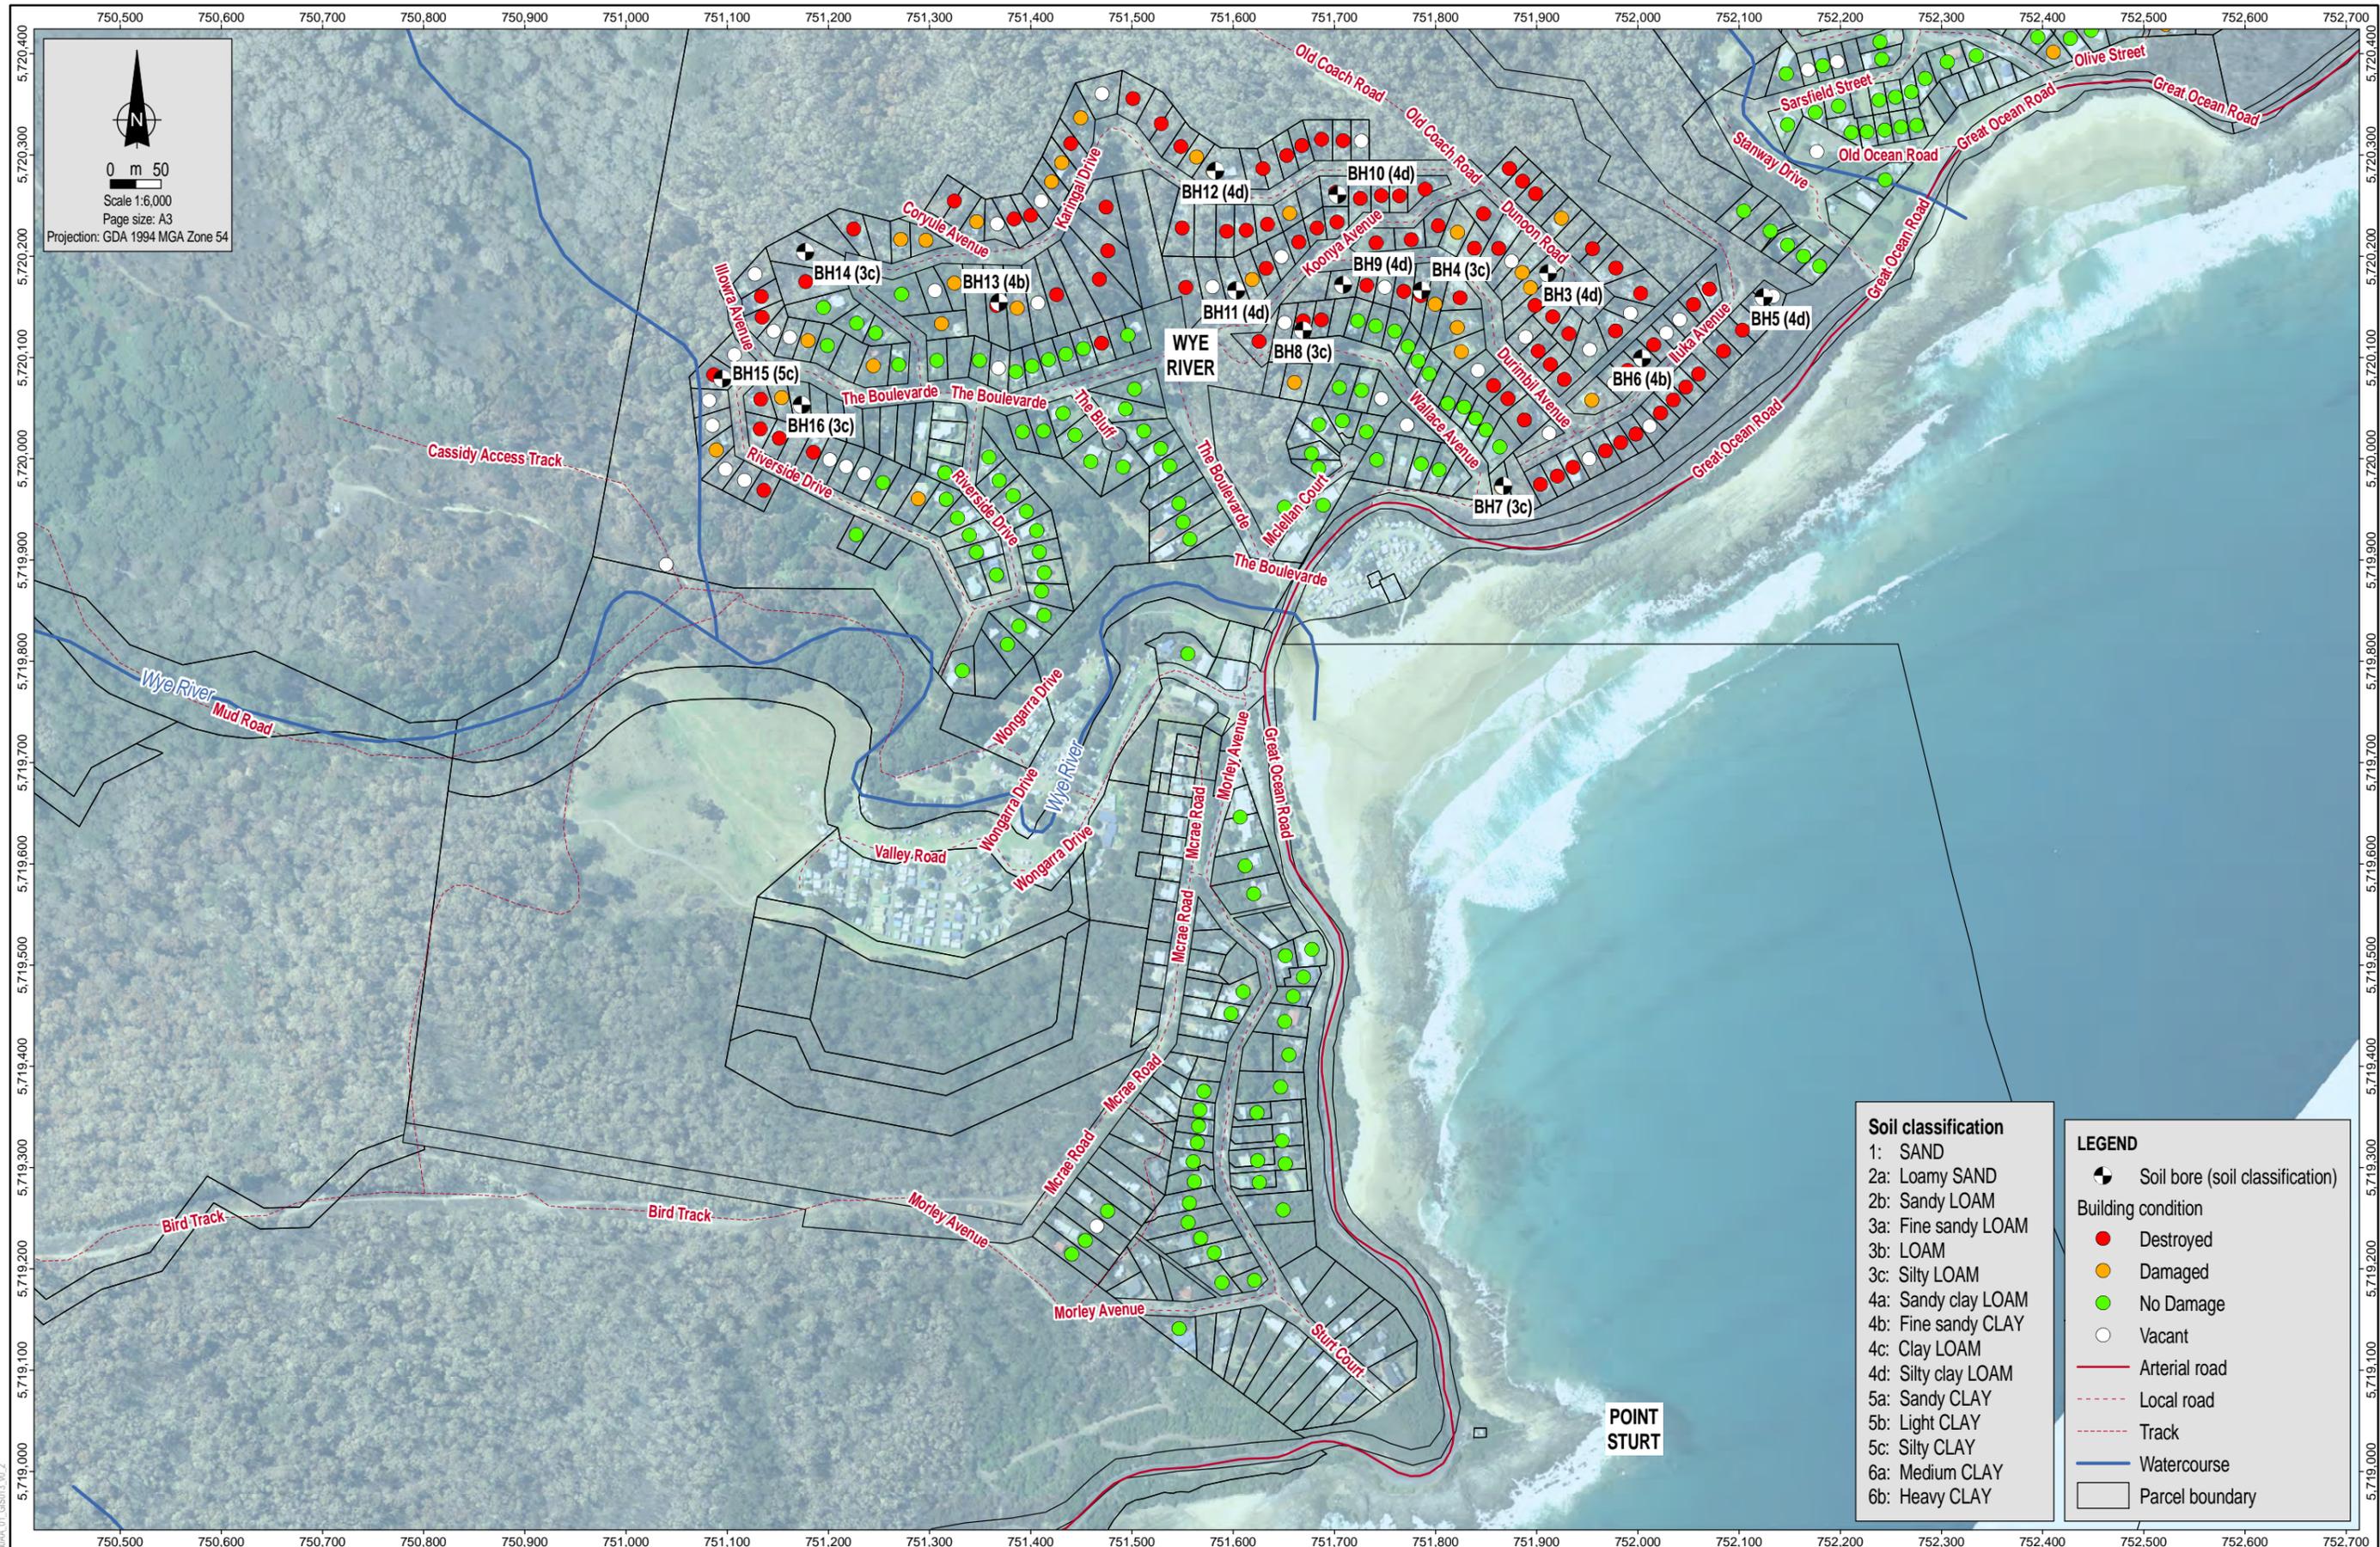
Figure No:
 3A

Soil classification
 Wye River

Based on the site soil field investigations, the soil profile intersected at Wye River ranges from a yellow brown silty loam to a brown silty clay loam with moderate structure, underlain by weathered sandstone and siltstone bedrock of the Eumeralla Formation (Figure 3a). The depth to rock varies but is typically intersected at approximately 1 mbgs. The indicated permeability (K_{sat} - EPA Publication 891.3) of these shallow soils is likely to range between 1.5 to 3.0 m/day.

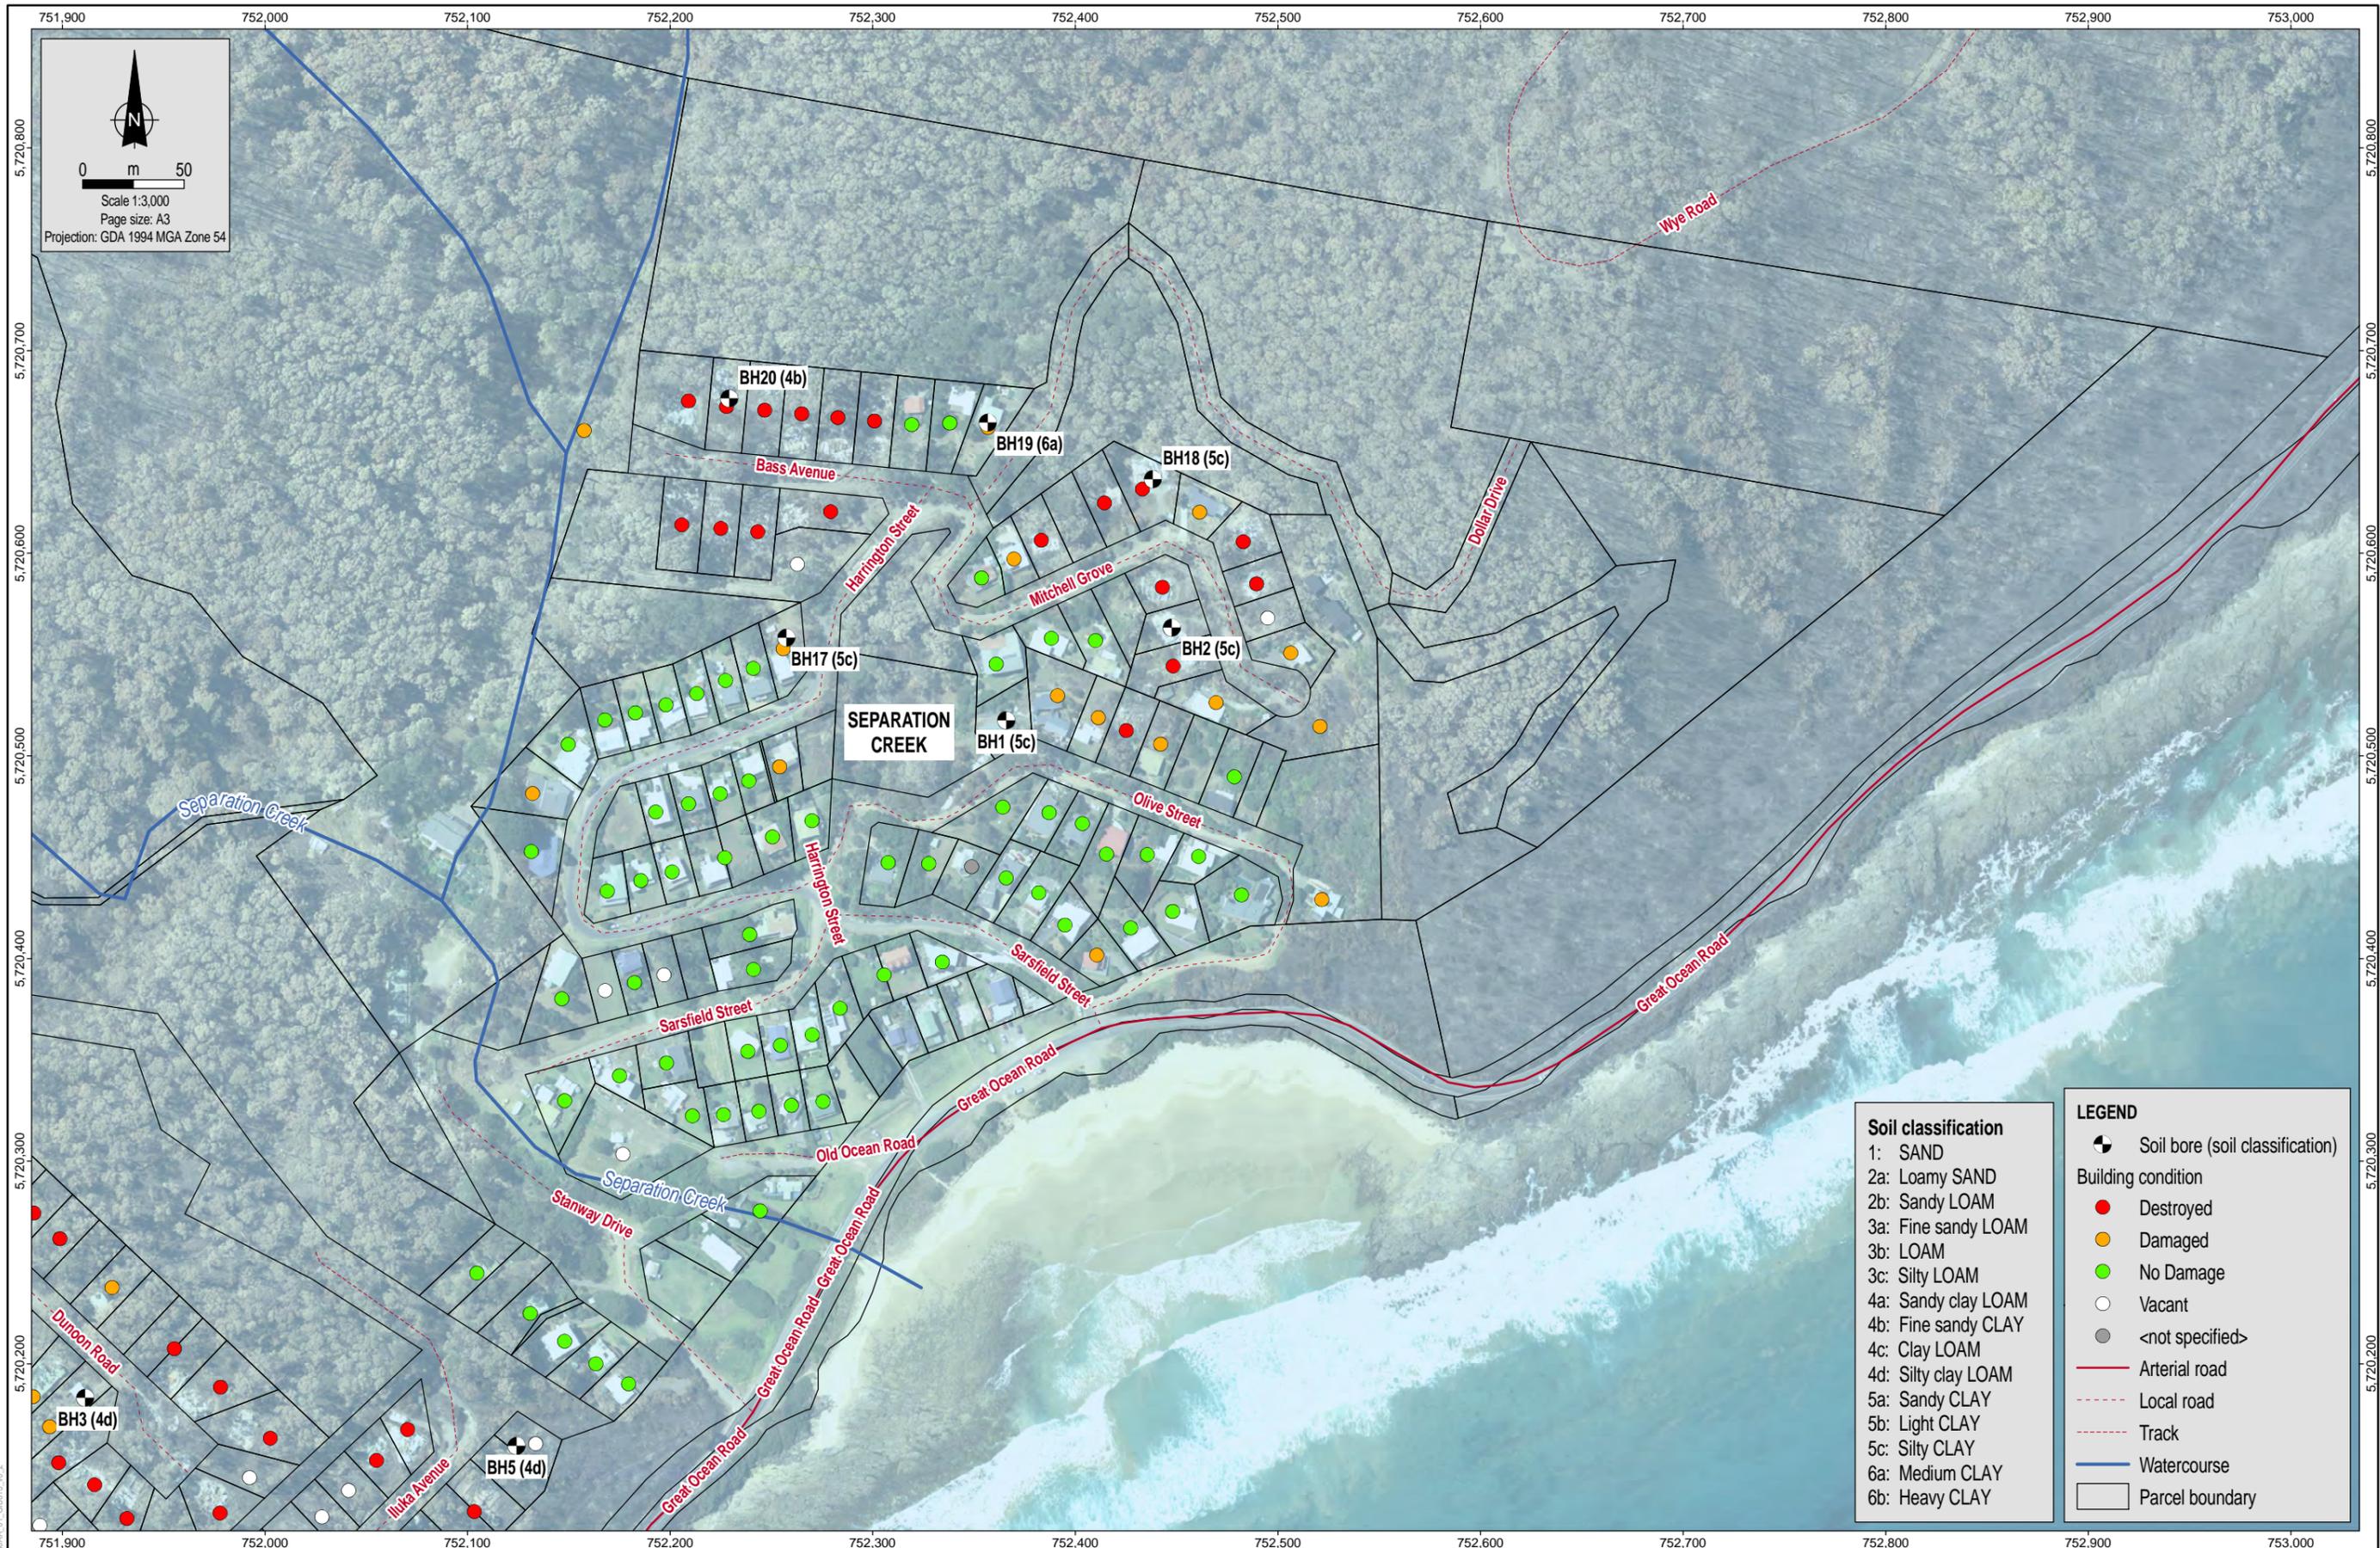
The soil profile at Separation Creek was found to typically comprise brown silty clay with moderate structure (Figure 3b). The depth to rock also varies but is typically intersected at approximately 1 metre below ground surface (mbgs). The indicated permeability (Ksat) of these shallow soils is likely to range between 0.06 to 0.12 m/day.

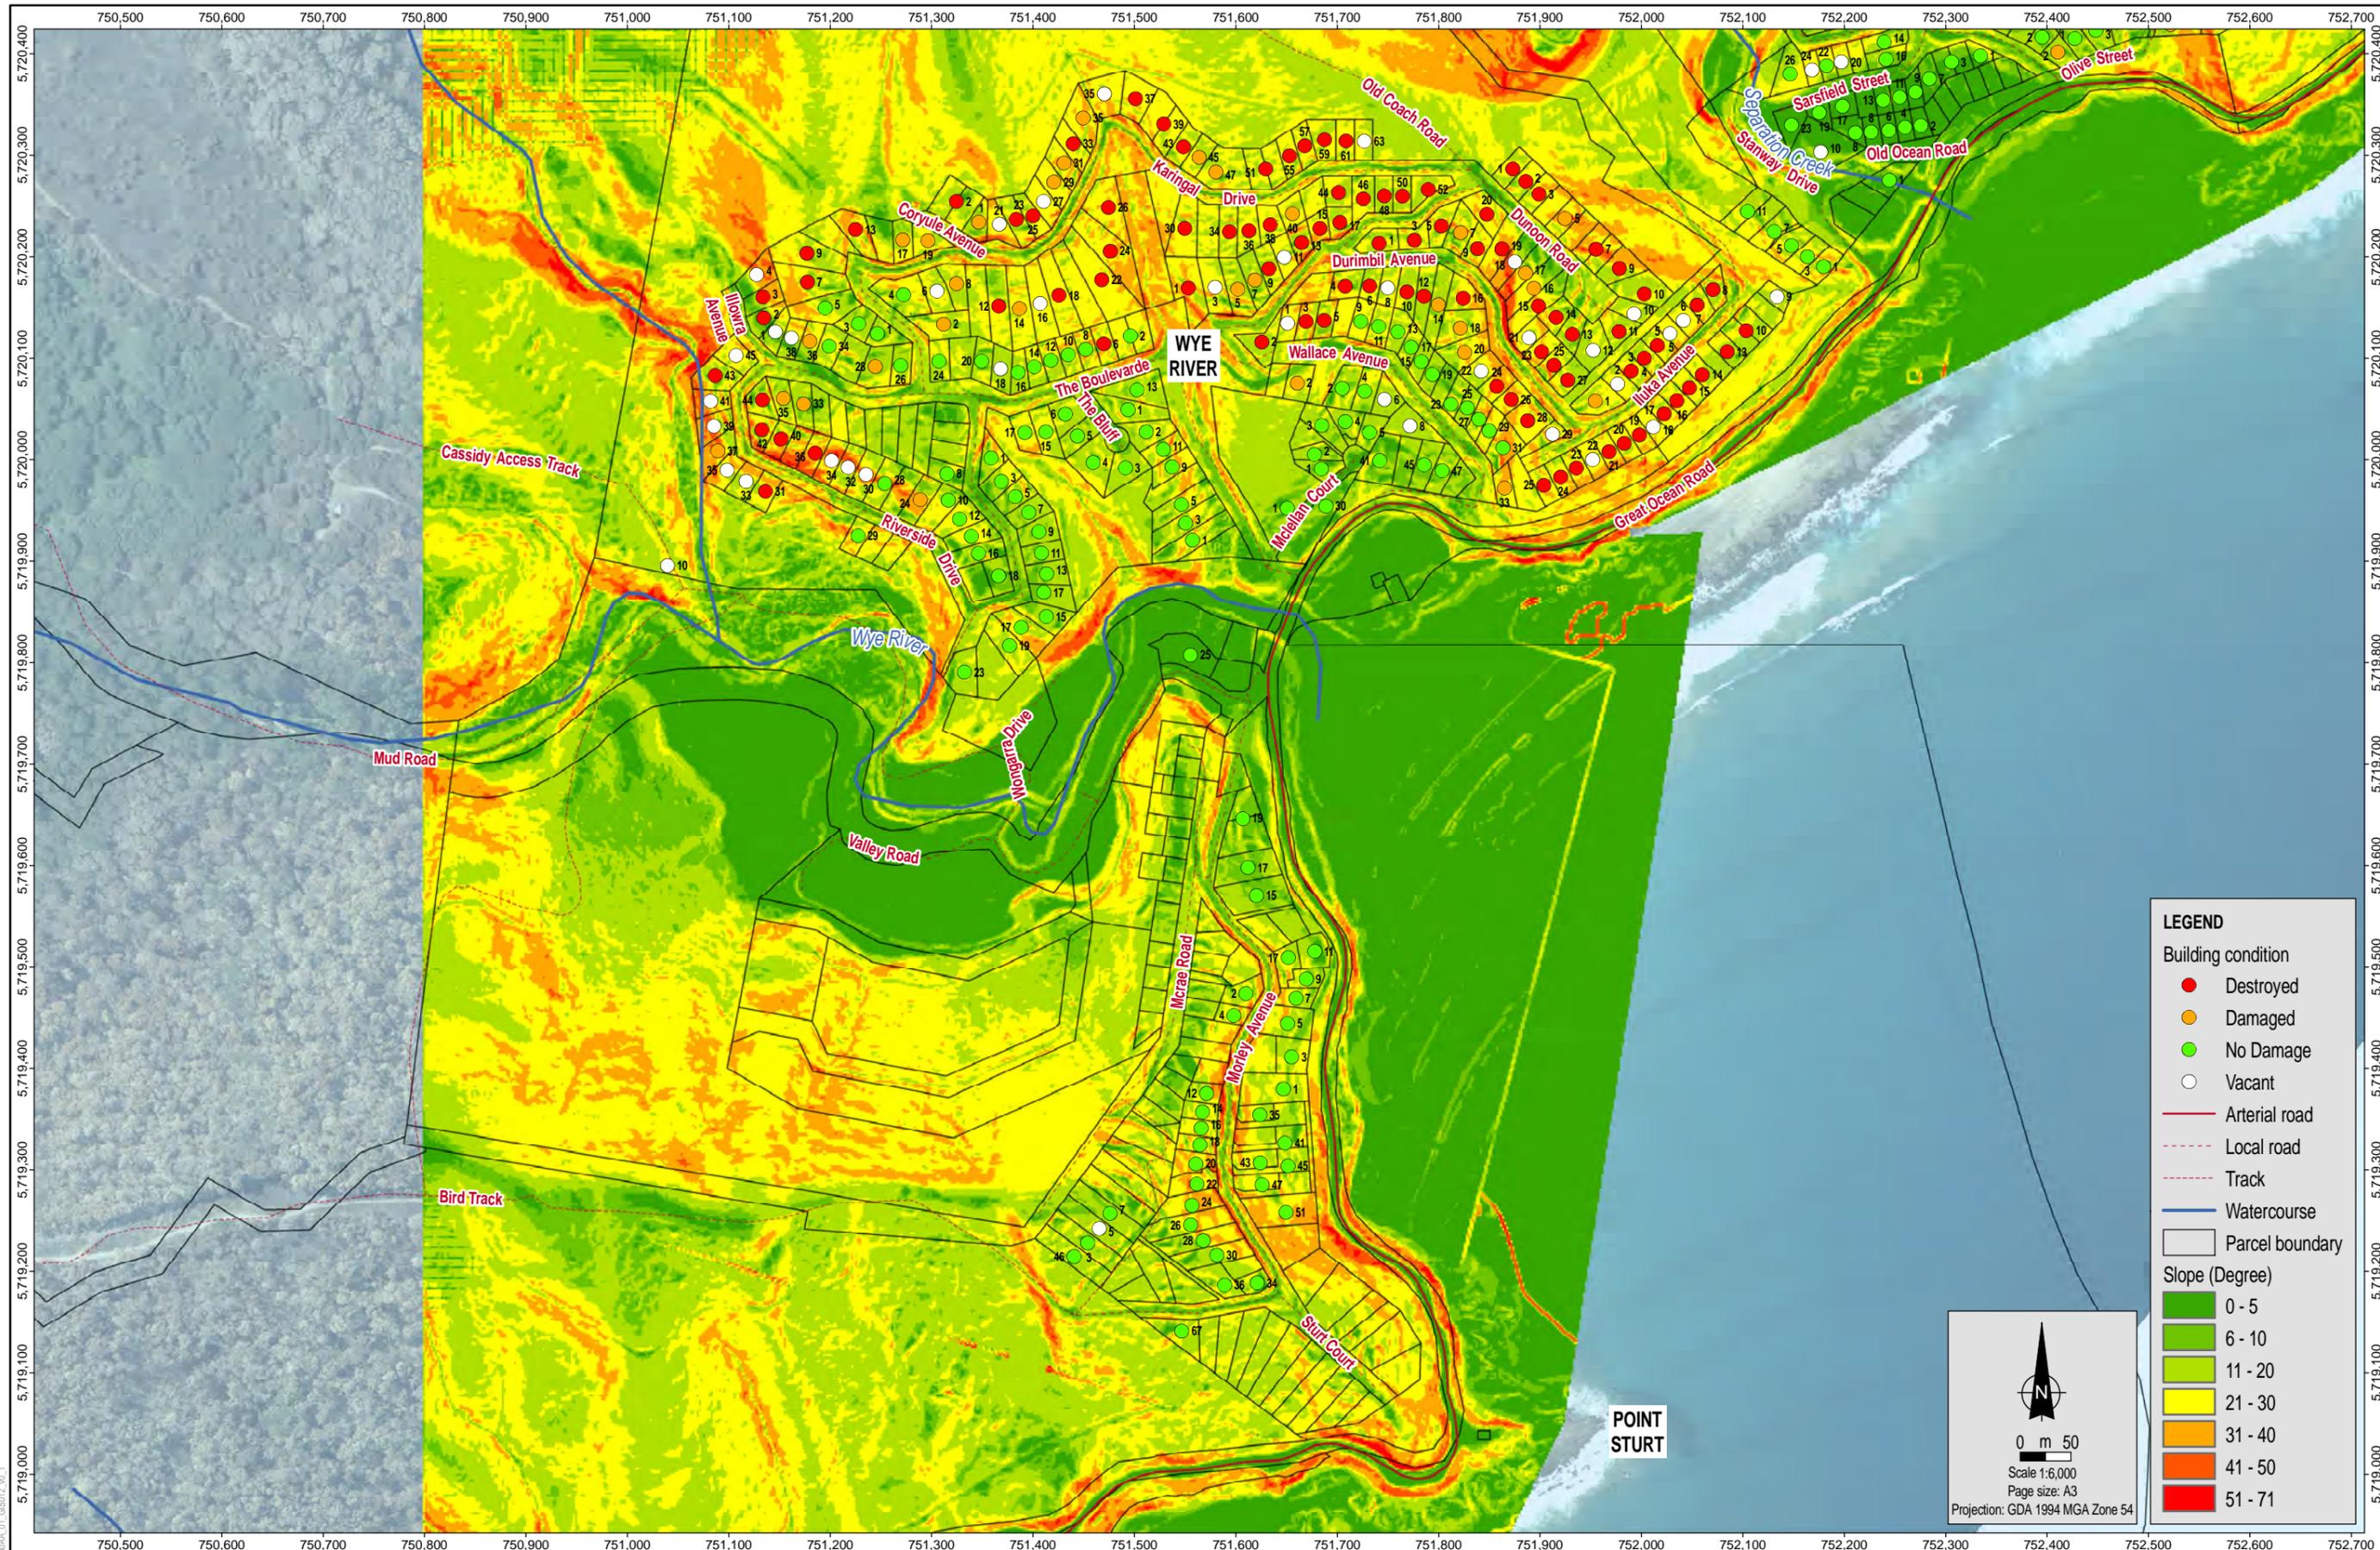
Figure No:
4A

Slope analysis
Wye River

In cases where steep slope is a constraining factor, a range of approaches may be feasible to mitigate the constraint, but would require individual assessment:
