Department of Environment, Land, Water and Planning

**Wye River and Separation Creek -
Geotechnical, Land Capability and
Wastewater Solutions**

Land Capability Assessment

31 March 2016

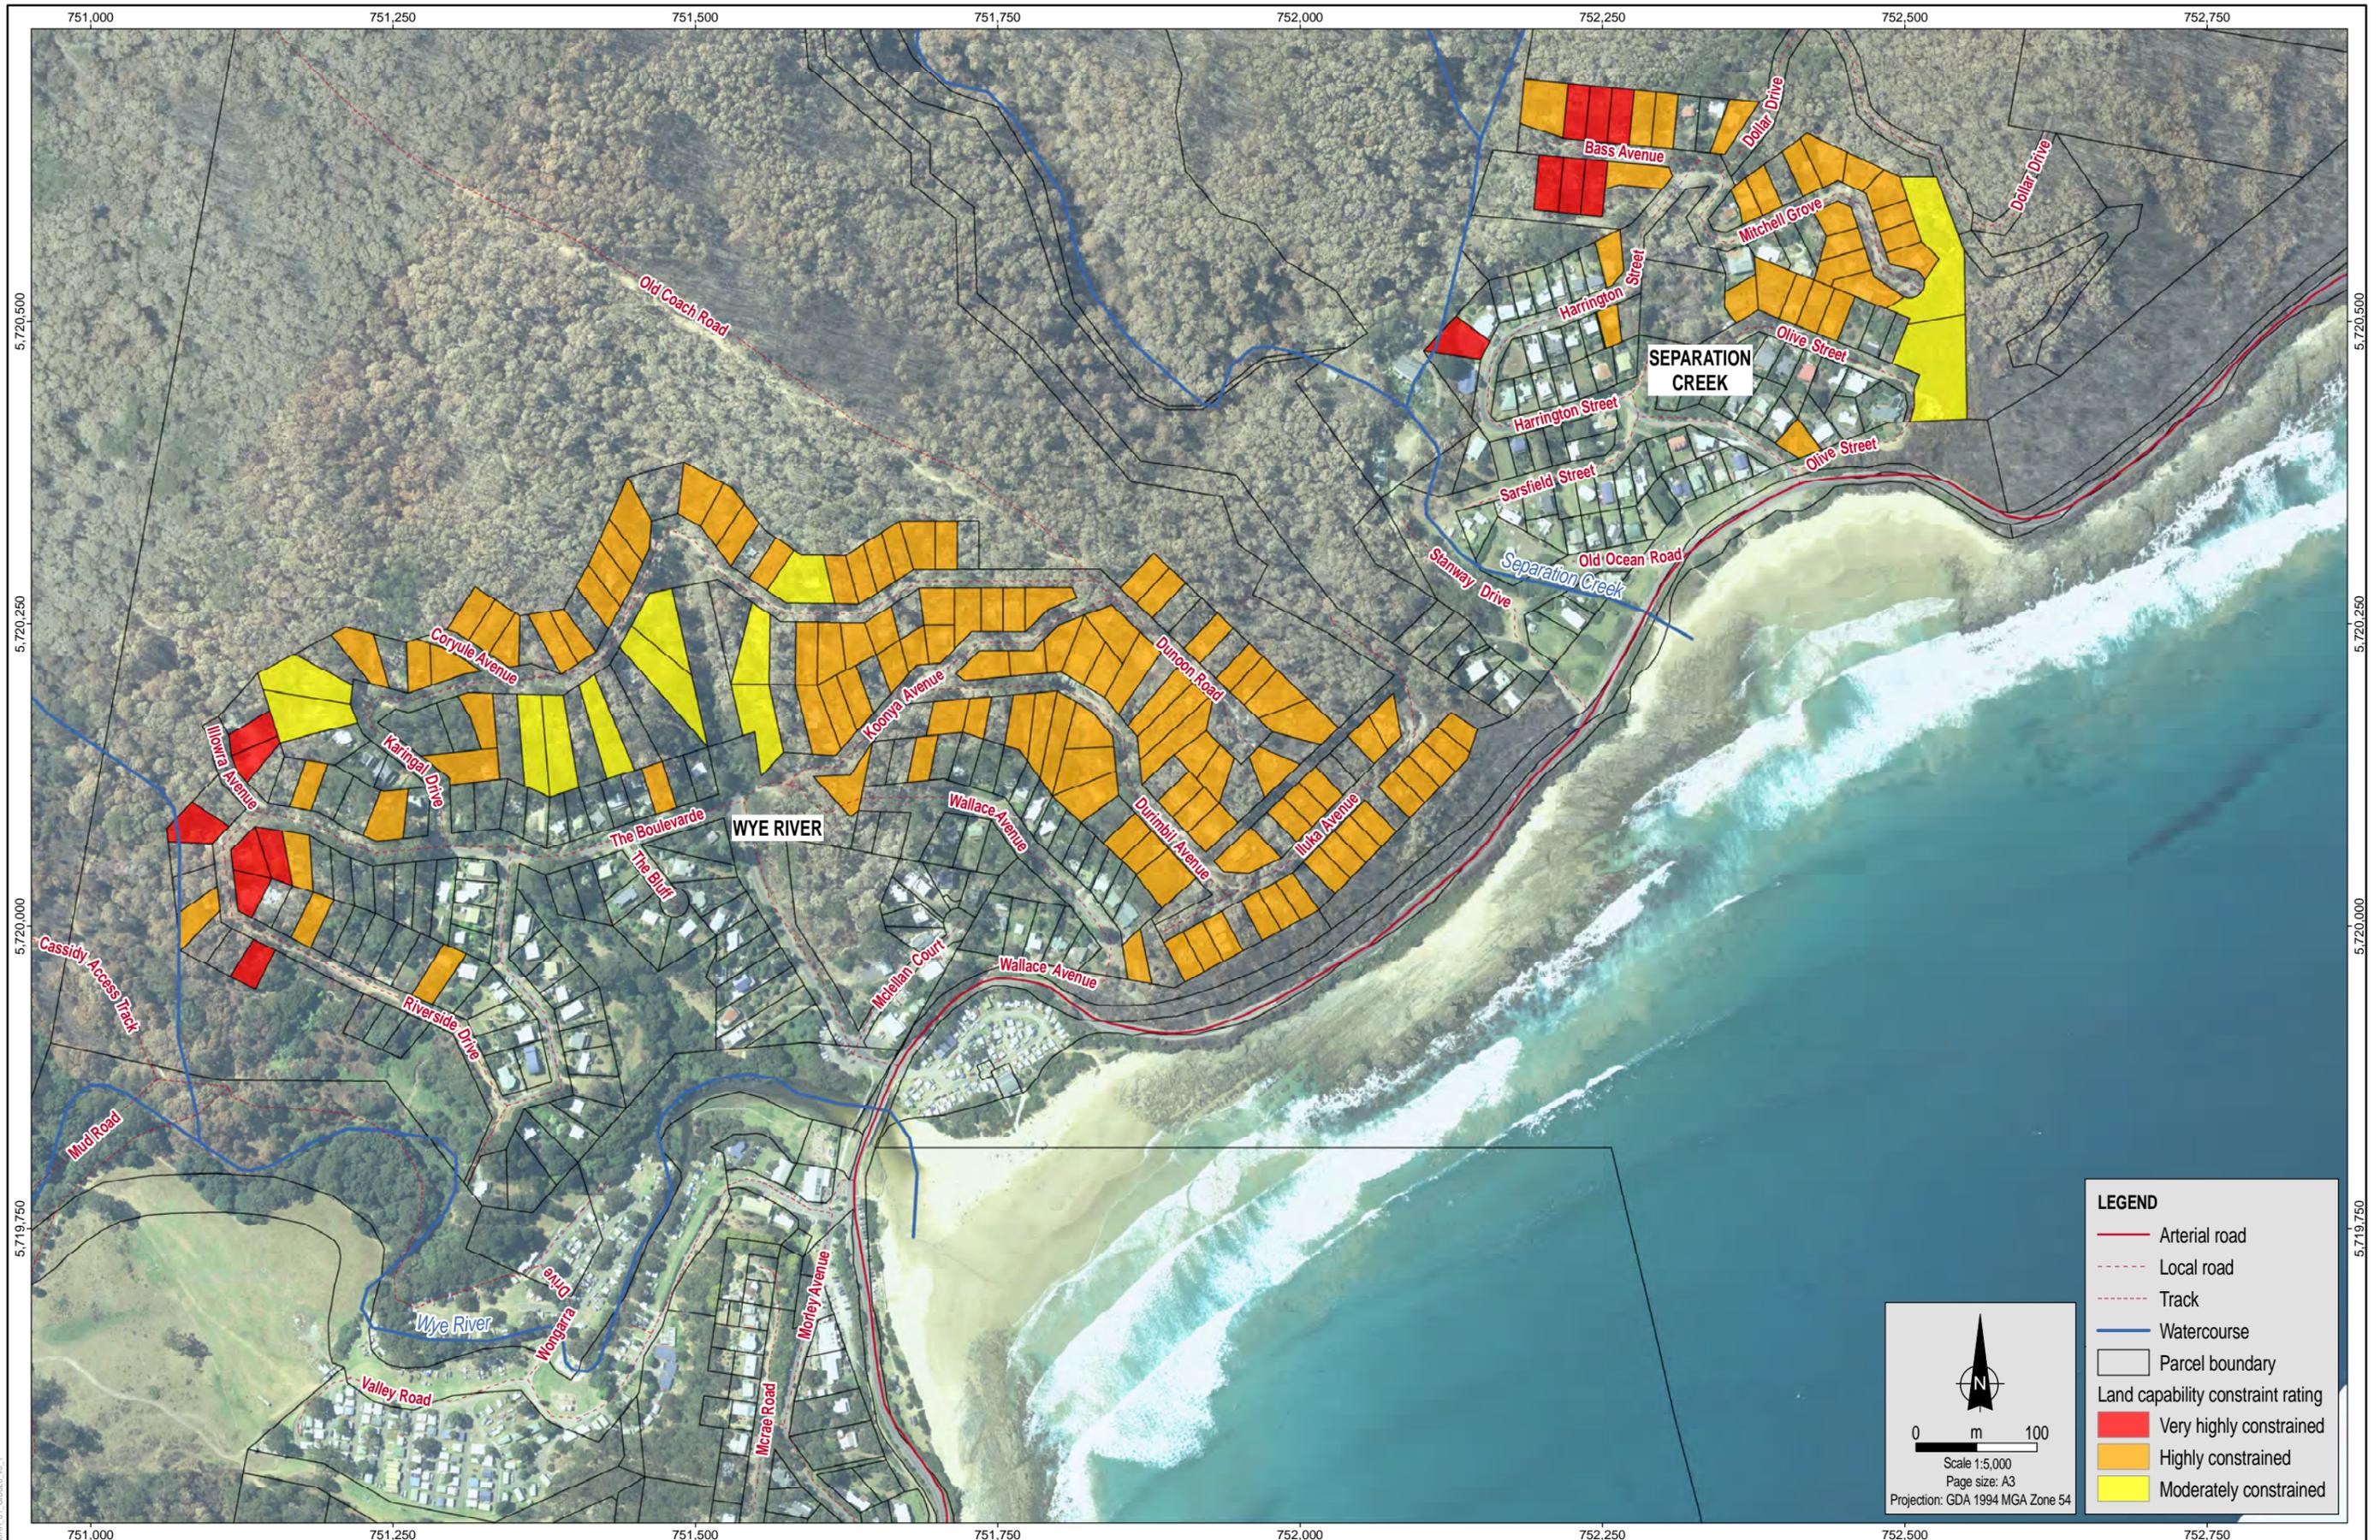
- Arterial road
- - - Local road
- . . . Track
- Watercourse
- Parcel boundary
- Land capability constraint rating
- Very highly constrained
- Highly constrained
- Moderately constrained

The onsite wastewater containment assessment identified that 14 properties are very highly constrained, 124 properties are highly constrained and 12 properties are moderately constrained (classified as being partially able to contain treated wastewater on site). The results of the assessment are found to be consistent with previous investigations across Wye River and Separation Creek.
