PP263/2018-1

571 Wild Dog Road APOLLO BAY

Use and Development of a Dwelling

EXHIBITION FILE

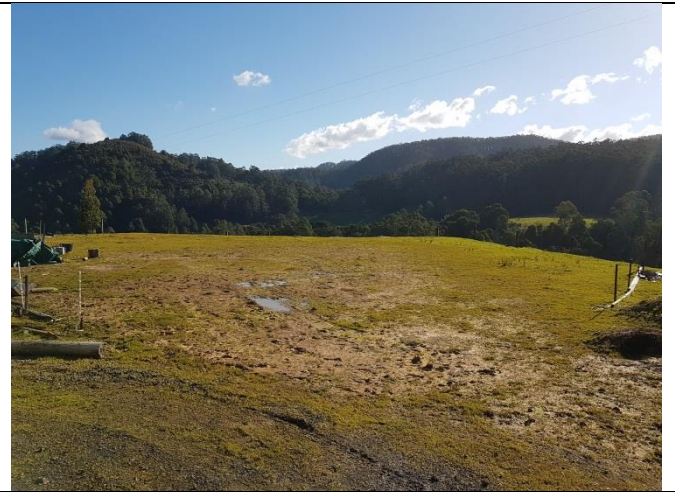
Photo 2: Overview of the proposed development area.

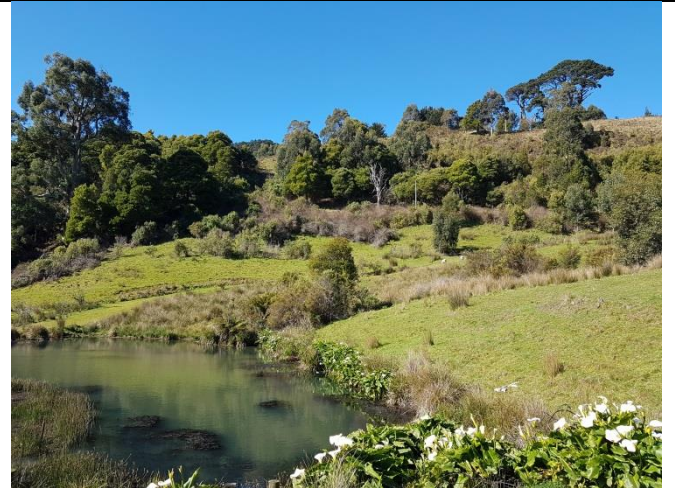
Photo 4: Dam and seeps behind proposed building site.

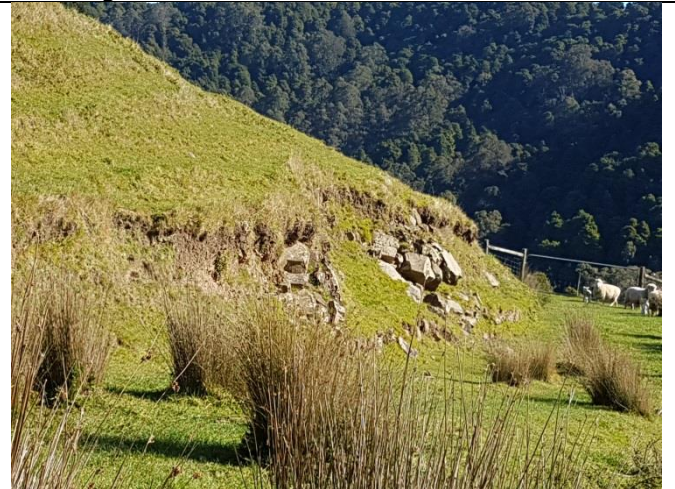
Photo 6: Cutting on neighboring property exposing typical debris material.

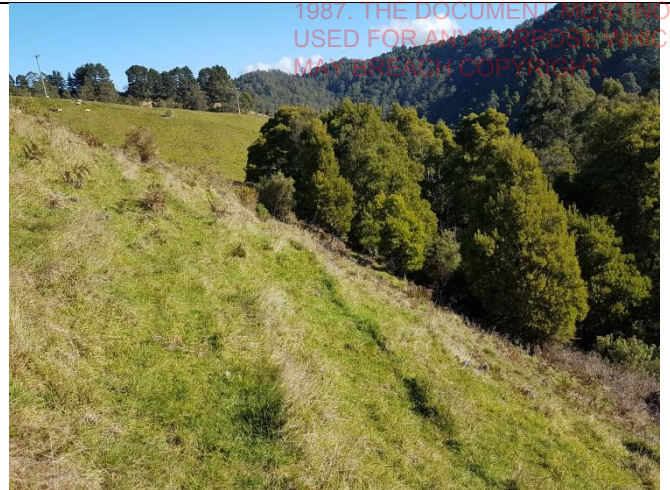
Photo 2: View of landslide scarp looking south

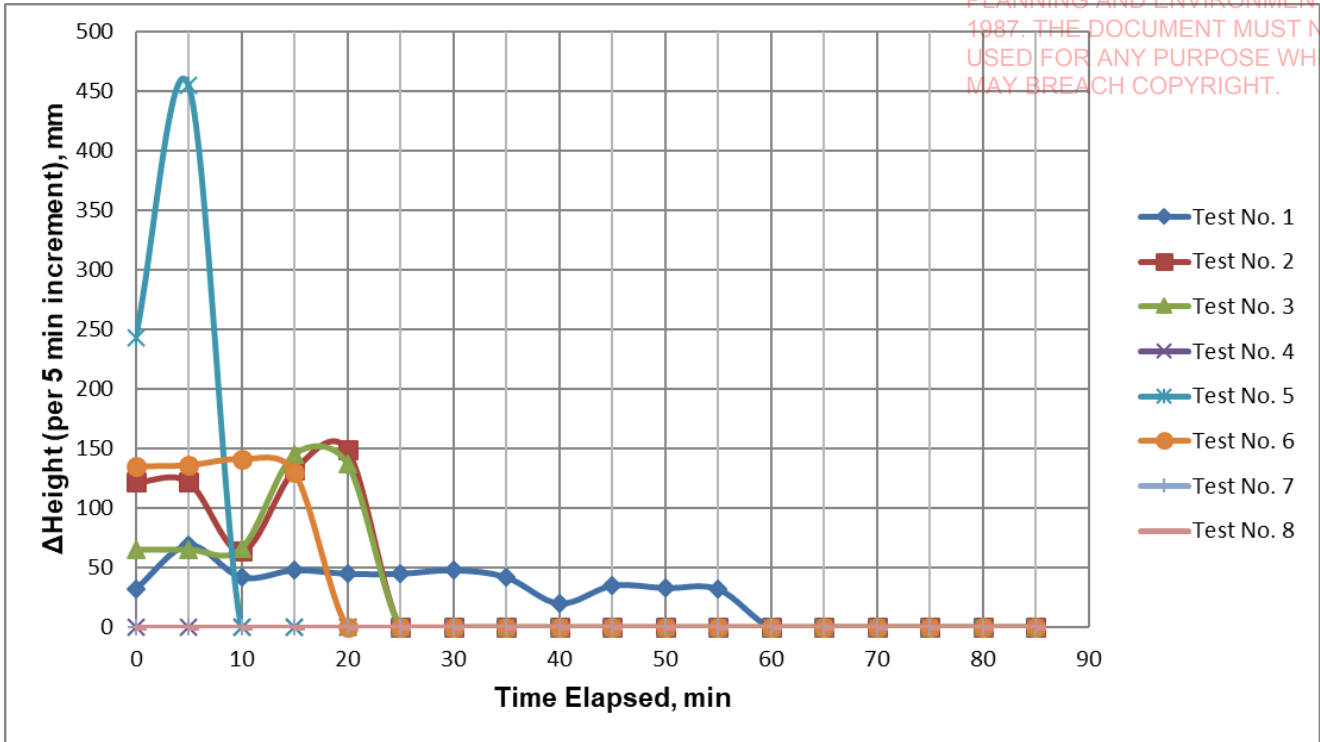
1	2	3	4	5	6	7	8
Starts uniform drop	15	10	20			5		
Stops uniform drop	60	25	25			20		
Time elapsed(min)	45	15	5			15		
Total Drop (cm)	34.8	34.5	13.7			40.7		
z	2.0	2.0	2.0			2.0		
Flow, Q (cm ³ /min)	9.7	28.9	34.4			34.1		
K _{sat} (cm/min)	0.0125	0.0371	0.0442			0.0438		
K _{sat} (m/day)	0.180	0.535	0.637			0.631		
	Average K_{sat} (m/day)						0.4956
