PP153/2019-1

45 Old Iluka Access YUULONG

**Use and Development of a Secondary School,
Removal of Native Vegetation, Alteration of
Access to a Road Zone in Category 1 and
Waiver of Bicycle Requirements (9 spaces)
and Associated works**

**LAND CAPABILITY ASSESSMENT
FOR PROPOSED DEVELOPMENT**

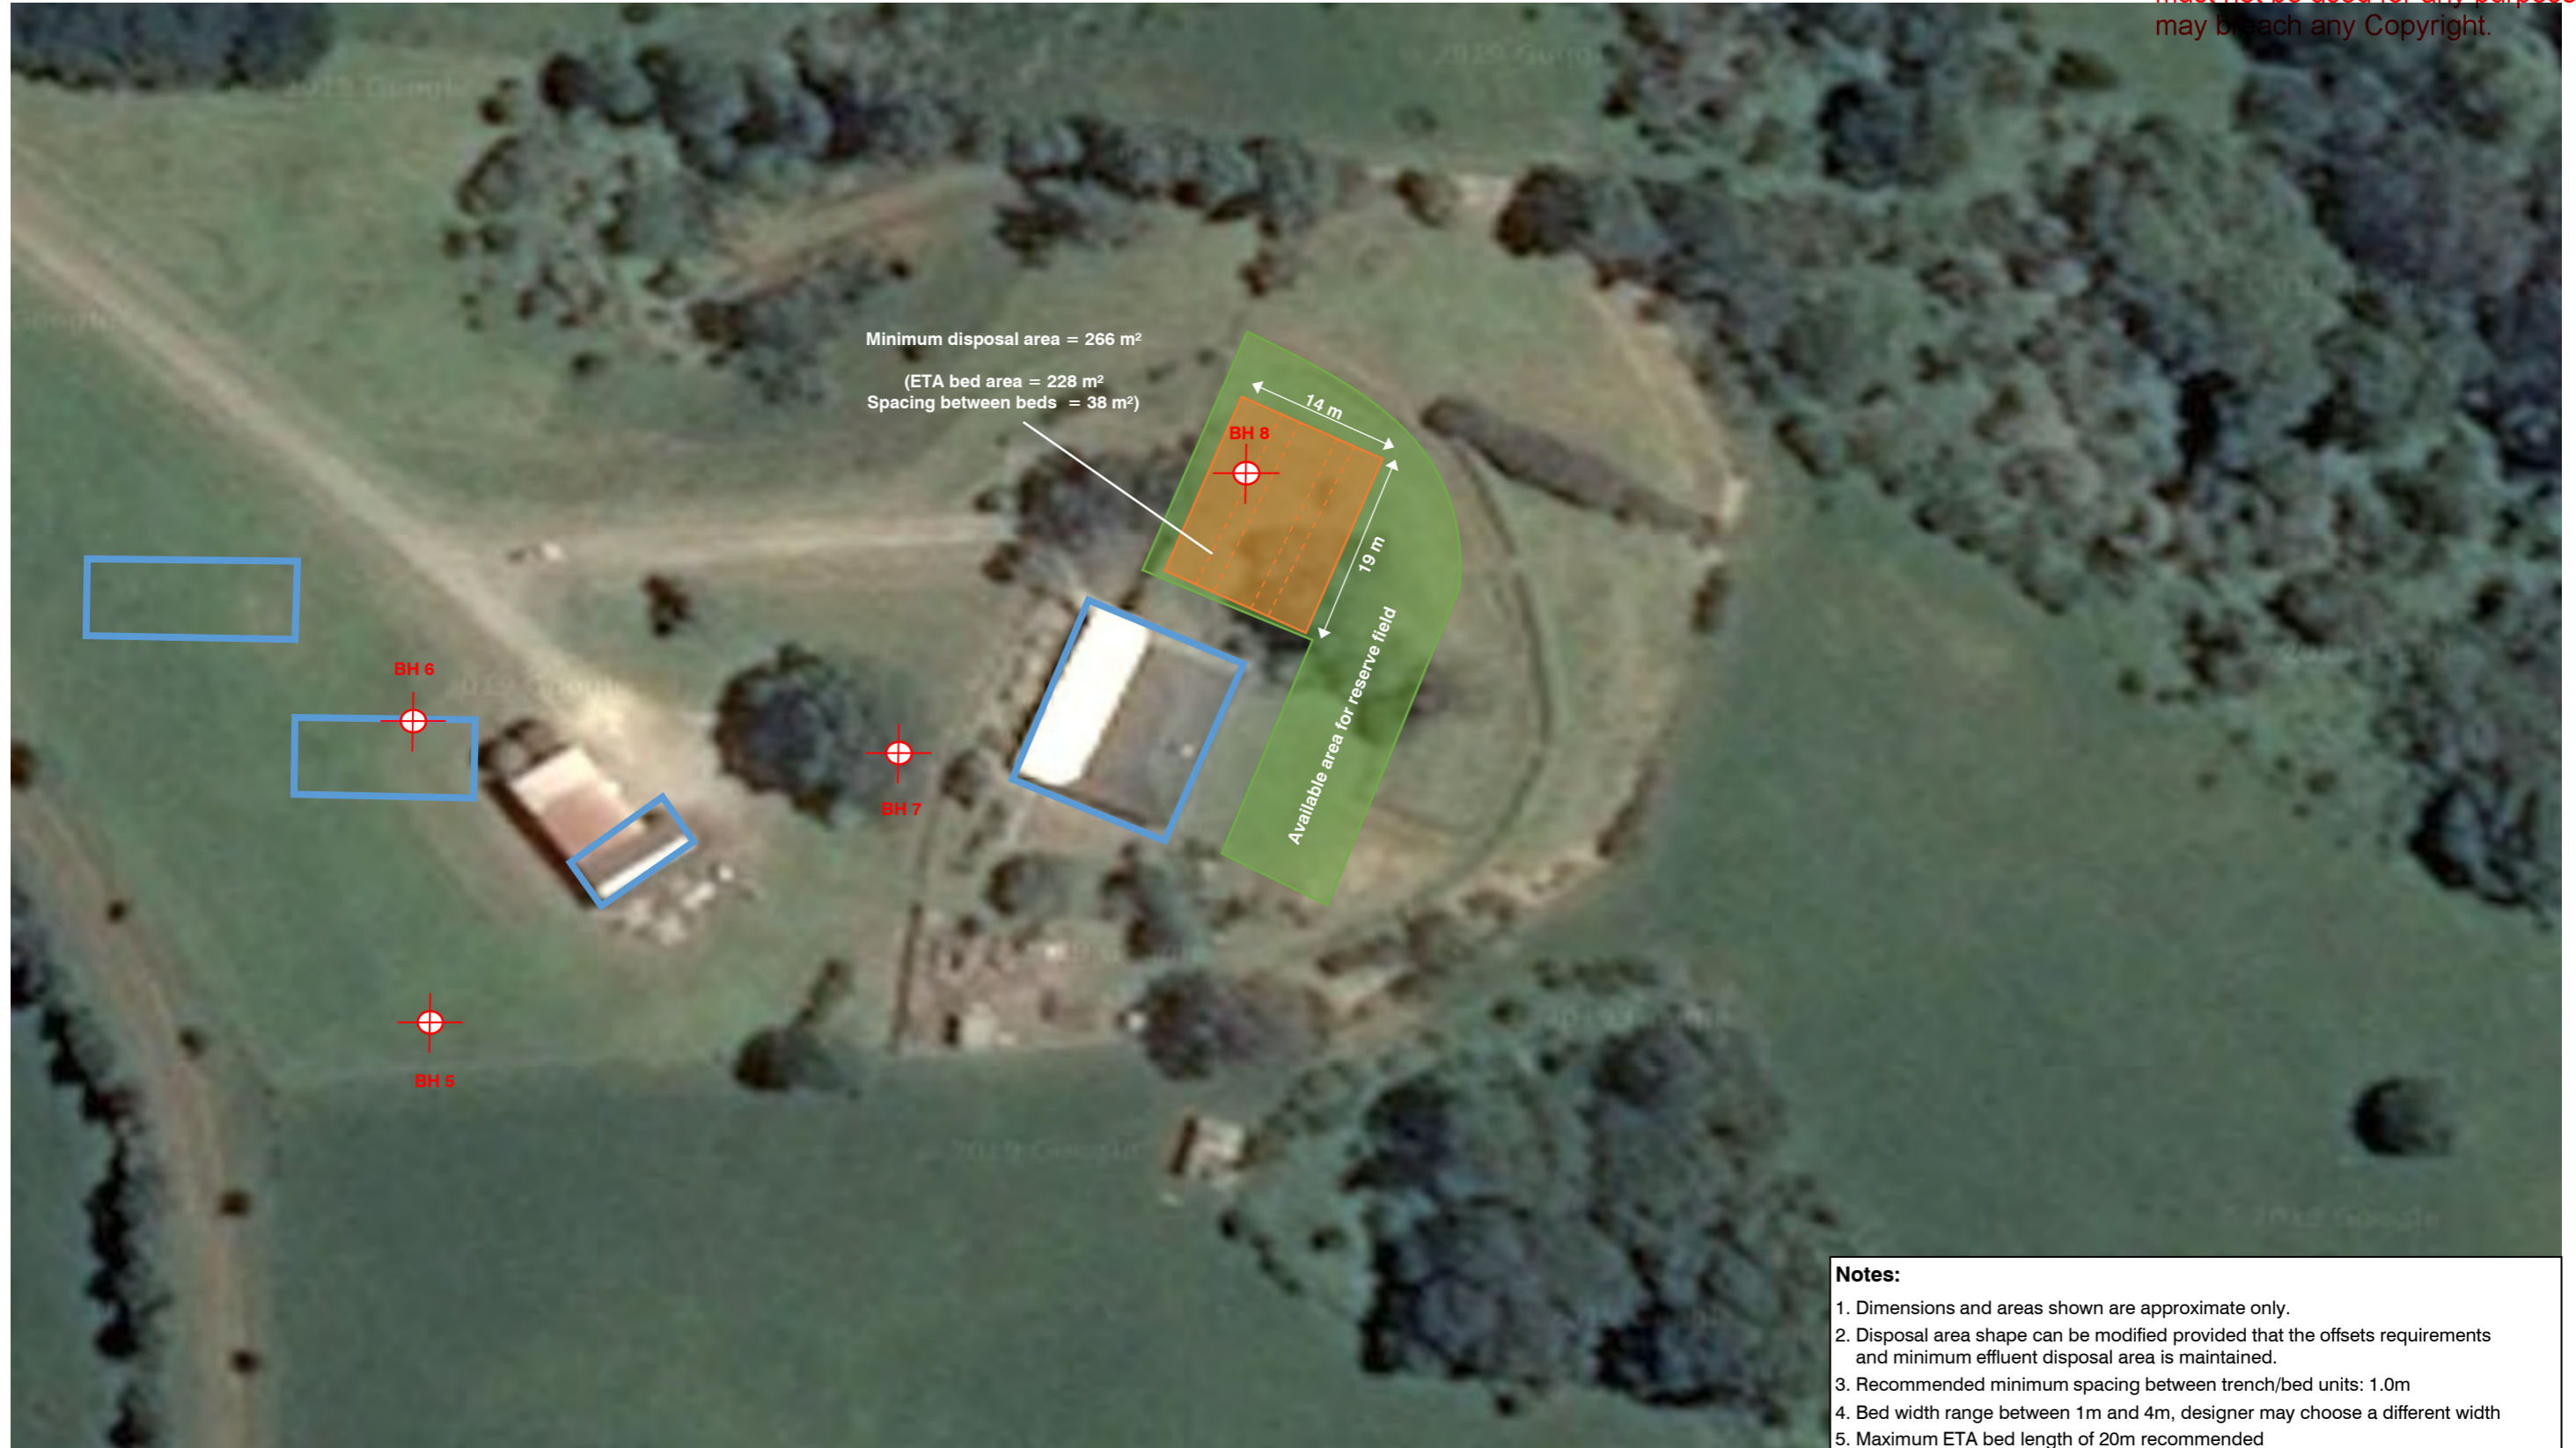
Site Plan - Staff Accommodation Area

- Notes:**
1. Dimensions and areas shown are approximate only.
 2. Disposal area shape can be modified provided that the offsets requirements and minimum effluent disposal area is maintained.
 3. Recommended minimum spacing between trench/bed units: 1.0m
 4. Bed width range between 1m and 4m, designer may choose a different width
 5. Maximum ETA bed length of 20m recommended

It is beyond the scope of this report to provide a detailed design specific layout of the treatment and effluent disposal system. We have provided an indicative suggestion of the effluent disposal area shape used for illustrative purposes in Appendix A. We endorse variation in ETA bed length / width and location, provided the design is in accordance with our recommendations.

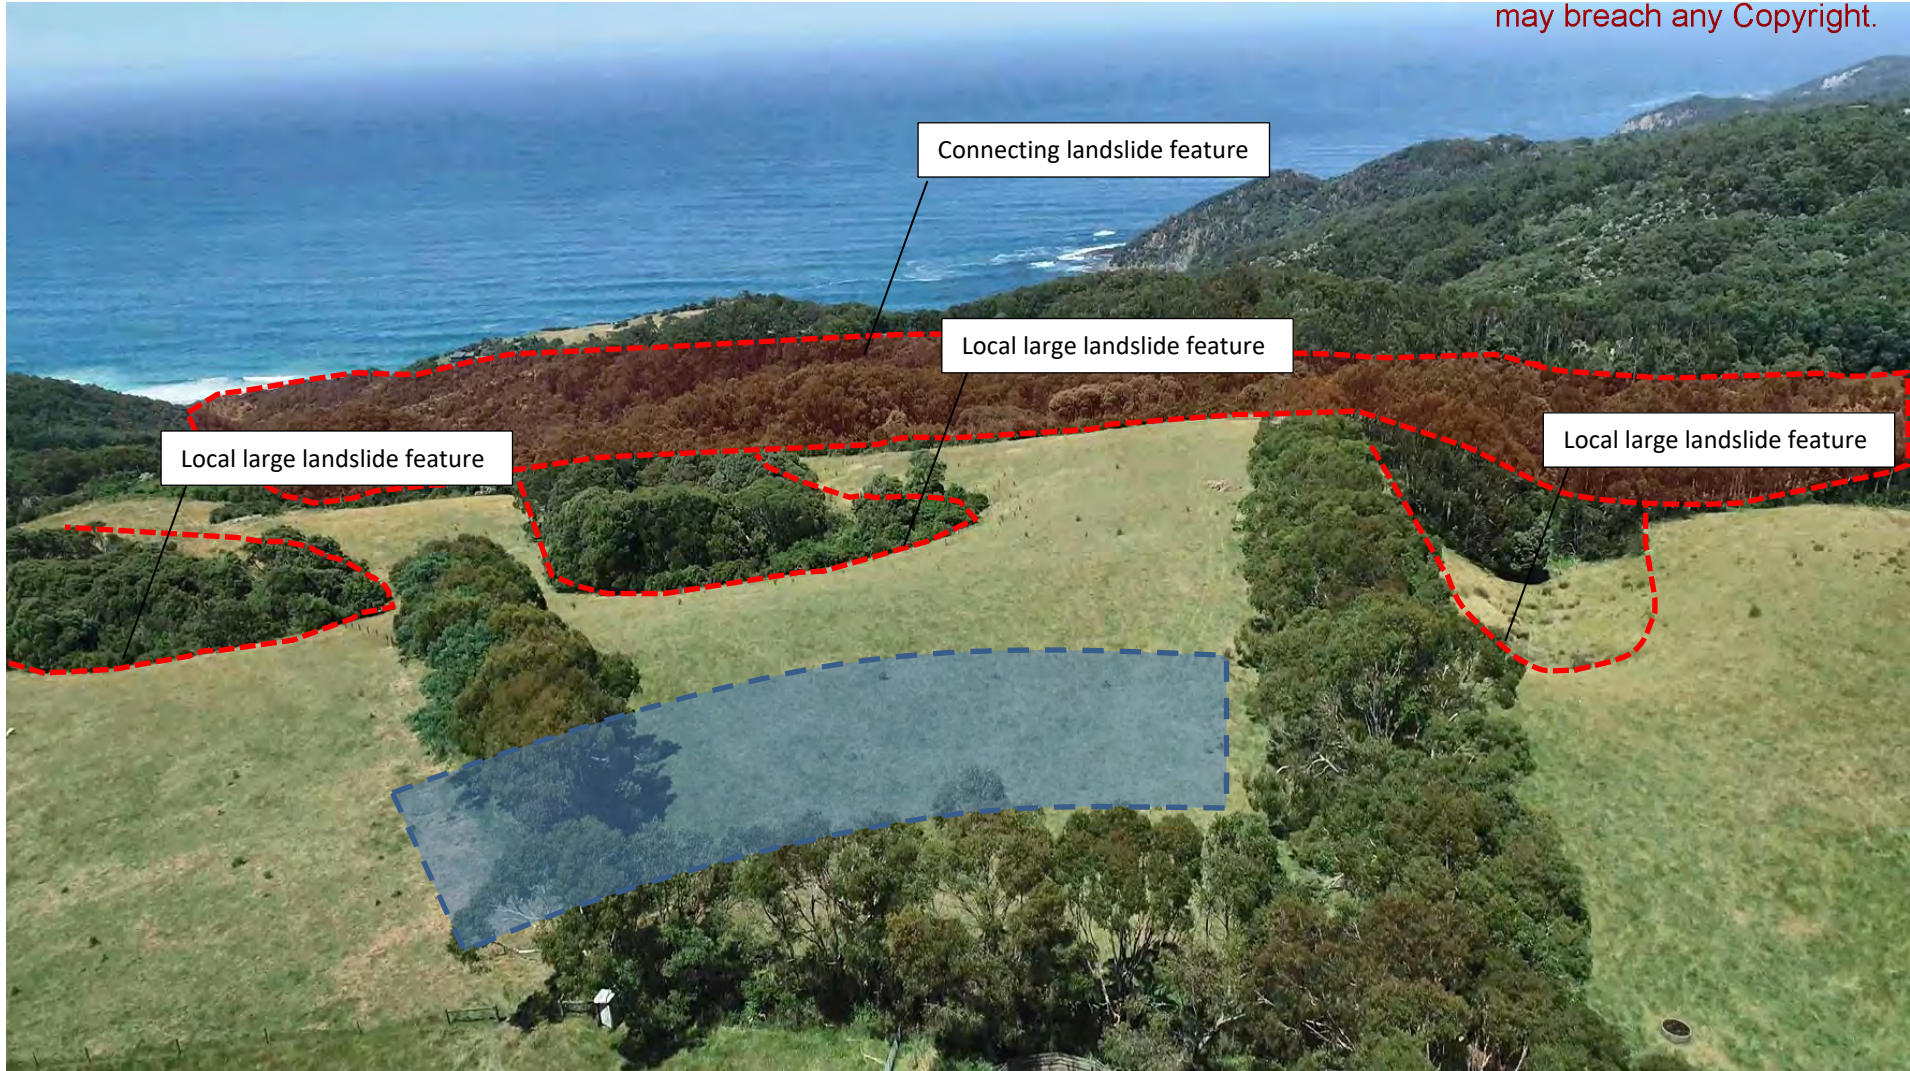
Aerial photograph of proposed dorm development area and inferred landslide

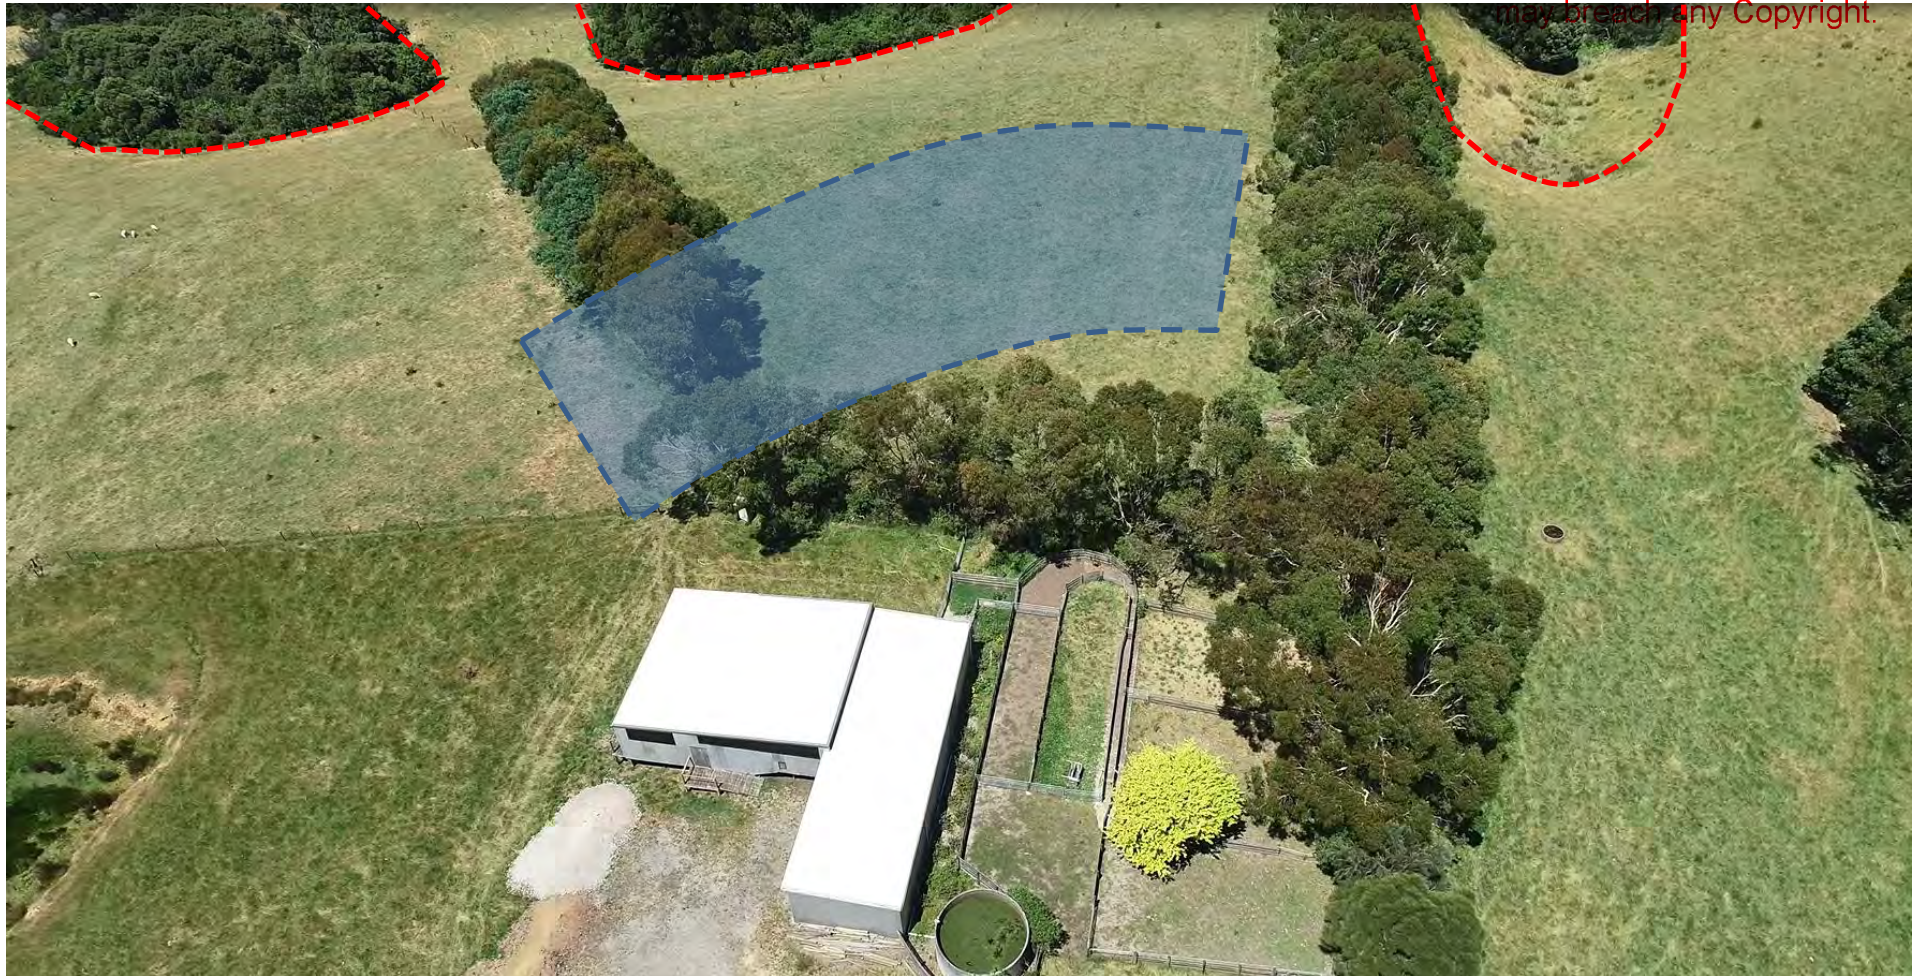
Aerial photograph of proposed dorm development area and inferred landslide features

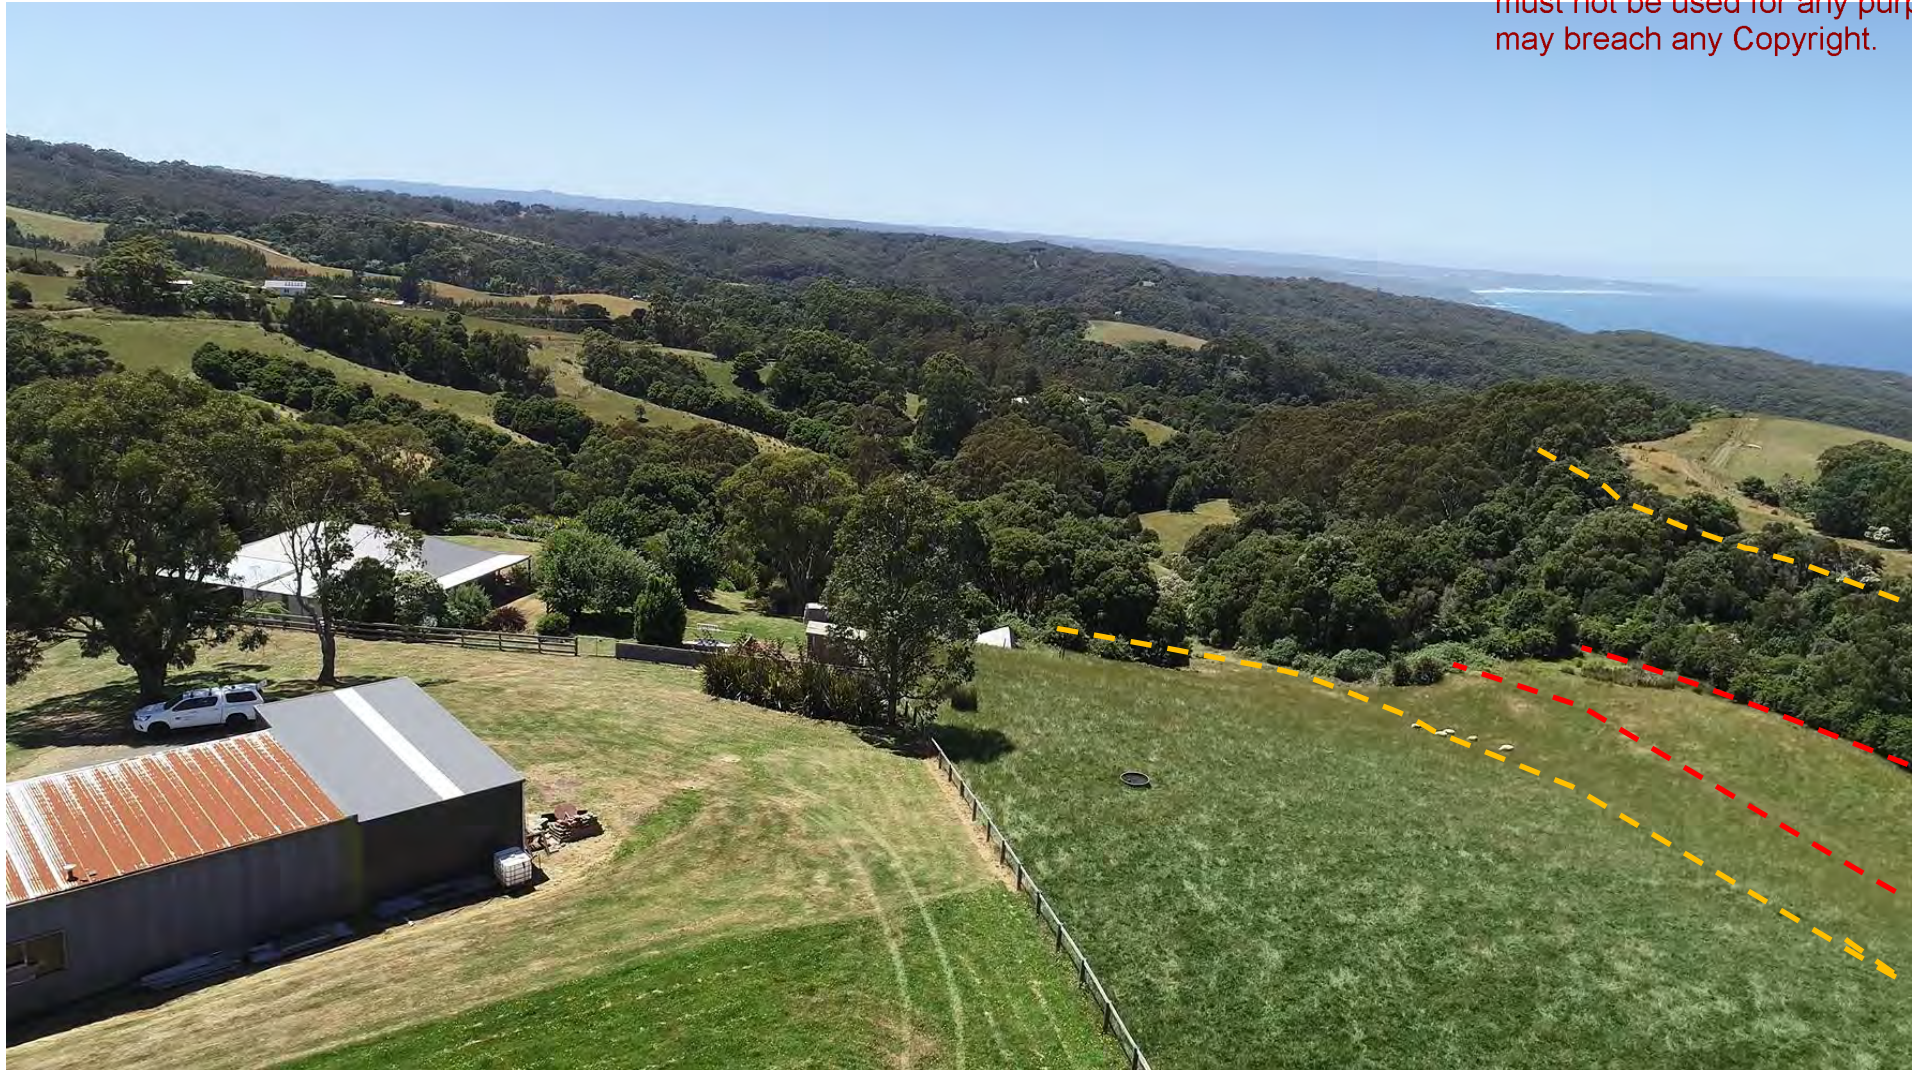
Aerial photograph of proposed staff accommodation development area and inferred landslide

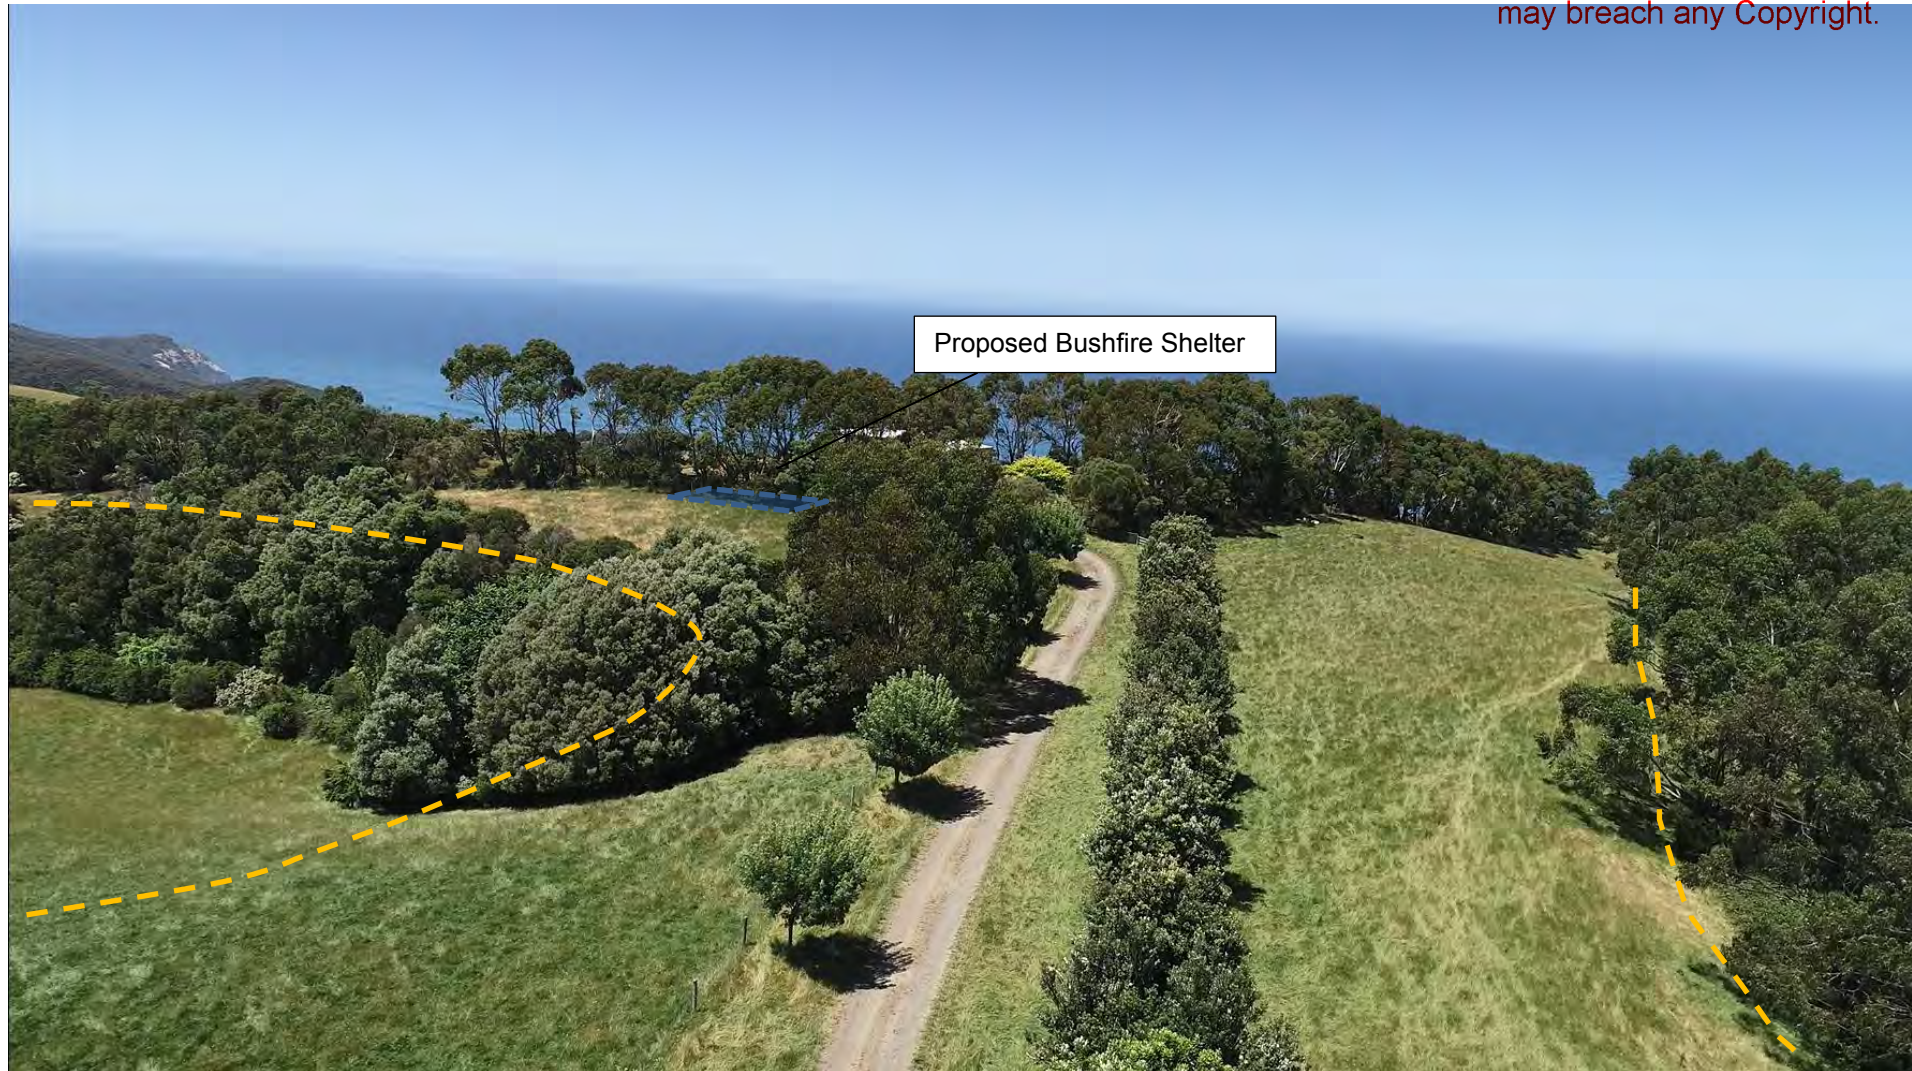
Aerial photograph of existing access (denoted as Hornes Road) and inferred adjacent landslides

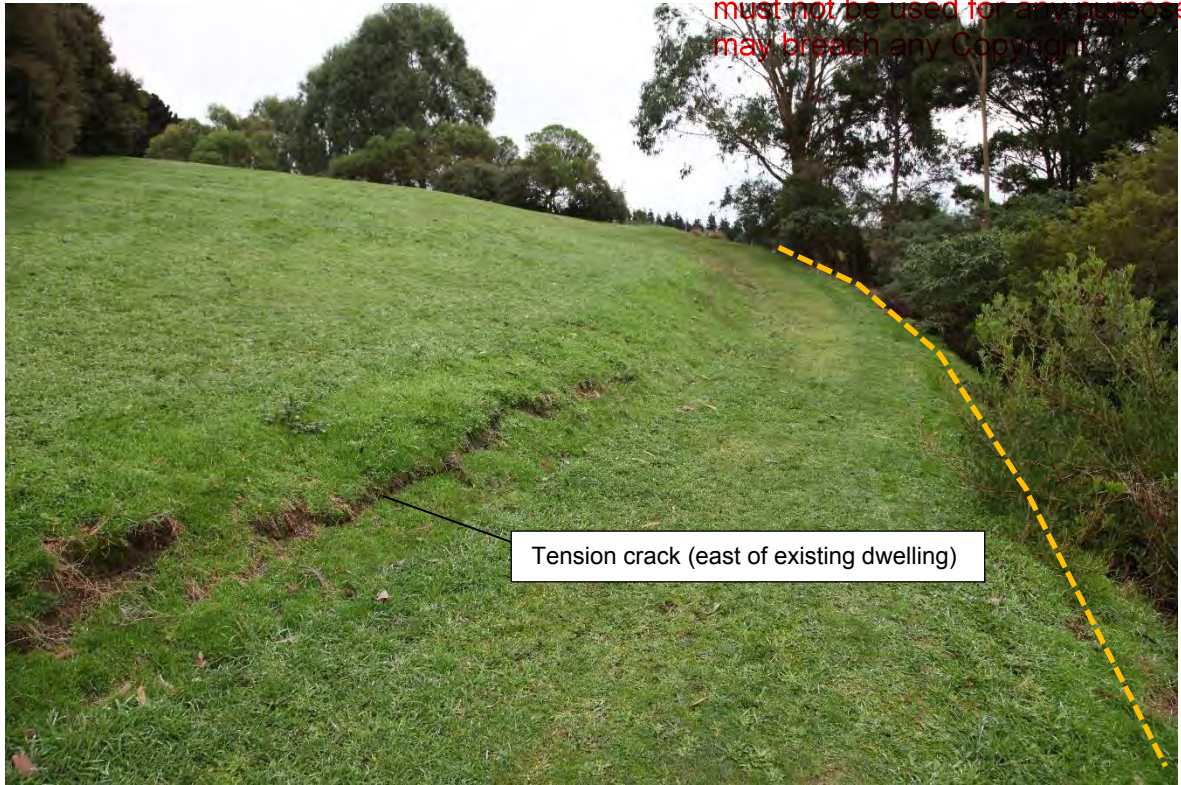
Tension crack and highlighted main scarp

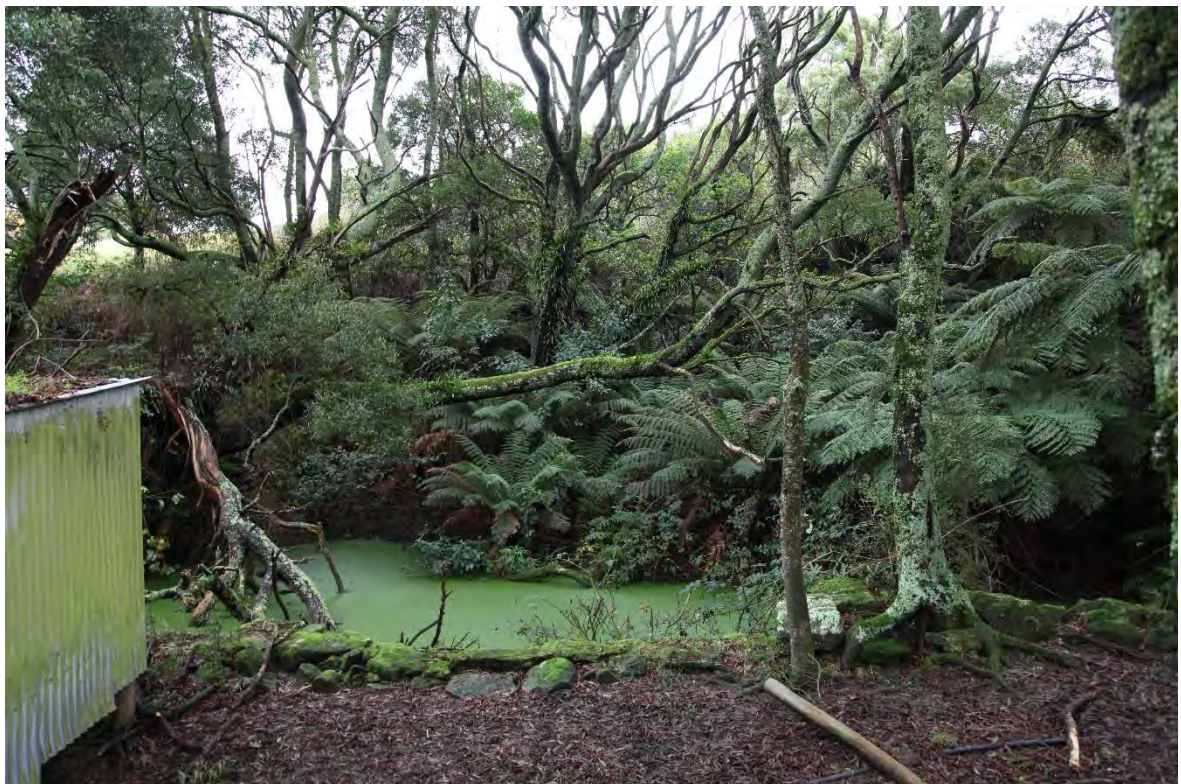
Existing spring (south of existing dwelling)

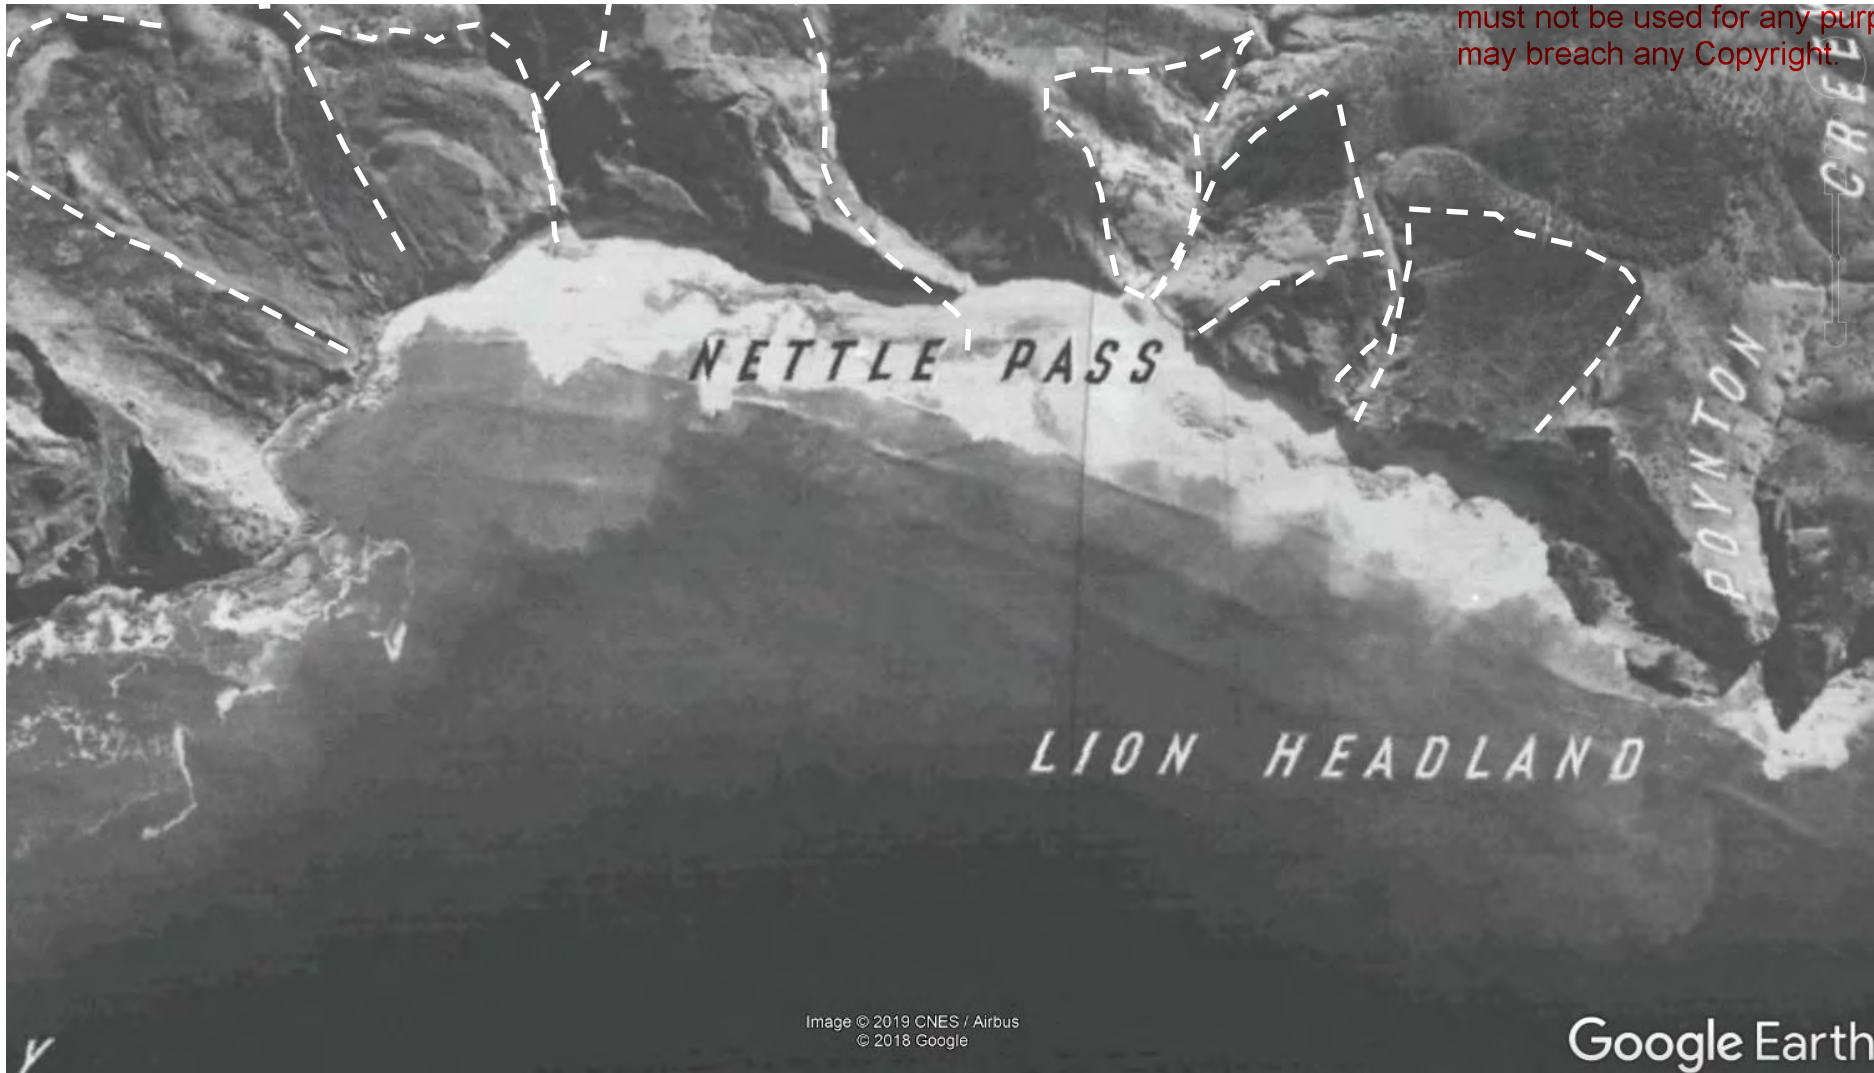
Prominent Landslide Features Milanesia Beach 1945

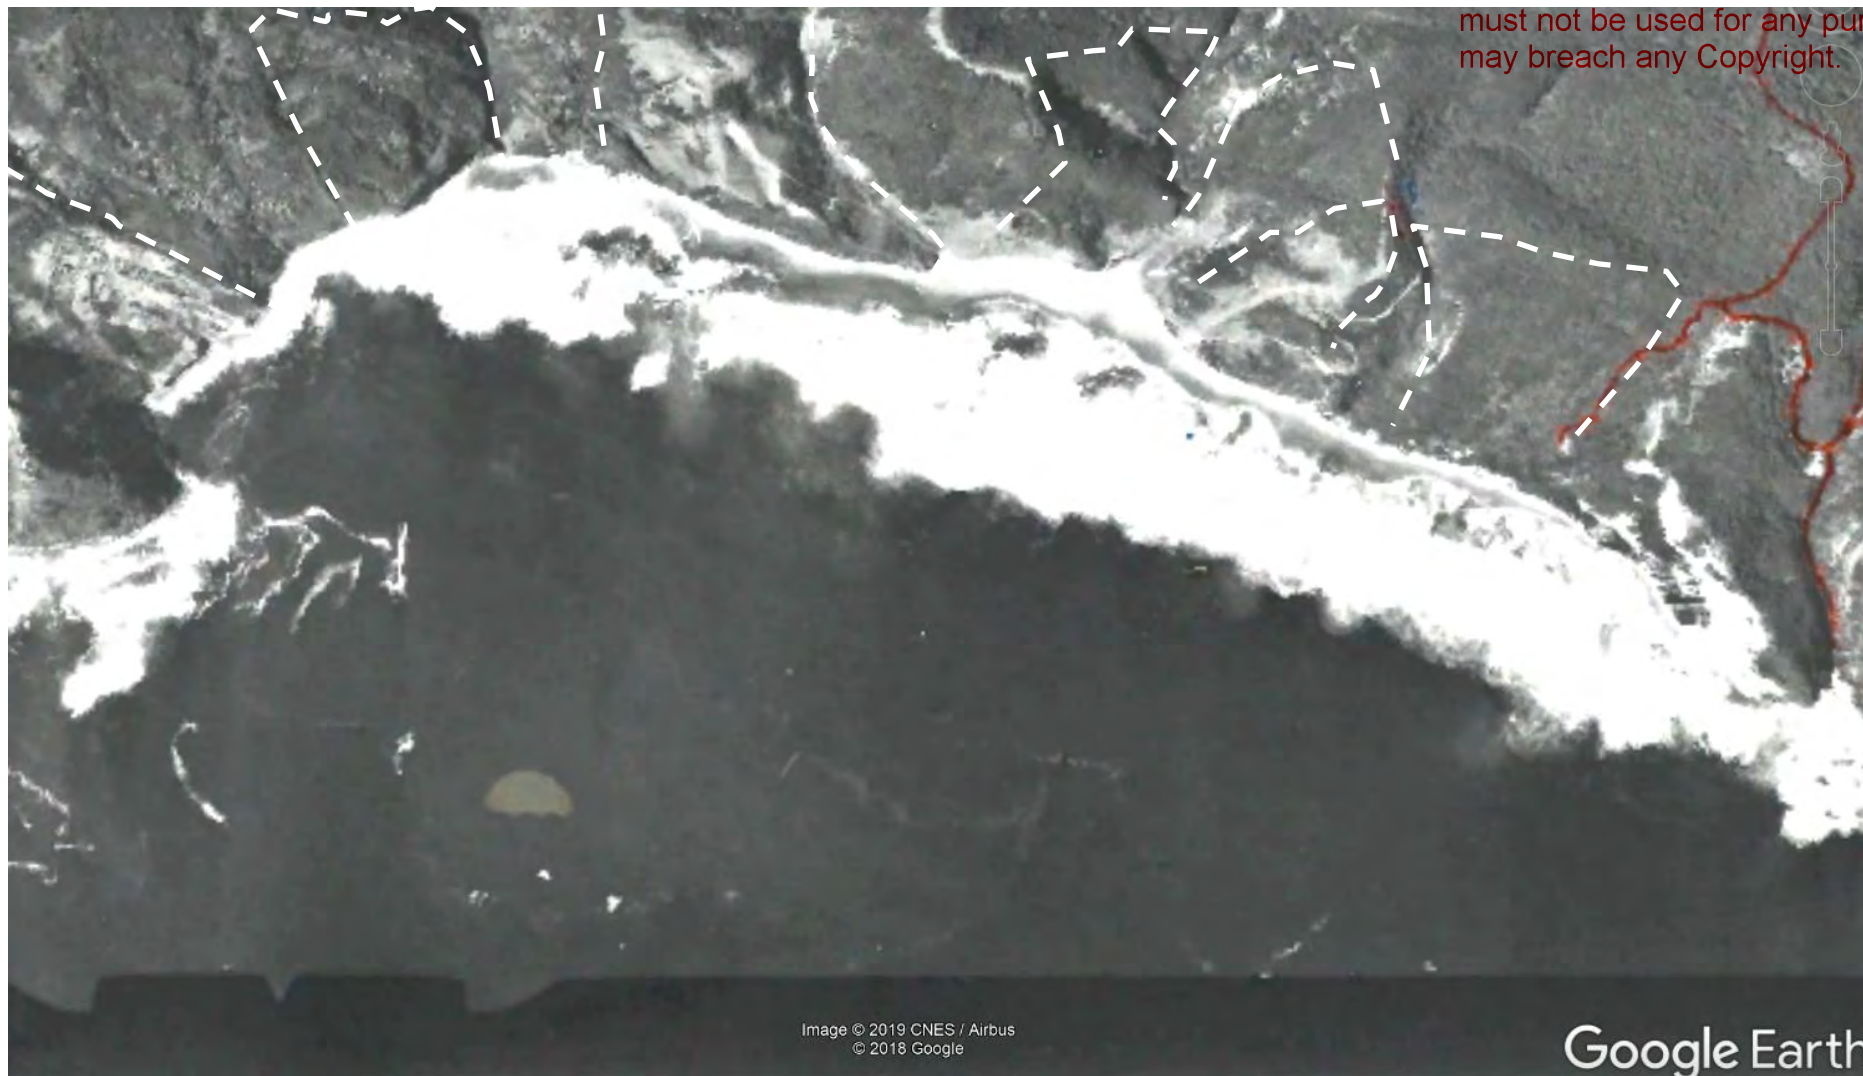
Prominent Landslide Features Milanesia Beach 1983

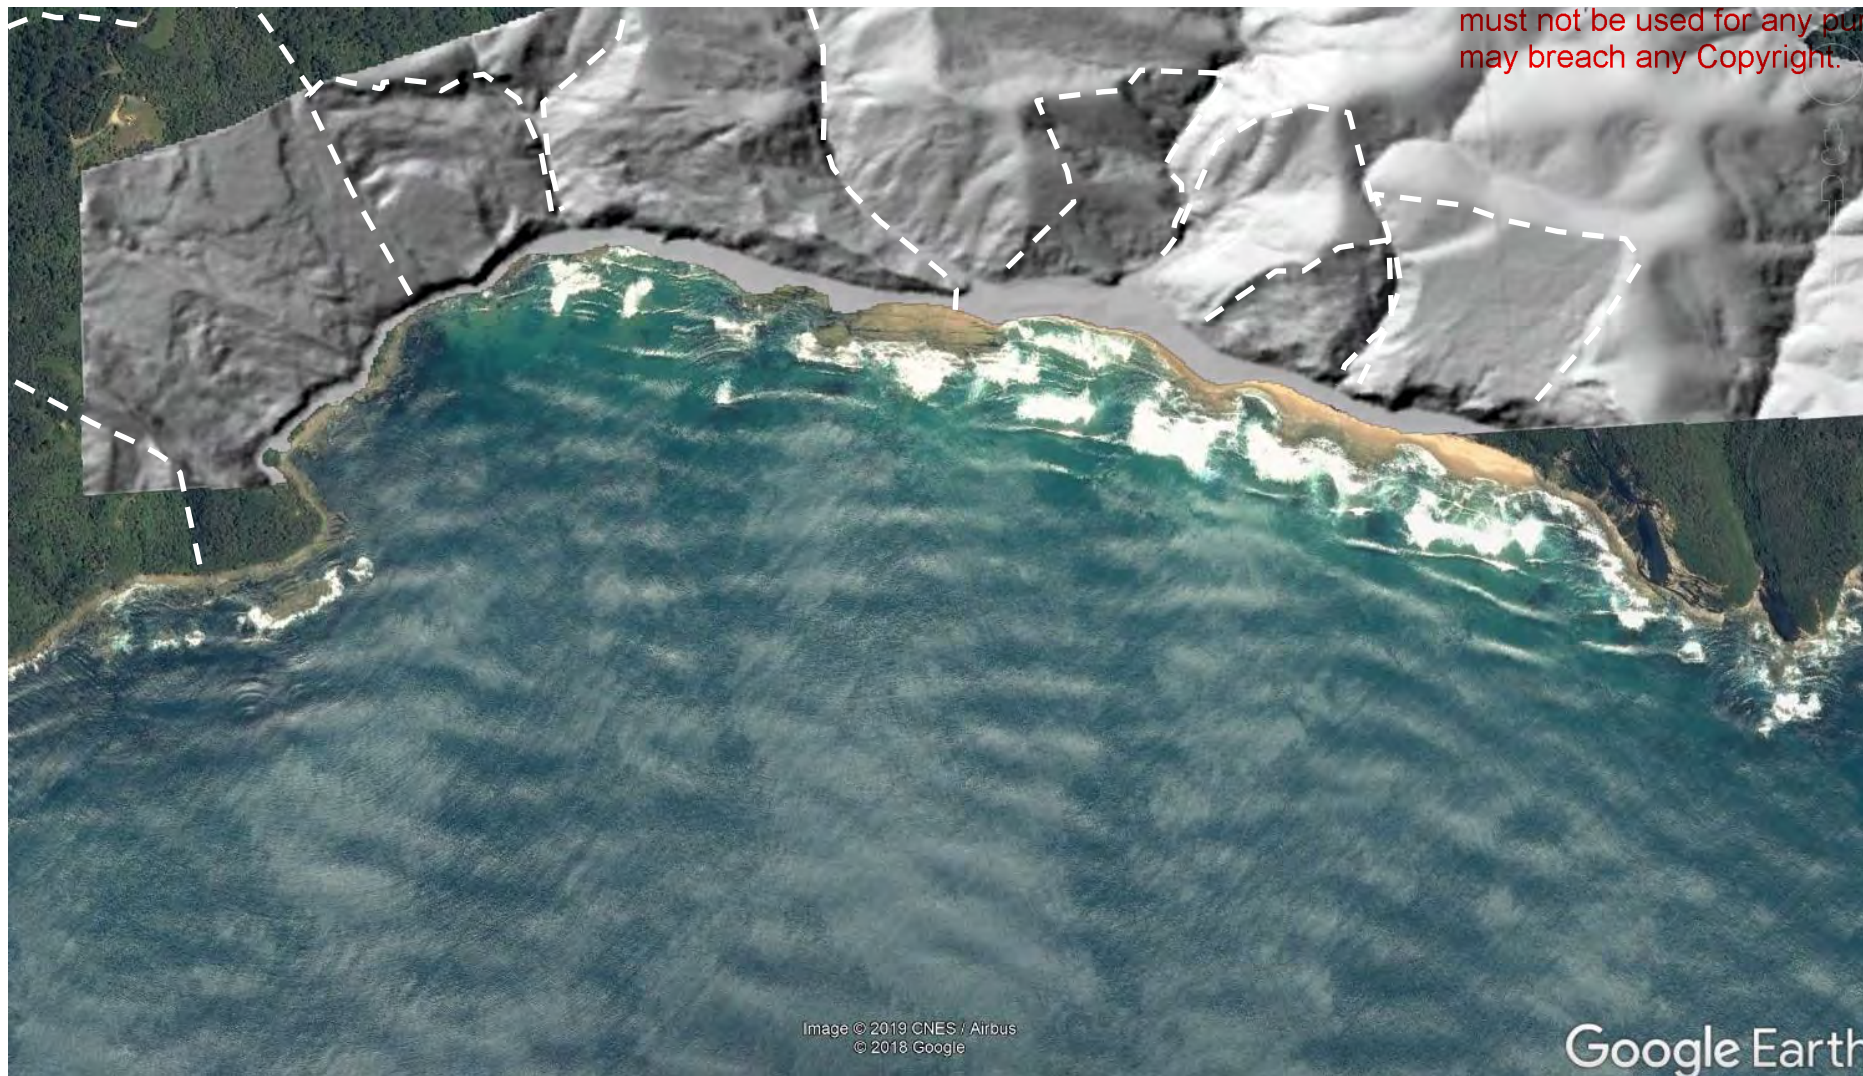
Inferred prominent Landslide Polygons Milanesia Beach DEM, 2019
