**Road Reserve near Great Ocean Road
WYE RIVER**

**Use of utility installation & vegetation
removal associated underground drainage**

Biodiversity Assessment: Detailed Assessment Pathway for Proposed Drainage Works

Client: **COLAC OTWAY SHIRE**
 Project: **WYE RIVER AND SEPARATION CREEK STORMWATER MANAGEMENT SYSTEM**
 Title: **ILUKA AVE DRAINAGE UPGRADE DETAILED LAYOUT PLAN**

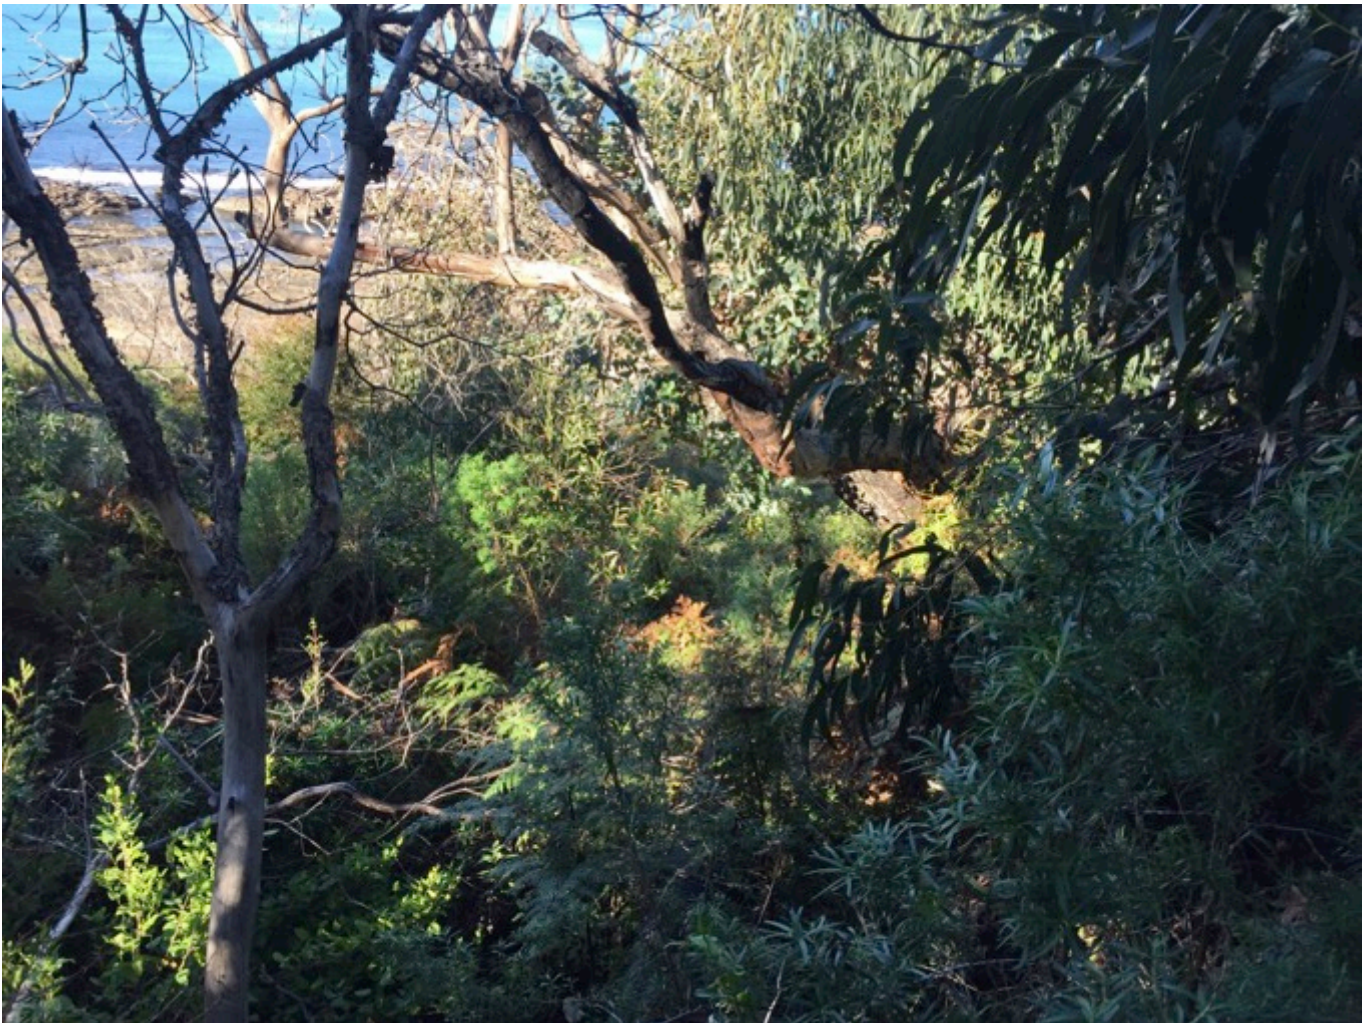
Plate 1. Habitat Zone SFF1 within the study area.

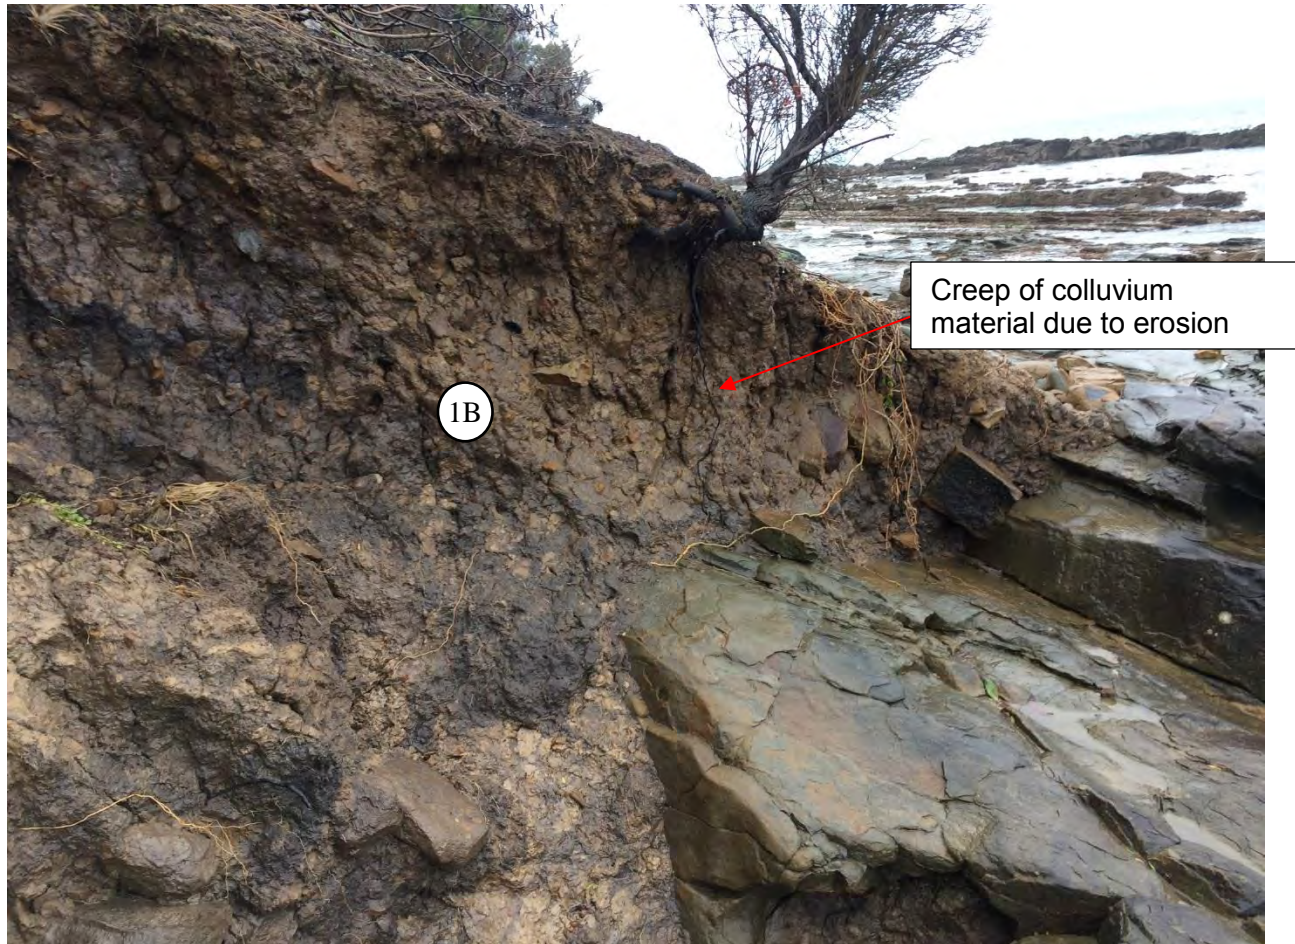
Photo 1 Creep of Colluvium on the rock platform.

LOCATION	MODE OF FAILURE	STRATIGRAPHY	SLOPE CONTROL	COMMENTS
COASTAL PLATFORM BELOW ILUKA AVENUE	Planar Slide	Sandstone Colluvium	Wave action undercutting sandstone beds on the rock platform	Failure of the overlying soils, Photo 1 and in some cases, slab failures of slightly weathered rock, Photo 2. Presence of colluvium overlying rock indicates that this process has been occurring for a significant amount of time.
	Creep	Colluvium	wave action groundwater fault zones	Eroded fault zones are present on the rock platform and the risk of further erosion has historically been addressed by block retaining walls. Observed tilt to one of the retaining walls would support that it is affected by passive slope movements (creep of colluvial materials).
PADDY'S PATH 24 to 25 ILUKA AVE	Translational slide and debris flow	Residual soils and extremely weathered rock	over-excavation at the toe prolonged heavy rainfall coastal erosion lack of stormwater controls	<p>May 2016 - post failure slope of a small (~600 m²) sized and shallow translational slide was observed immediately above the Great Ocean Road and below 24 Iluka Avenue, Photo 3. The backscarp was approximately 1.5 m above the translated mass. Bedding planes were observed at the base of the failure and measureable seepage was observed on the shoulder of the Great Ocean Road. Rotated trees were obvious.</p> <p>September 2016 - after a period of heavy rainfall this failure regressed further upslope and close to the property boundary of 24 to 25 Iluka Avenue, Photo 4.</p> <p>It is possible that the Great Ocean Road was built on this colluvial material. Alternatively the road construction may have undercut fabric of weathered rock and led to instability immediately north of the road. Vicroads have since designed and constructed a slope remediation system to mitigate the effects of this landslide.</p>

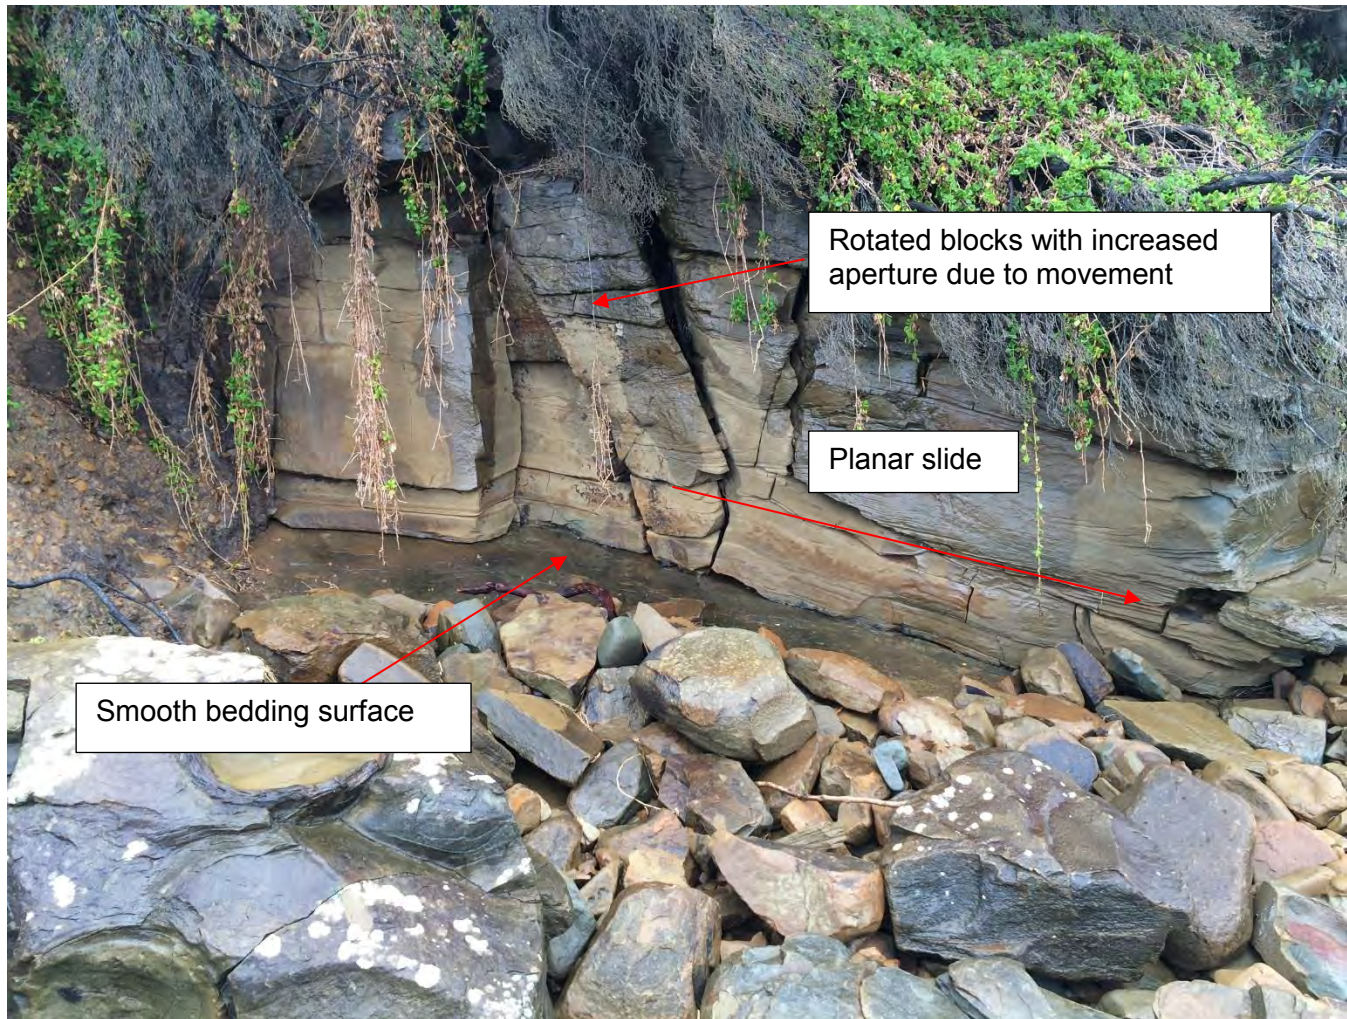
Photo 2 Planar slide of Moderately to Slightly Weathered SANDSTONE on smooth bedding plane

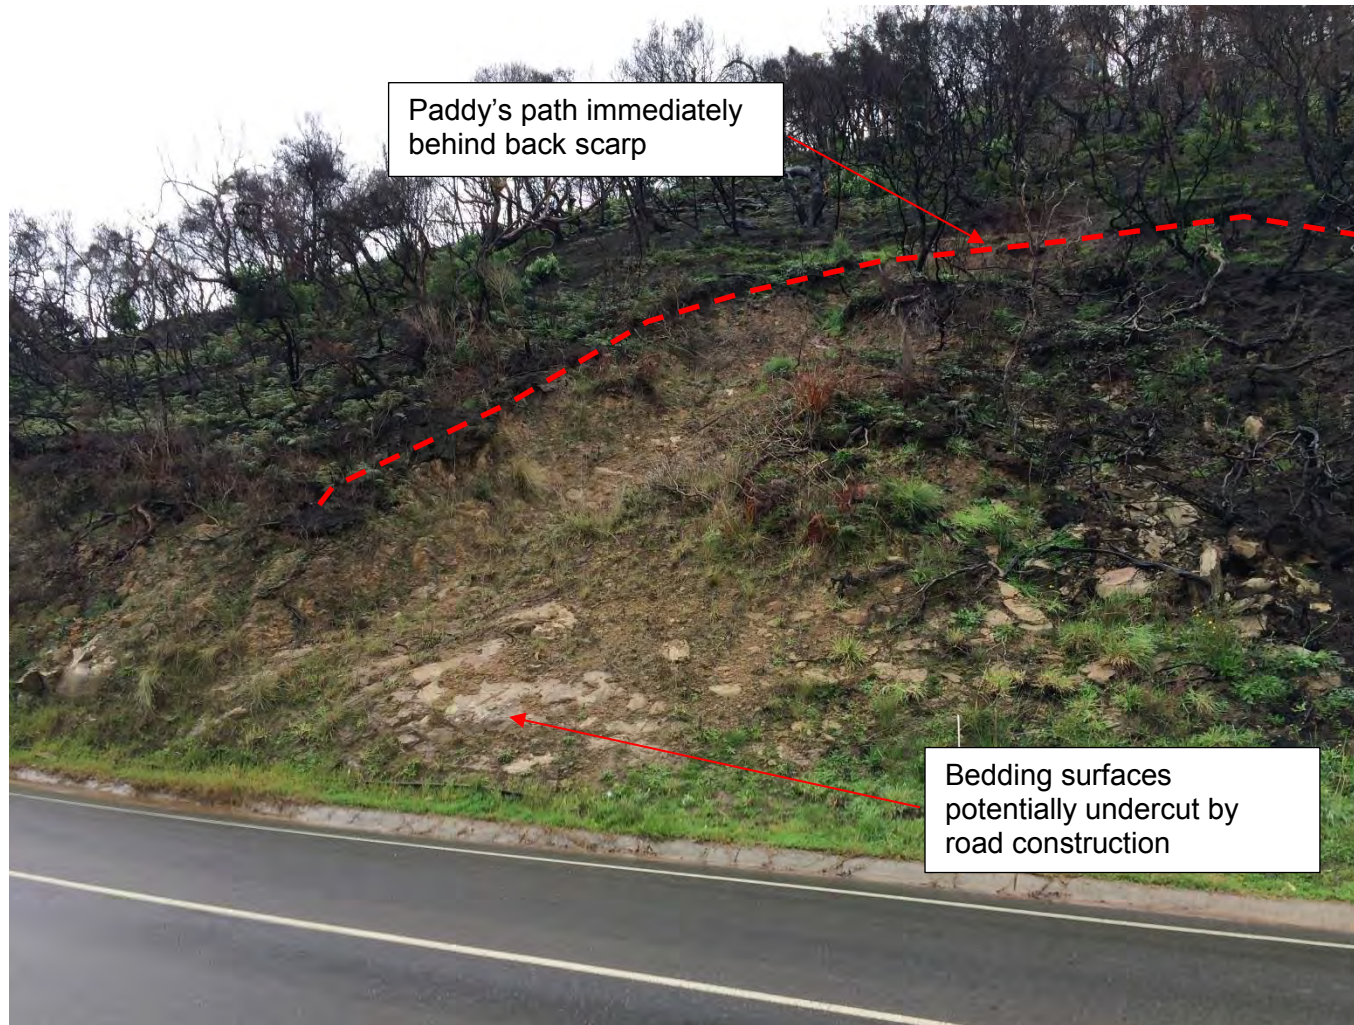
Photo 3 Small translational failure above the Great Ocean Road, looking north west.

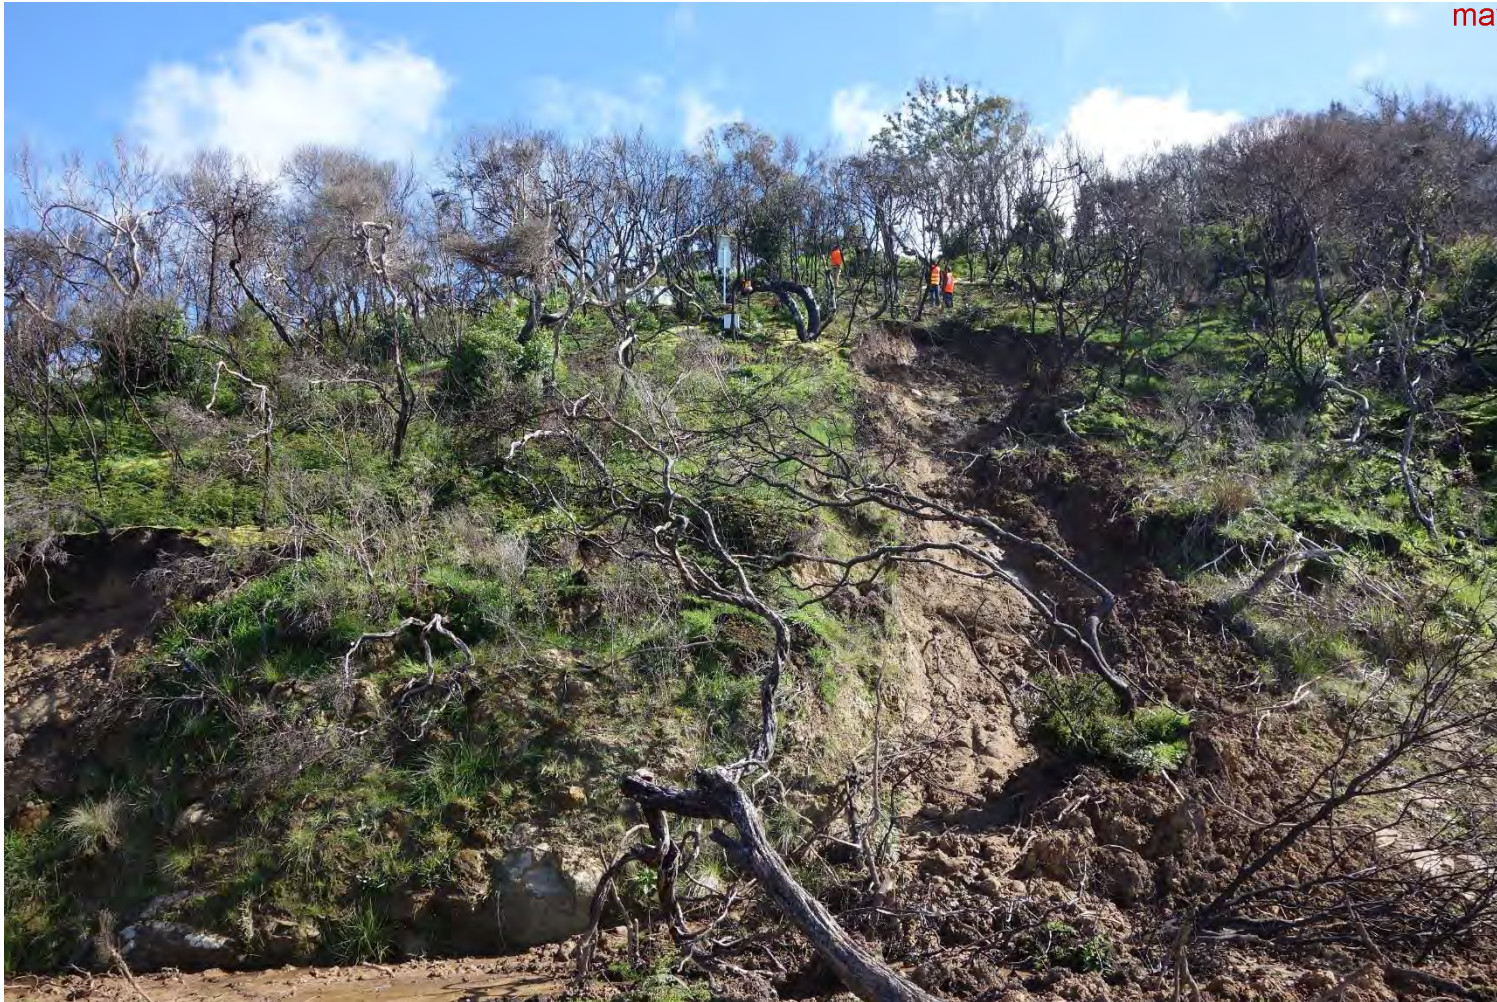
Photo 4 Regression of Paddy's Path failure following heavy rainfall in September 2016.

LOCATION	MODE OF FAILURE	STRATIGRAPHY	SLOPE CONTROL	COMMENTS
PADDY'S PATH BELOW 17 ILUKA AVE	Translational slide and debris flow	Residual soils and extremely weathered rock	over-excavation at the toe, prolonged heavy rainfall reduced vegetation cover lack of stormwater controls	July 2016 - small translational failure occurred in the Great Ocean Road cutting, Photo 5.
PADDY'S PATH, 11ILUKA AVENUE	Creep	Surficial, residual soils and extremely weathered rock	Poor stromwater control Over-steep fill batters Non-engineered retaining walls	Common in the Wye River and Separation Creek area. Accumulation of colluvium at the toe of the dipslope may be a product of ongoing slab failures and creep. Non-engineered retaining walls (landscape walls) with obvious tilt
23 ILUKA AVENUE	Planar Slide	Highly weathered Sandstone	Bedding defect strength	May 2016 - man-made cut slopes showed evidence of movement on bedding, Photos 6 and 7. Planar slide is occurring on Clay seams and smooth bedding partings with the remaining shotcrete walls restricting movement.

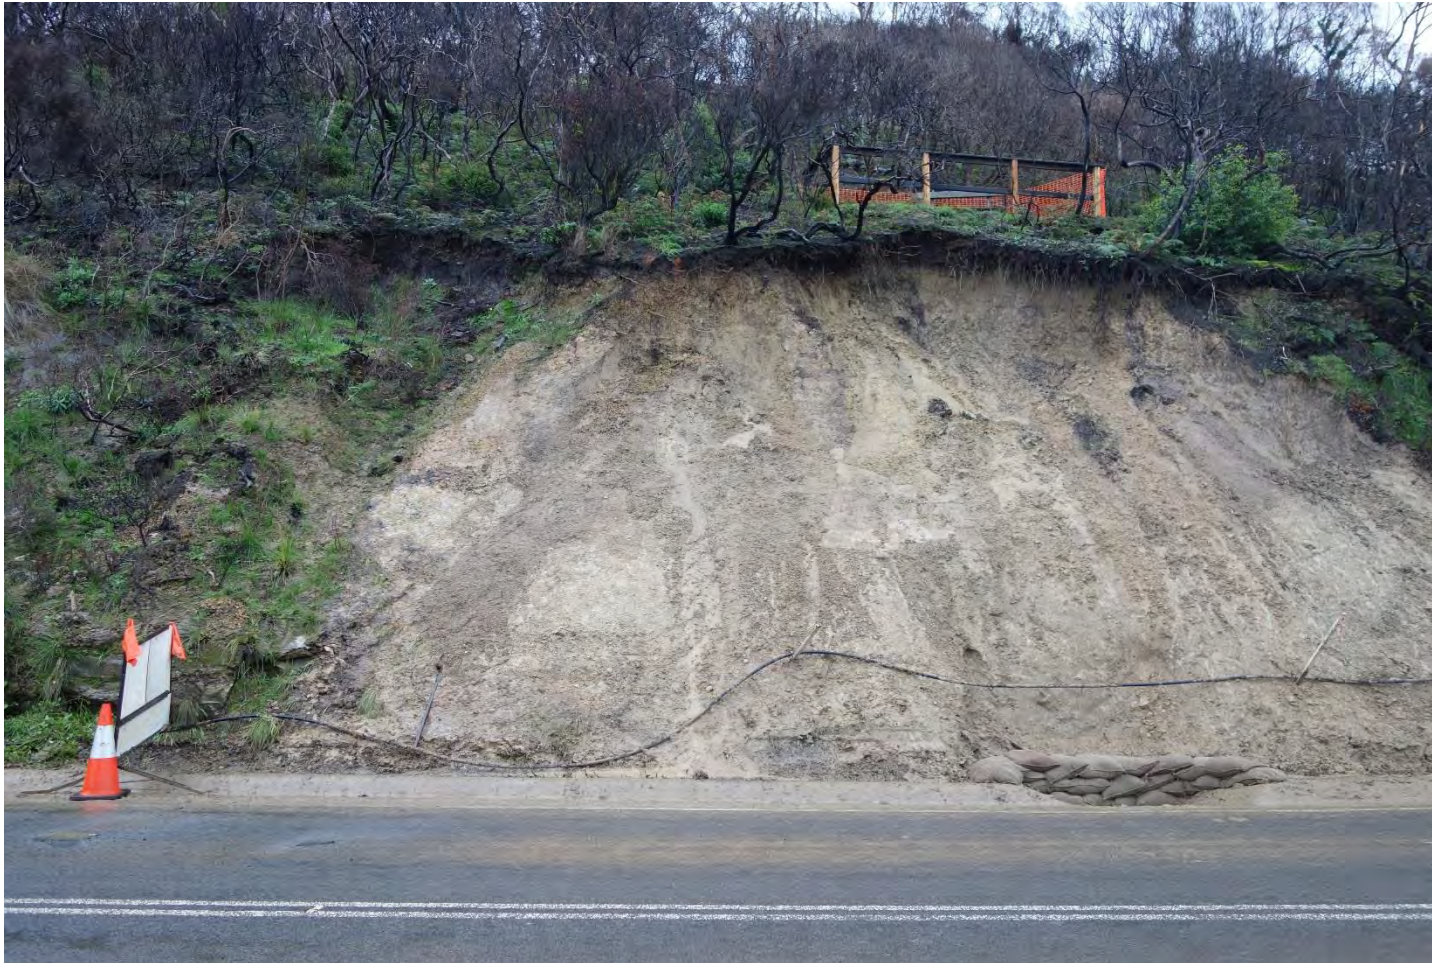
Photo 5 Small translational failure above the Great Ocean Road, looking north with highly weathered Sandstone bedding observed near the toe. Bedding does not appear to be undercut and sliding is occurring at the interface of colluvium/residual and the underlying more competent rock mass.

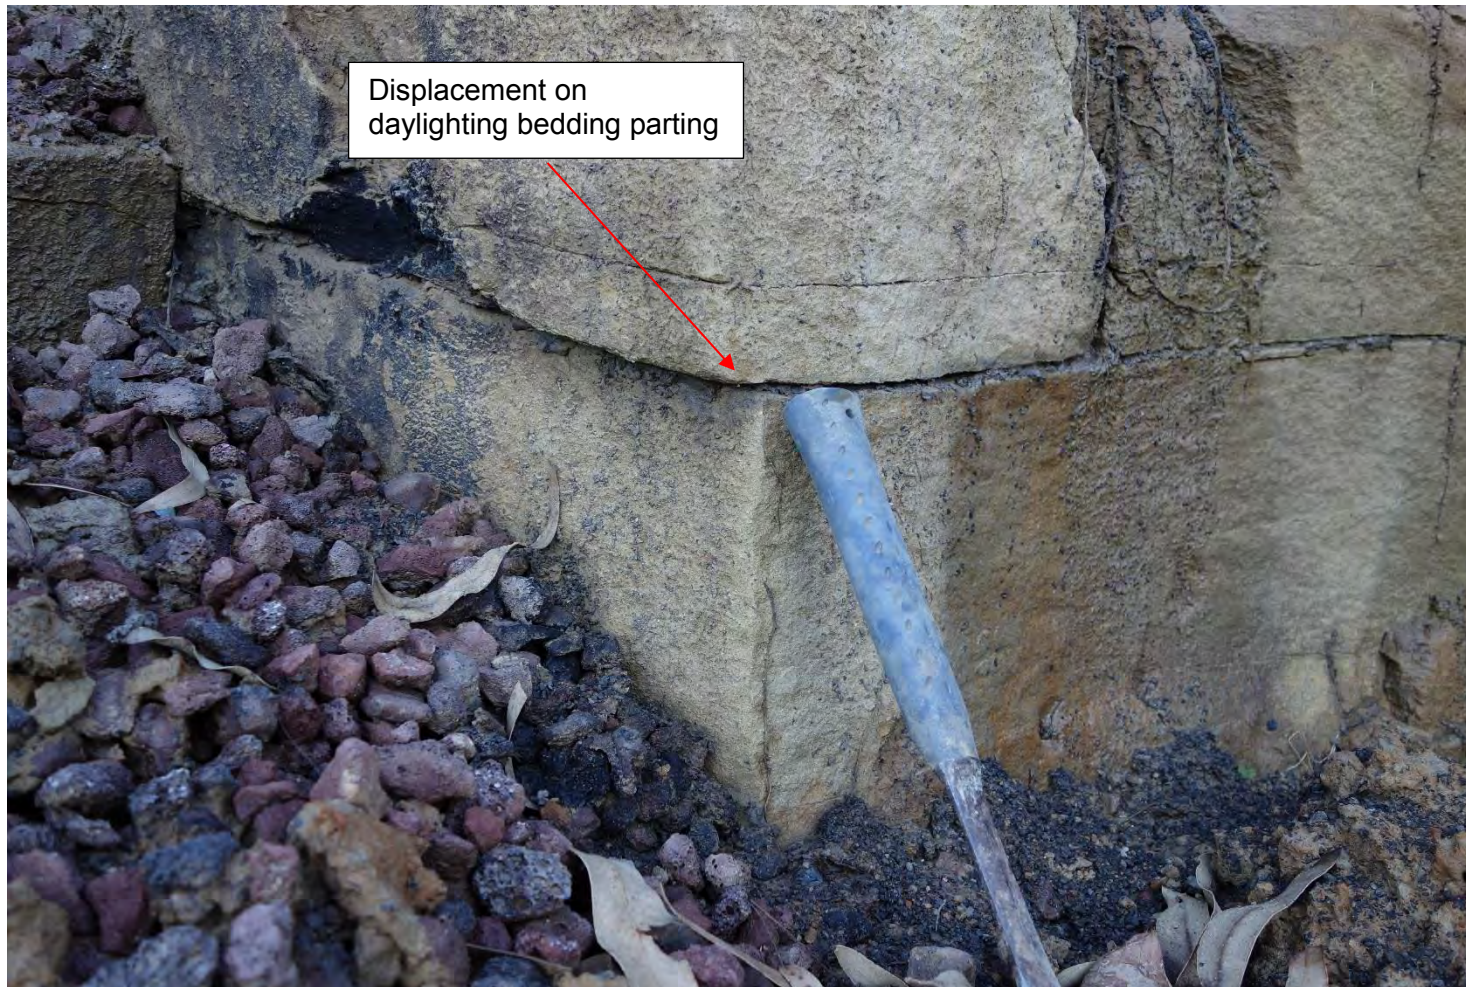
Photo 6 Burnt out retaining wall at 23 Iluka Ave - Displacement on bedding surfaces in Unit 3A.

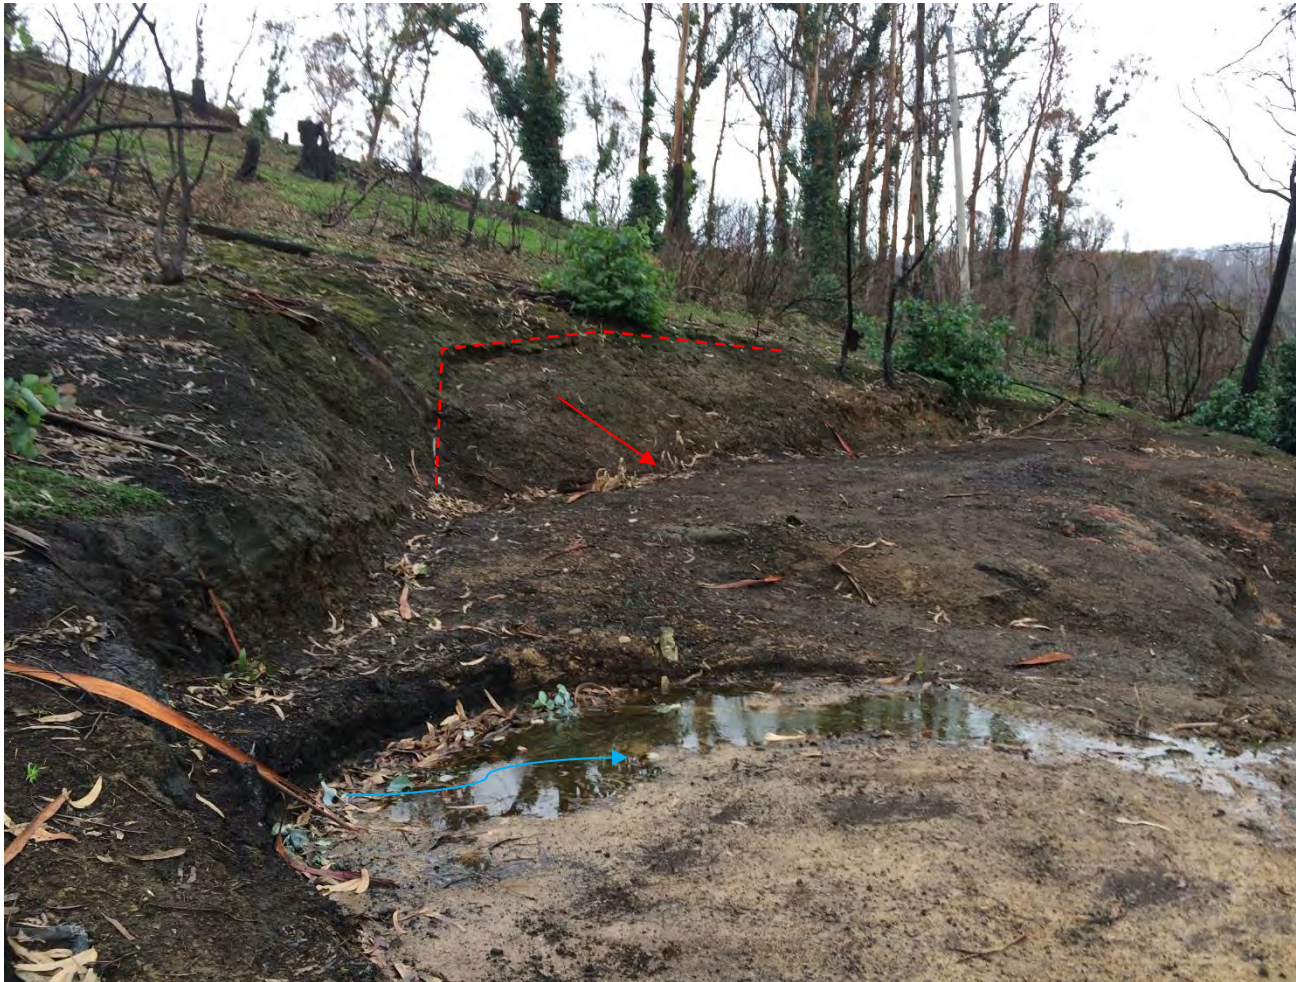
Photo 89 Slumping of cut slope in residual material (Unit 2) on 4 Iluka Avenue with strong seepage from broken stormwater in the foreground.

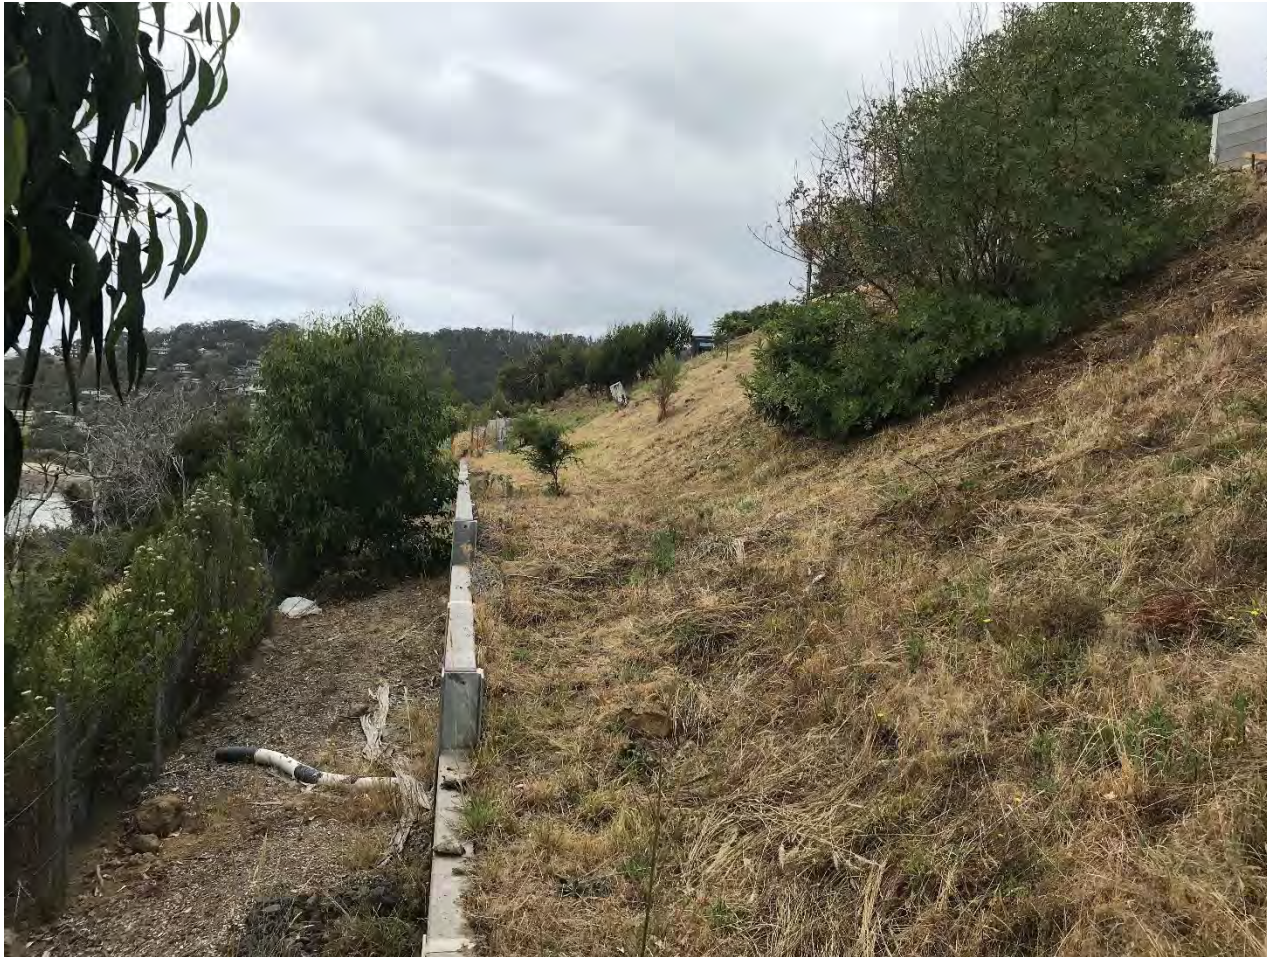
Photo 9 New Retaining walls below 17 Iluka Avenue looking south west with moderate back slope (for ~1.5 m width) immediately behind the wall.

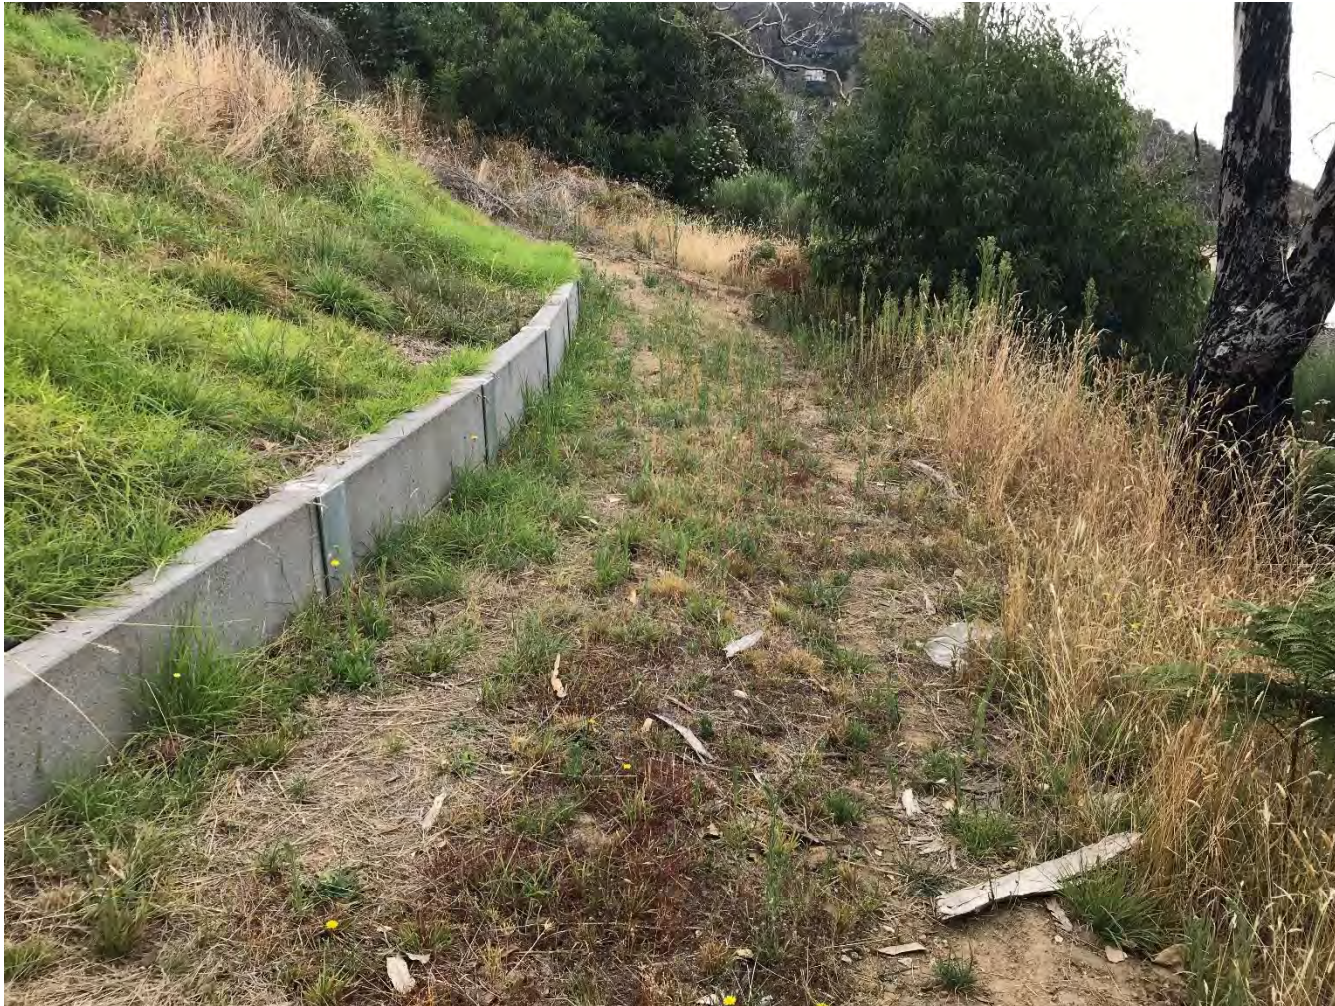
Photo 10 New Retaining walls below 10 Iluka Avenue with existing access track immediately below.

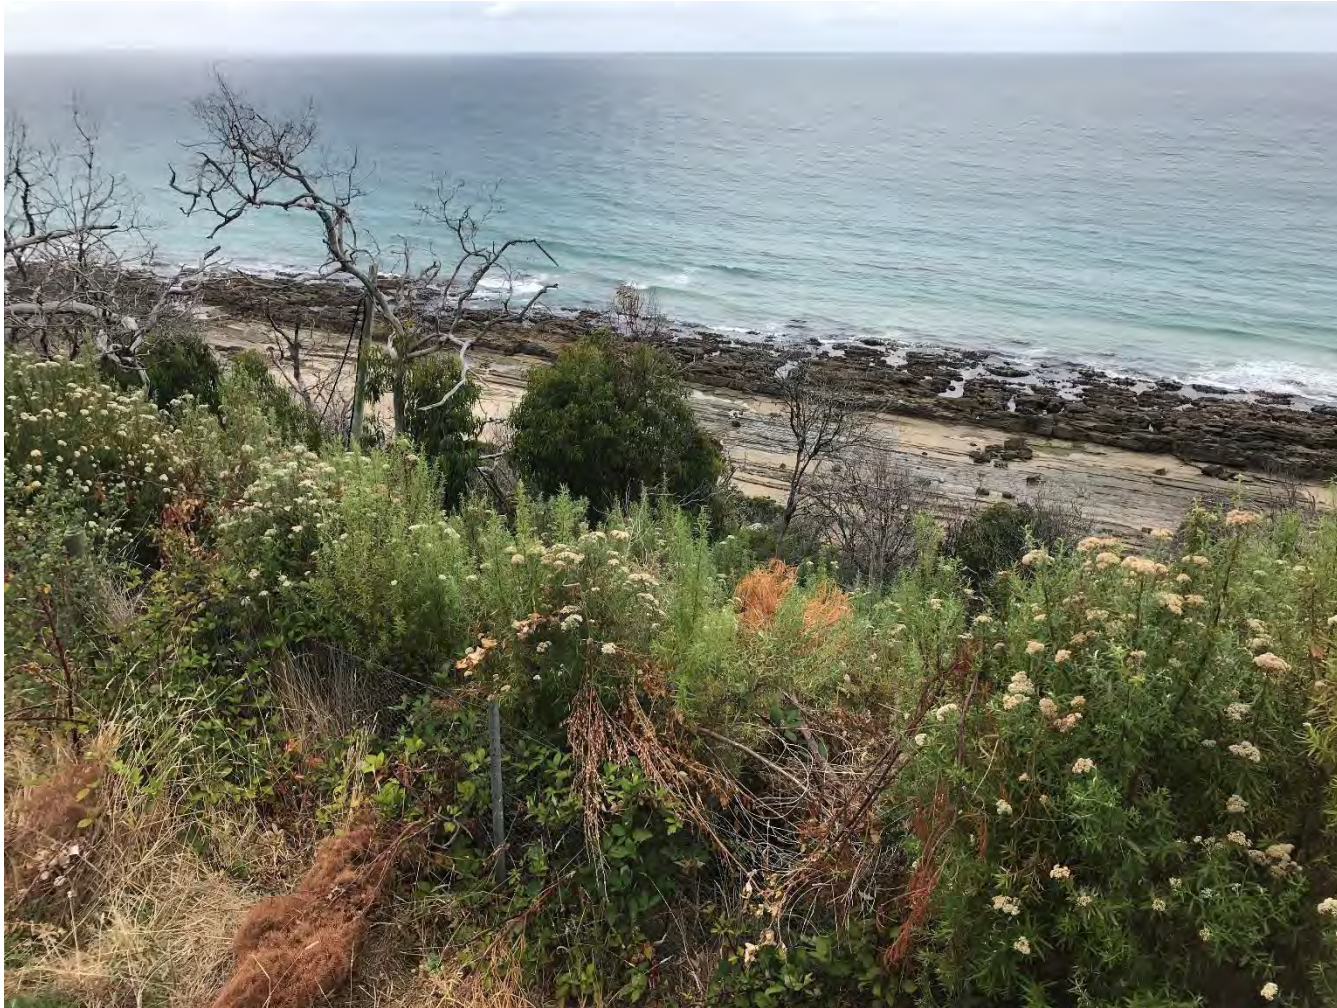
Photo 11 Typical slopes below 18 Iluka Avenue in the area of the proposed stormwater drain.

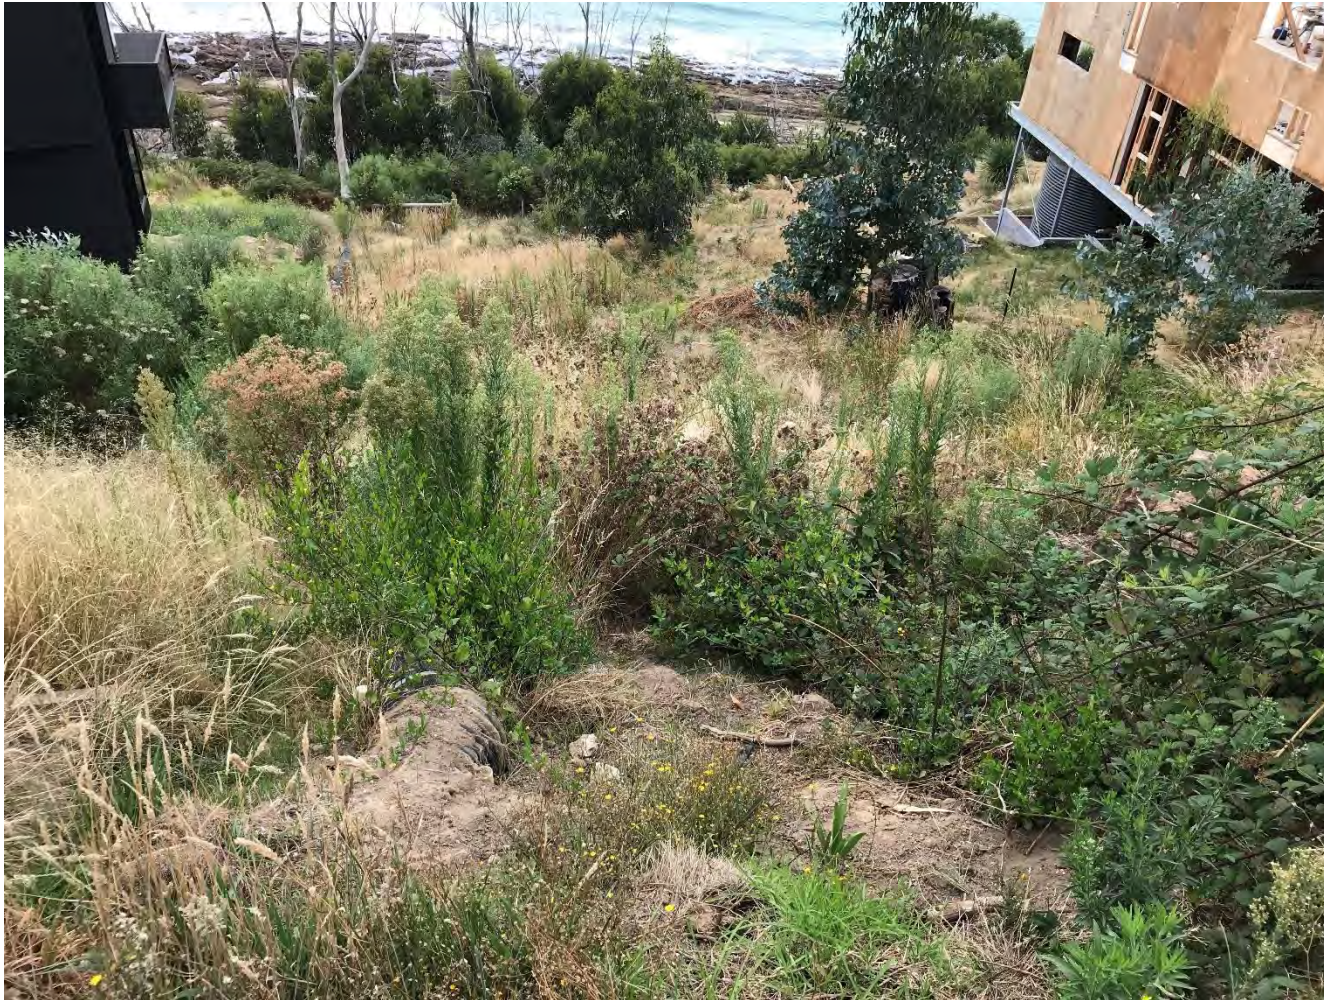
Photo 12 Typical Slopes in drainage easement between 13 and 14 Iluka Avenue.

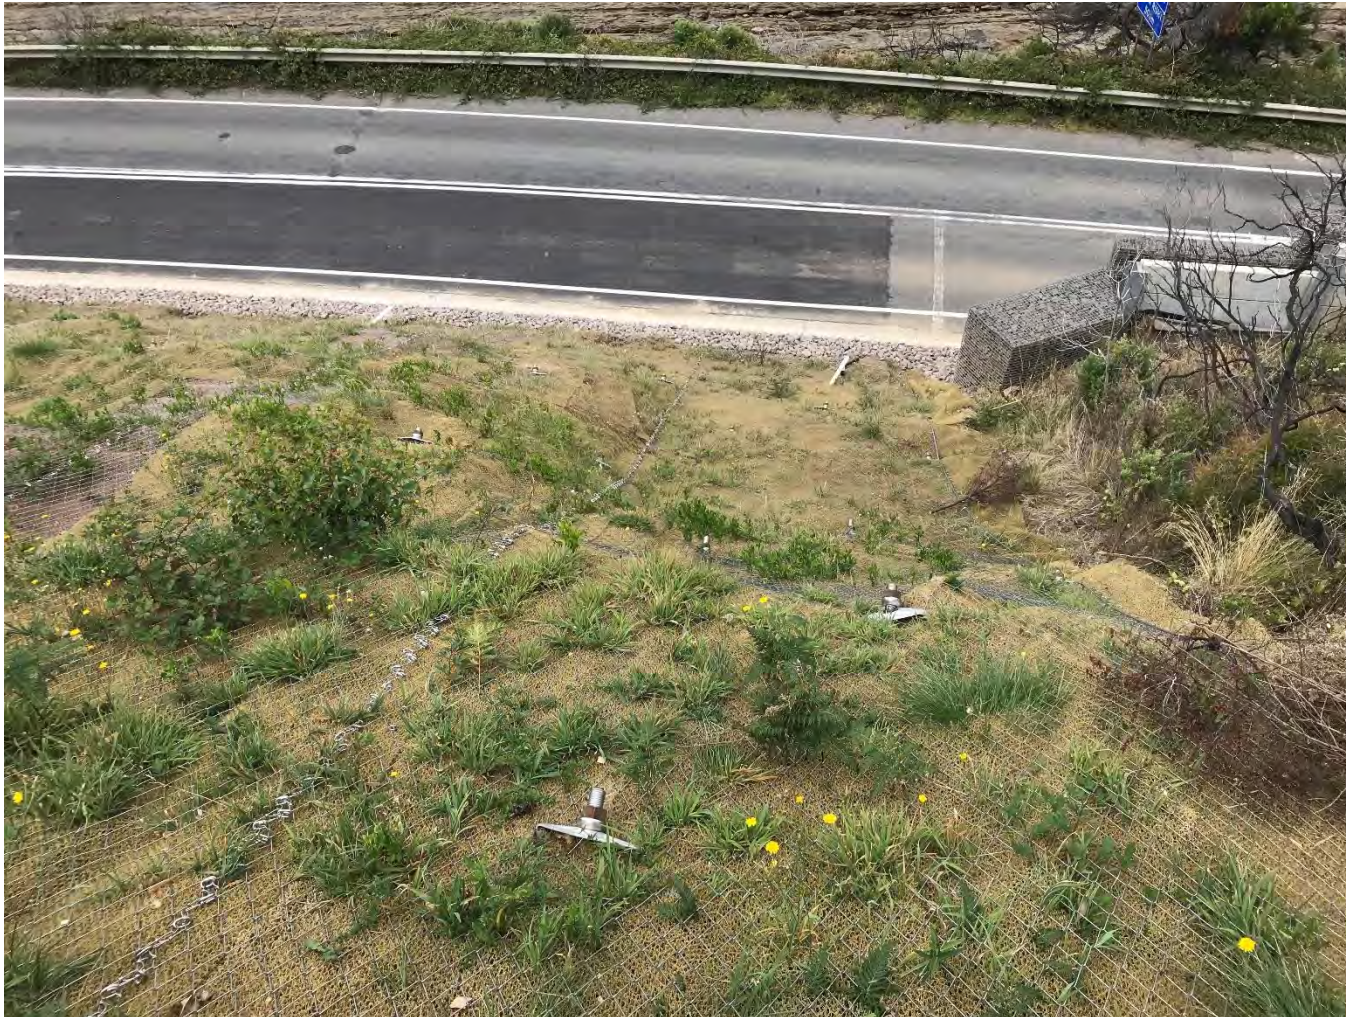
Photo 13 VicRoads remedial works of Great Ocean Road.

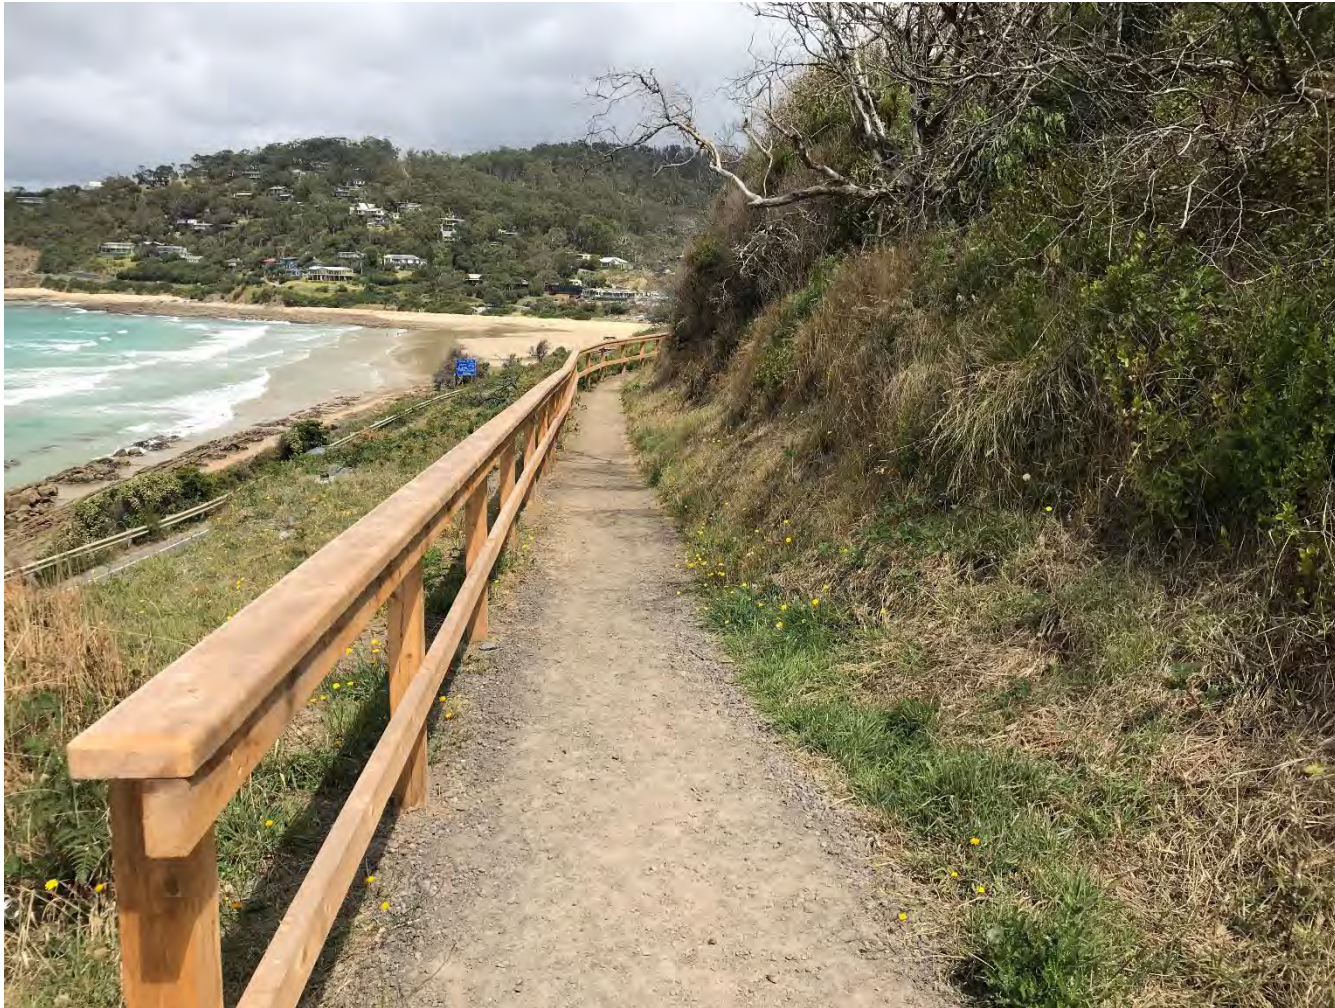
Photo 14 VicRoads remedial works at proposed outlet from 18 Iluka Avenue. Soil Nail and Mesh with drainage immediately downslope of hand rail.

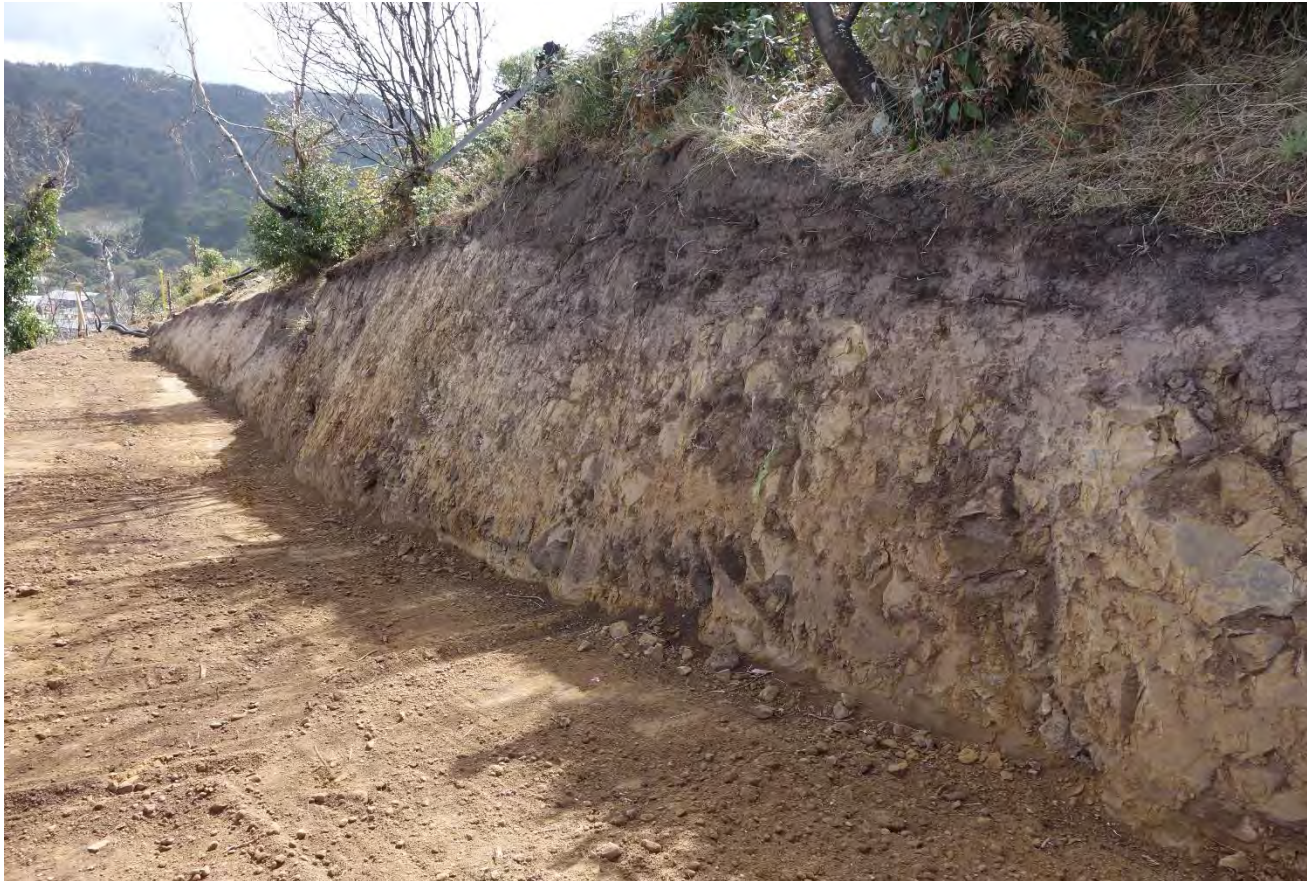
Photo 15 VicRoads retaining wall works – Slope 1 at 25 Iluka Avenue. Soil Profile of Colluvium overlying Highly Weathered SANDSTONE (at base of cut).

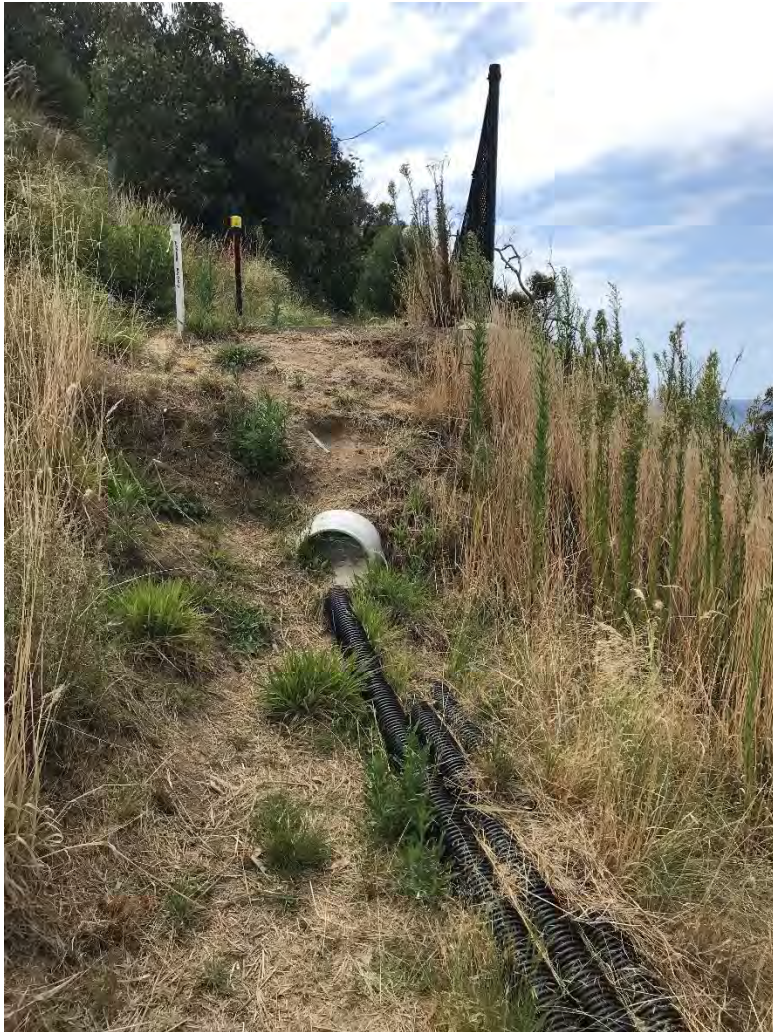
Photo 16 VicRoads retaining wall works at 25 Iluka Avenue – February 2019.
