**PP269/2019-1**

**1695 Carlisle Road CARLISLE RIVER**

**Two (2) Lot Subdivision and Creation of  
Access in Road Zone Category One (1)**

# GEOTECHNICAL ASSESSMENT

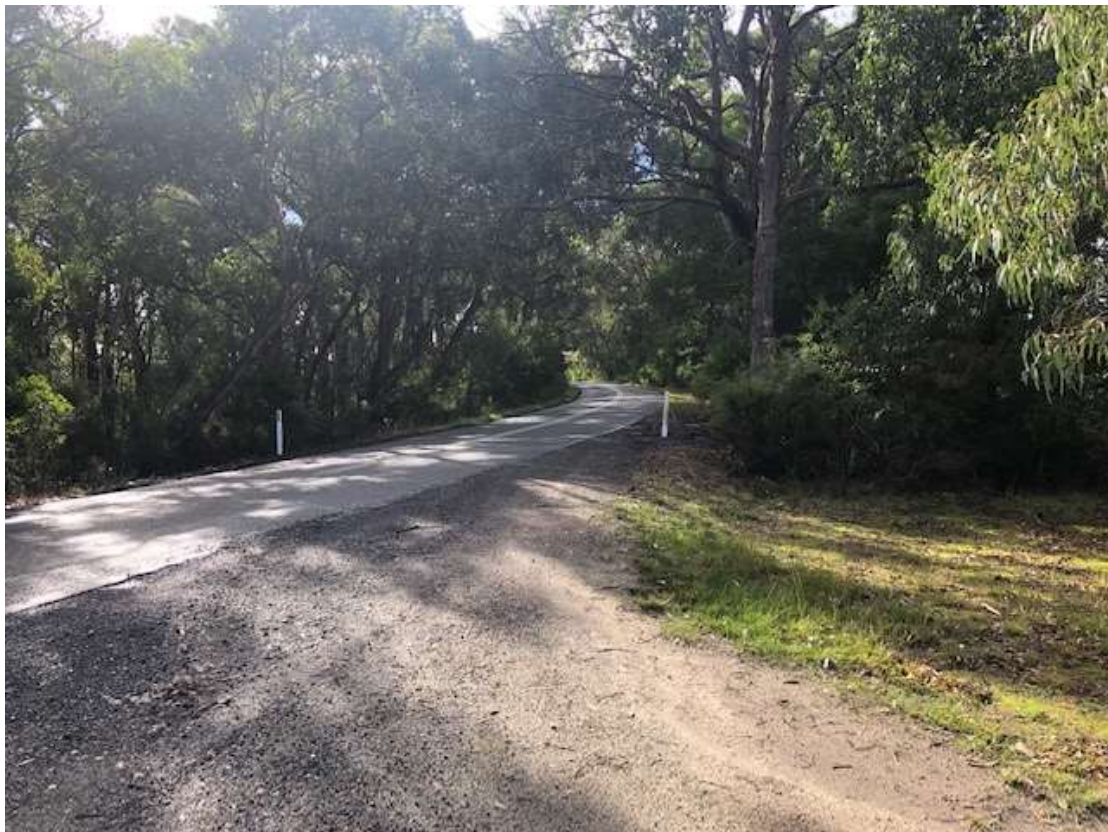
**Photo 2: Carlisle Road site distance from existing entrance to east.**

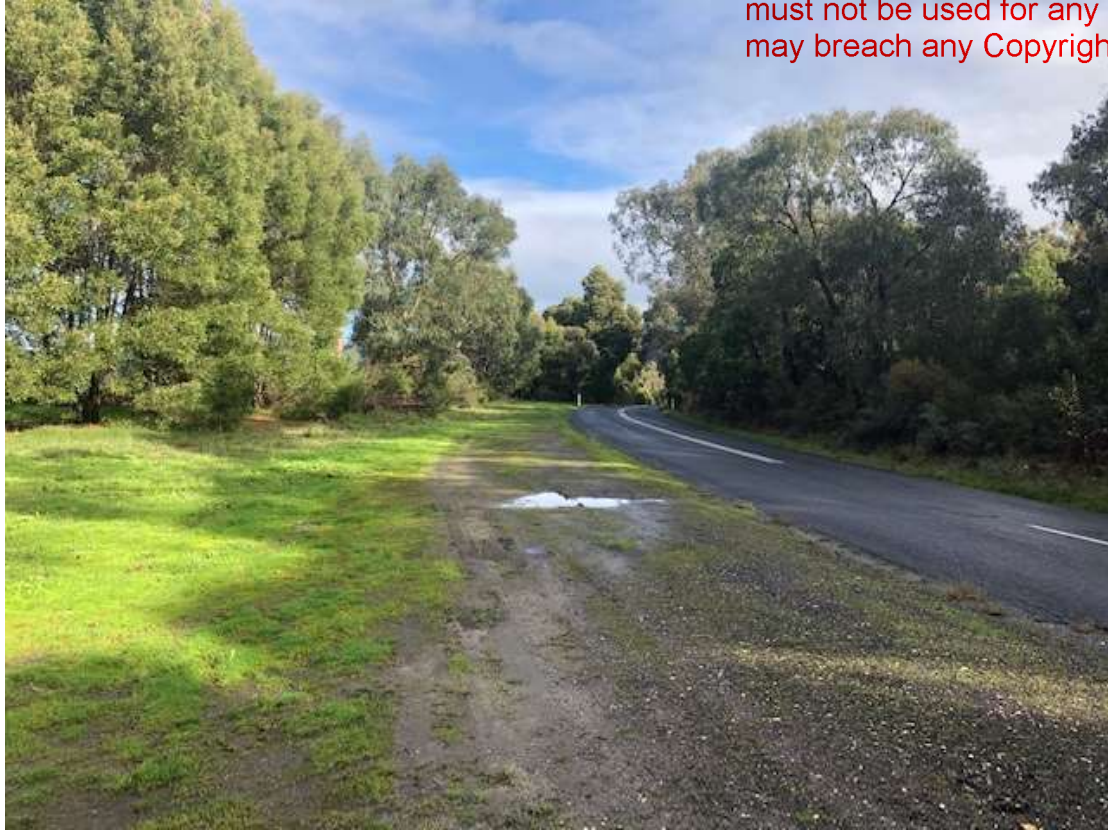
**Photo 3: Carlisle Road, existing entrance site distance to west.**

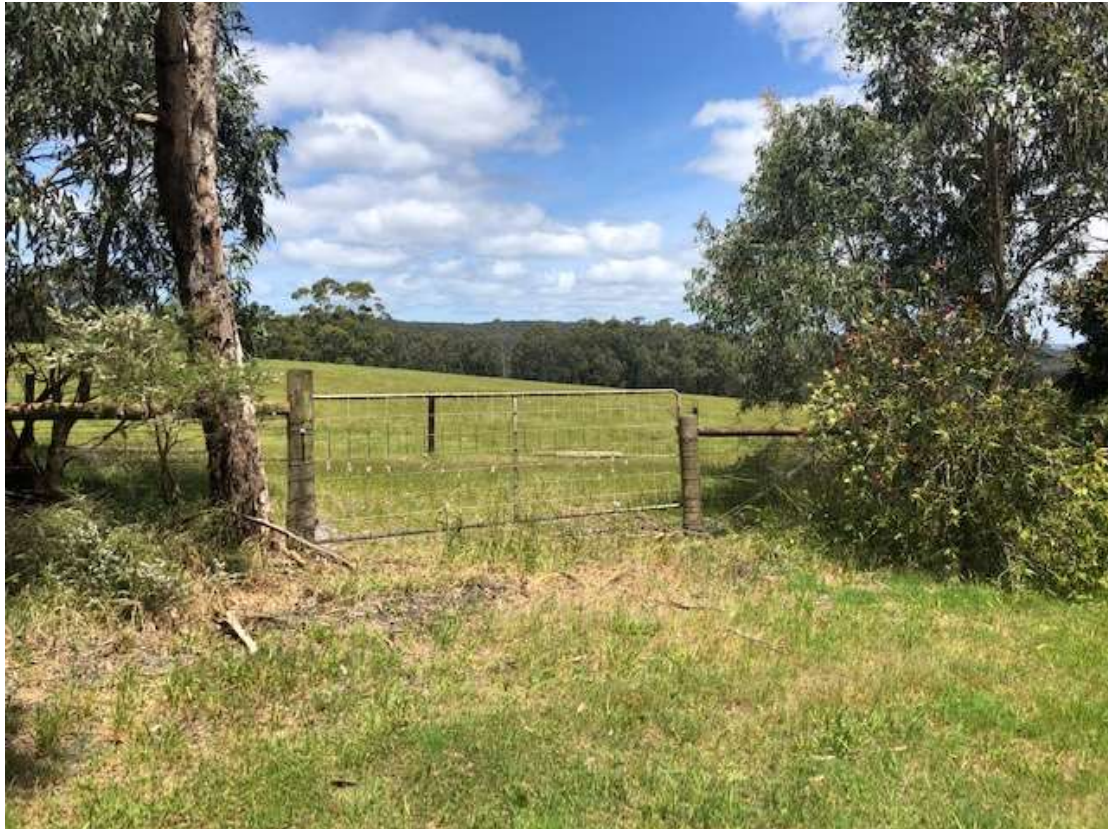
The proposed new entry point is approximately 50 metres west of the existing entrance point with an existing farm gate providing access currently.

**Photo 5: Existing farm gate. Proposed entry to Lot 2.**

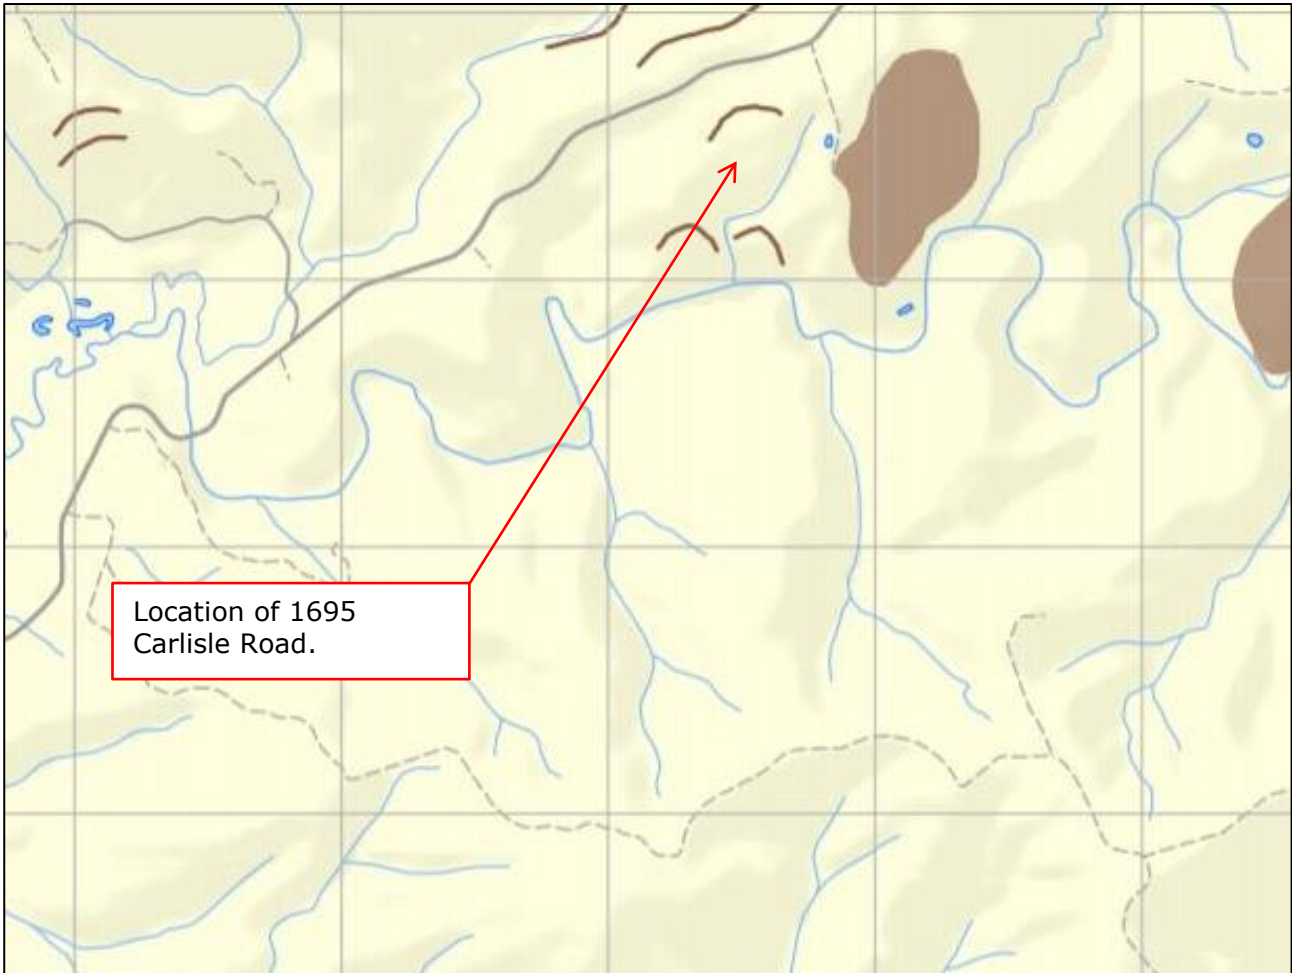
The inventory records several medium sized landslide scarps located on the subject site as well as a large area of landsliding which exists in the south-eastern corner of the property and extends across neighbouring properties. The inventory also records numerous other large landslide bodies or areas of landsliding to the east and south-east of site. Most of the inventory records coincide with the presence of the Eumeralla Formation Otway Group sediments or the margins of the Wiridjil Gravel in contact with the Eumeralla Formation.

**Figure 2: Previously recorded landslides on the landslide inventory (modified from AS Miner Geotechnical, 2007)**

Numerous landslide studies and geotechnical investigations have been previously conducted in the Gellibrand area. Cooney (1980), and Minor (2008) have both identified significant historical landslide failures from either aerial stereo photogrammetry interpretation or Lidar interpretation within the Carlisle River - Gellibrand area as can be seen in Figure 2.

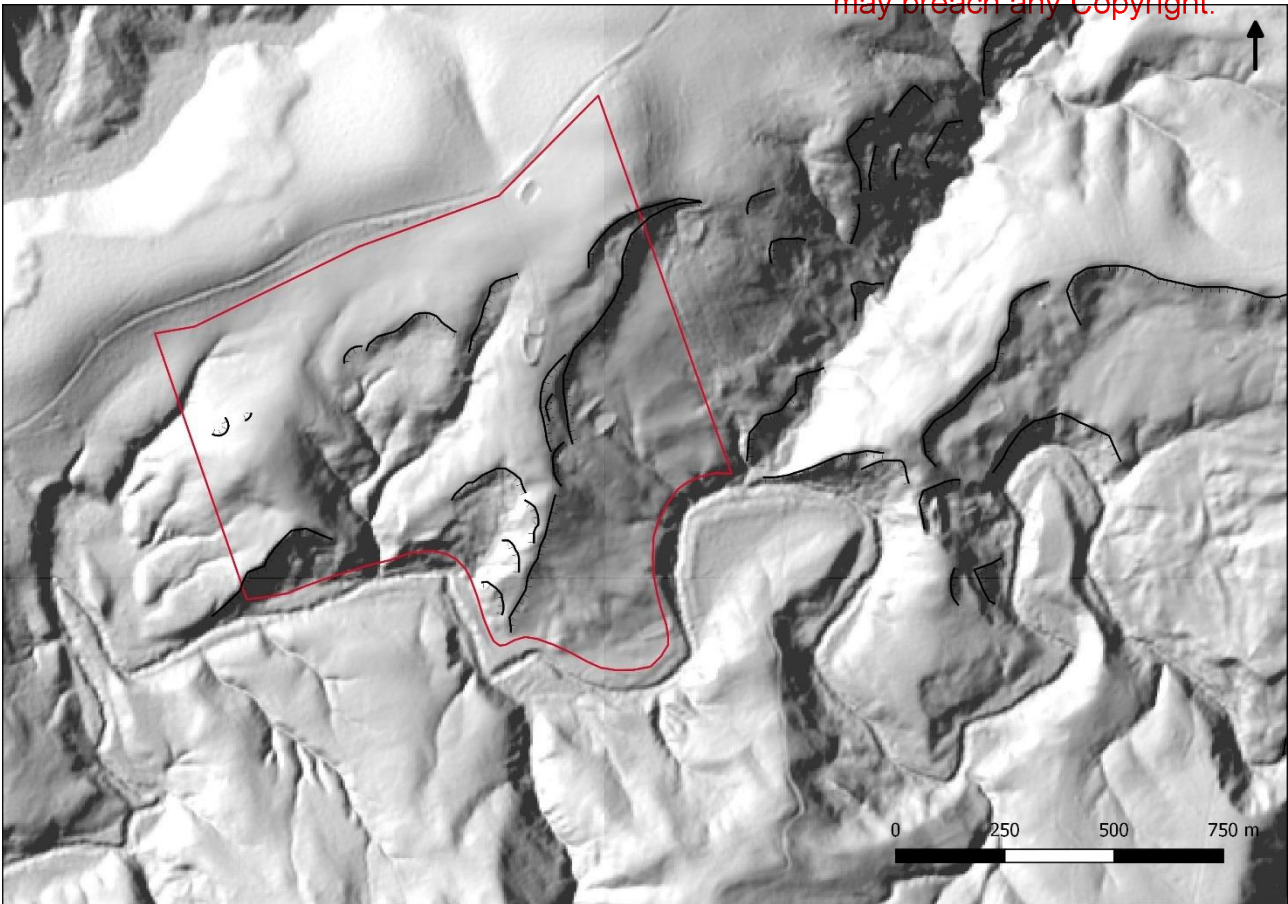
Figure 3 is a LiDAR derived Hill Shade DEM with interpreted landslide scarps. The Hill Shade DEM confirms the presence of historical landslides as depicted in the inventory record. Combining the known geological conditions with the presence of mapped and interpreted historical landslides, it is clear that steep, south facing slopes within Eumeralla Formation geologies are at high risk of slope instability.

**Figure 3: Hill Shade DEM interpretation of major landslides regional to the subject site (azimuth 300° illumination 45°)**

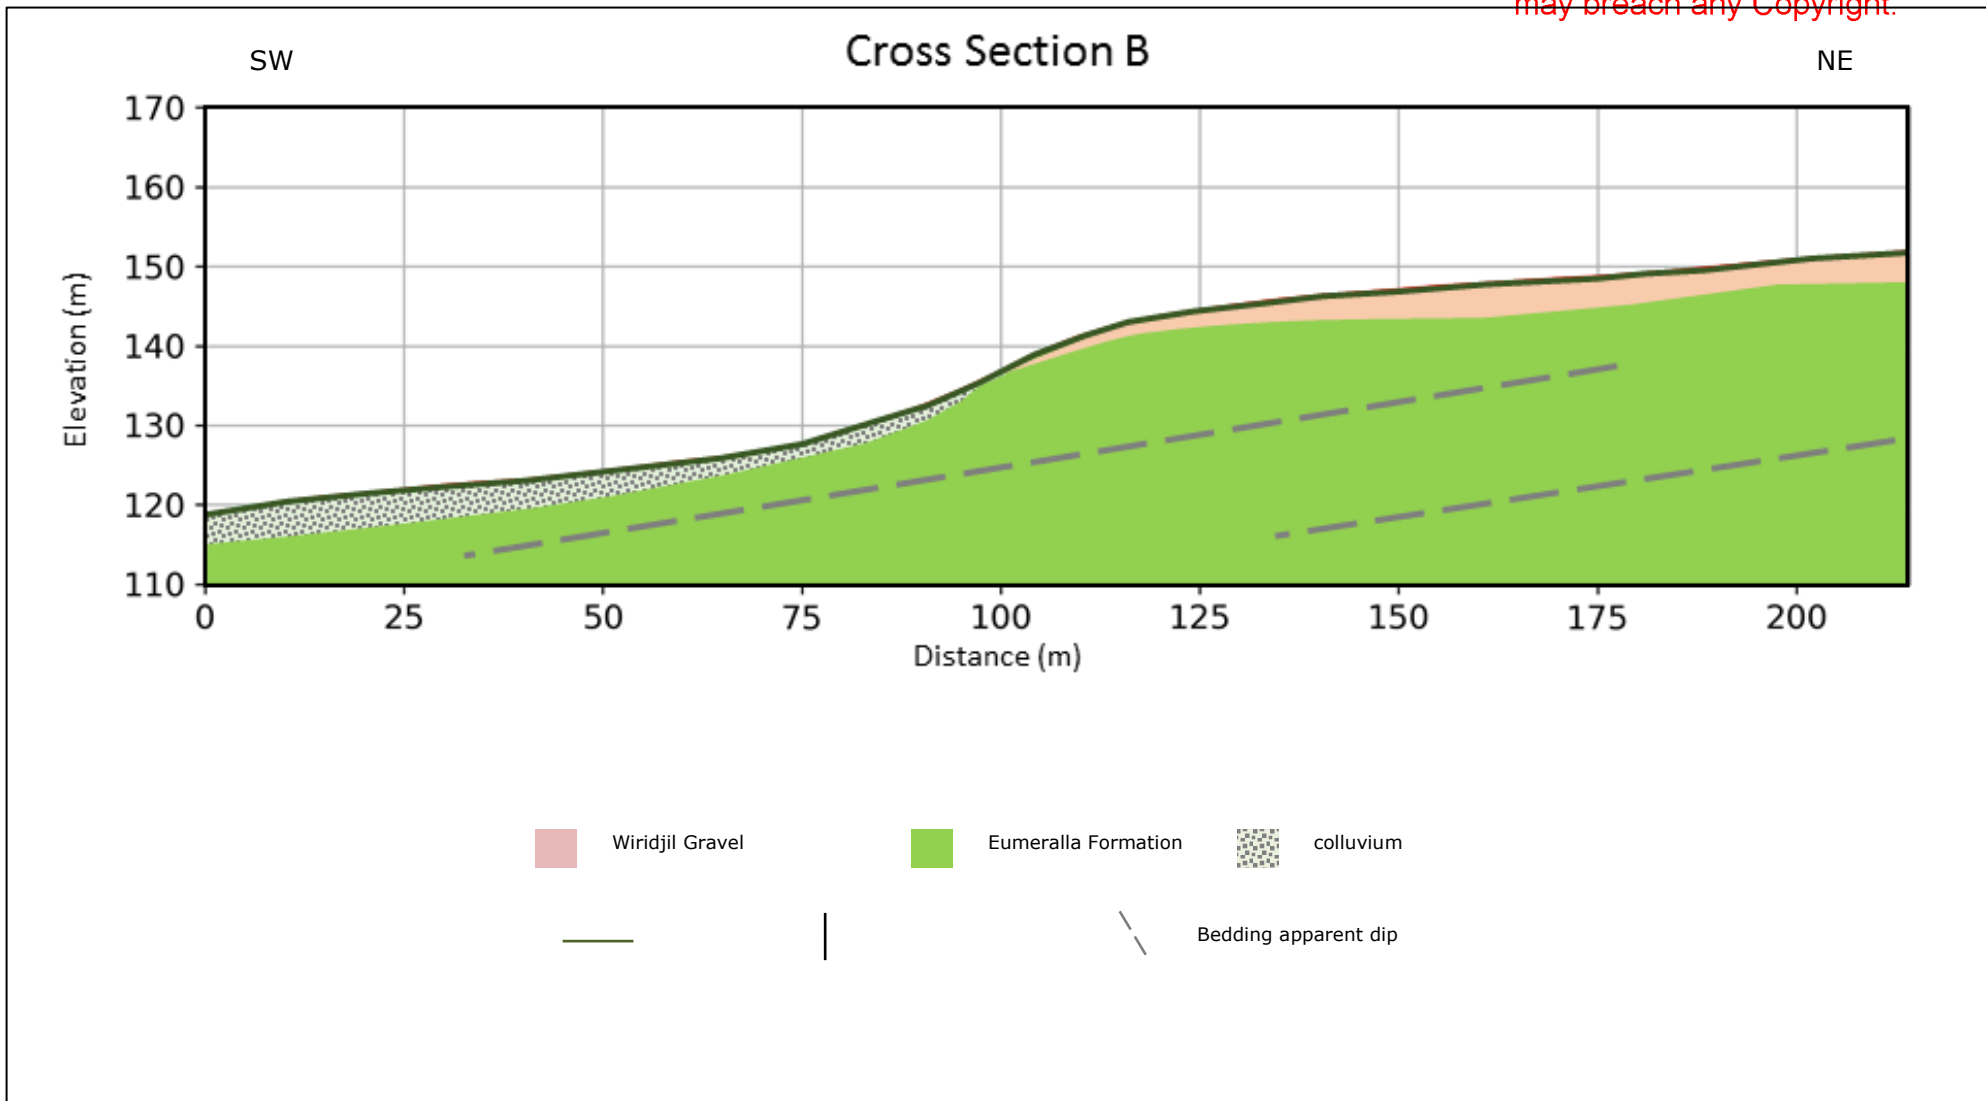
**Figure 6: Cross-section B representing the local geological model**

- Considering the geomorphology of the site and the surrounding area, the geological model formed implies that the soil profile on site has formed in-situ from weathering of the Wiridjil Gravel across the north of the property. Transported colluvial soils are inferred on crest and hill slopes in various locations and within the forested centre of the property.
- The soil profile is greater than 3500mm thick.

- 
- Bedrock was not observed during this investigation however regional bedrock structures indicate the property lies within regional monoclines on the southern limb of the Ferguson Hill Anticline.
  - The local ground model for landslide hazards involves shallow and deeper-seated translational earth-slides and earth flows on the margins of the Wiridjil Gravel, on steeper hill slopes and on the steep, south facing lower hill slopes of the Eumeralla Formation north of the Gellibrand River.

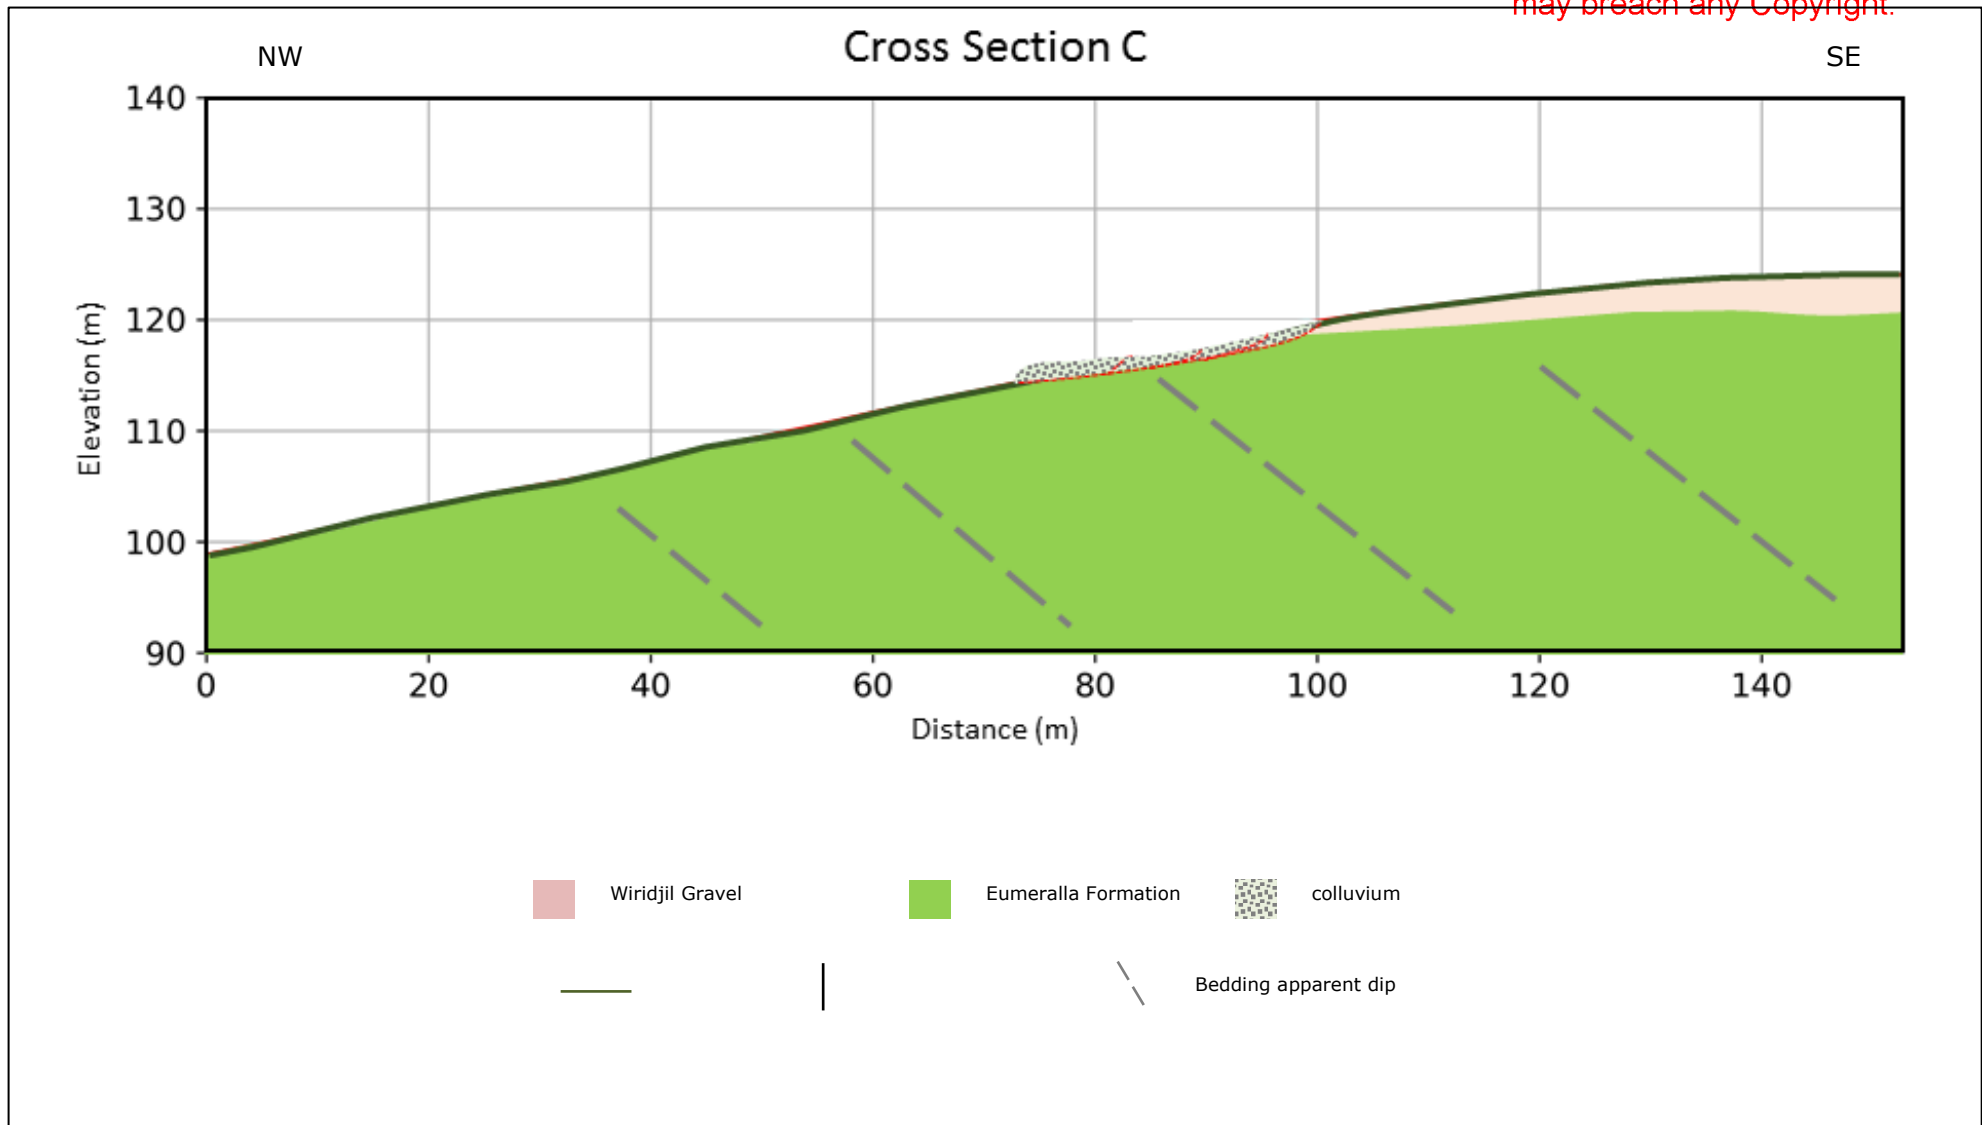
**Figure 7: Cross-section C representing the local geological model**

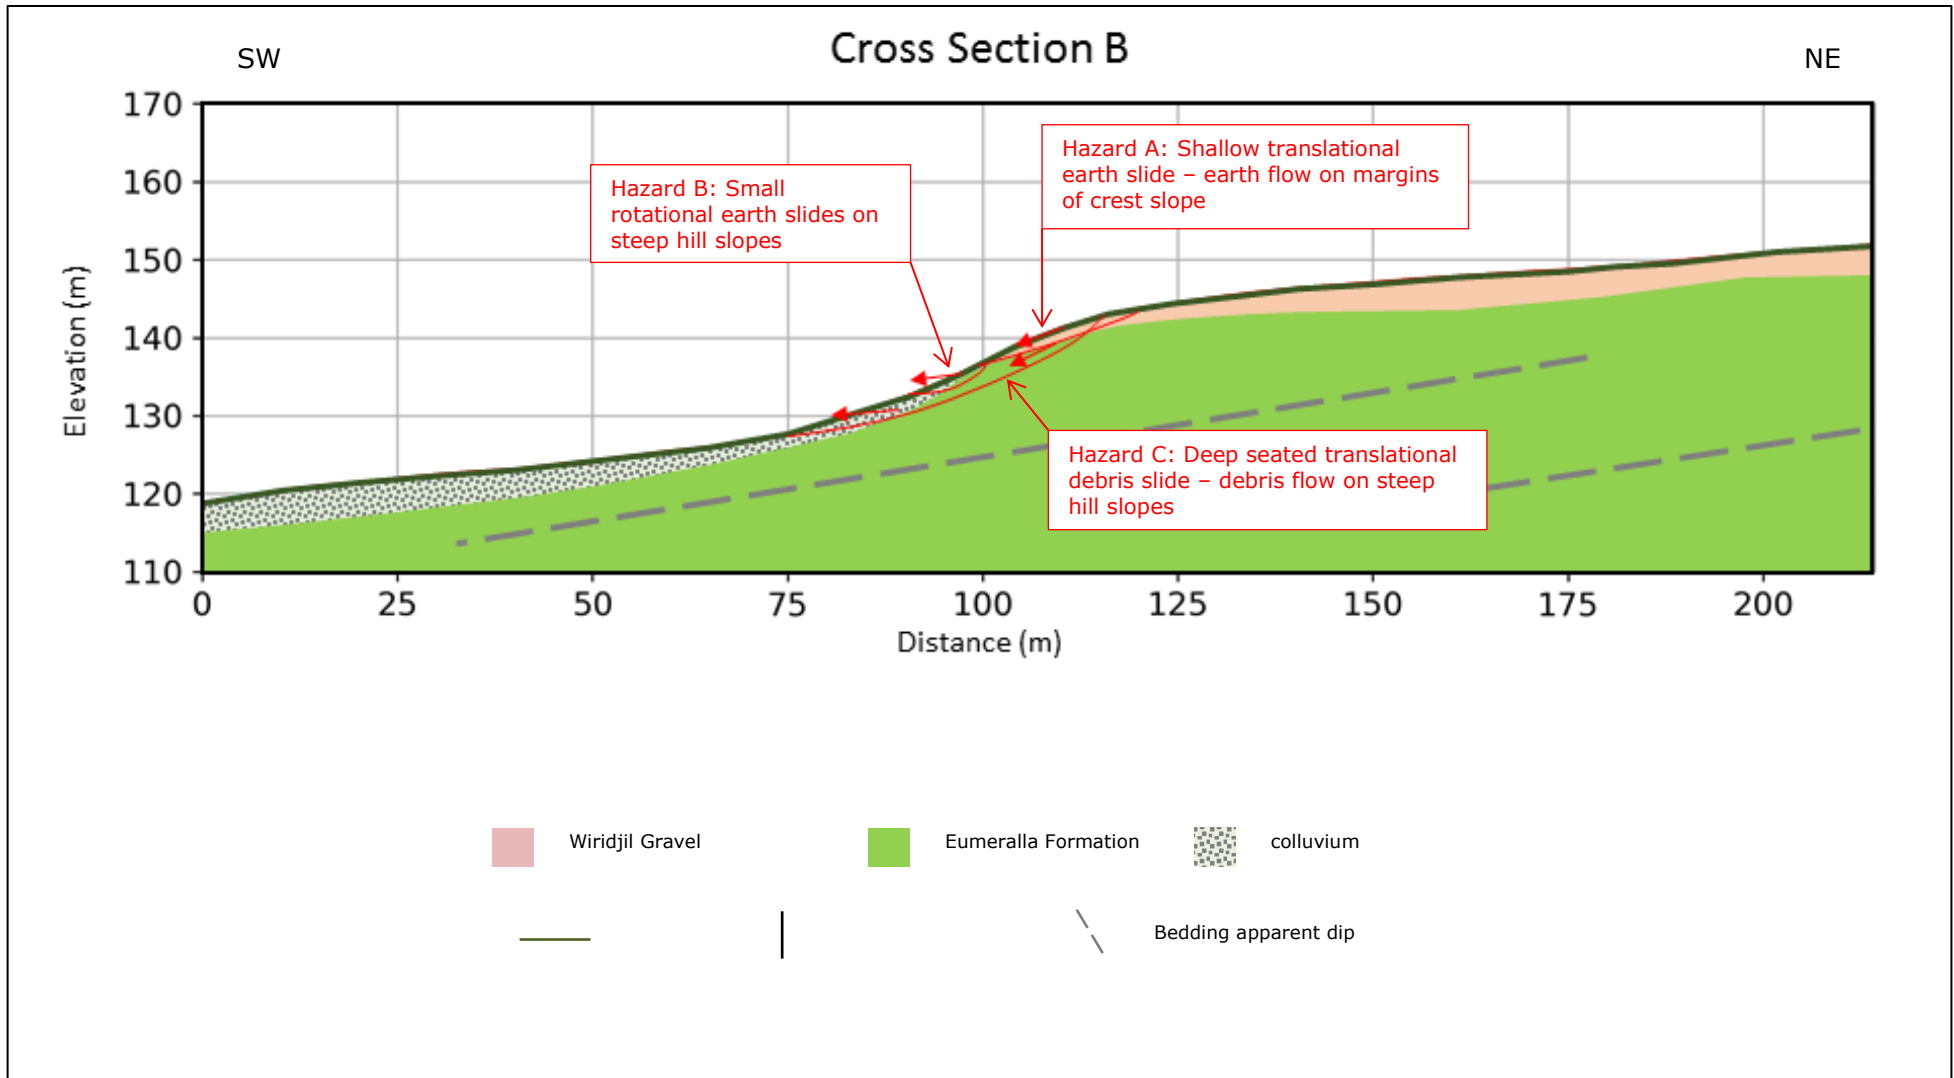
**Figure 8: Cross-section B representing the local geological model**

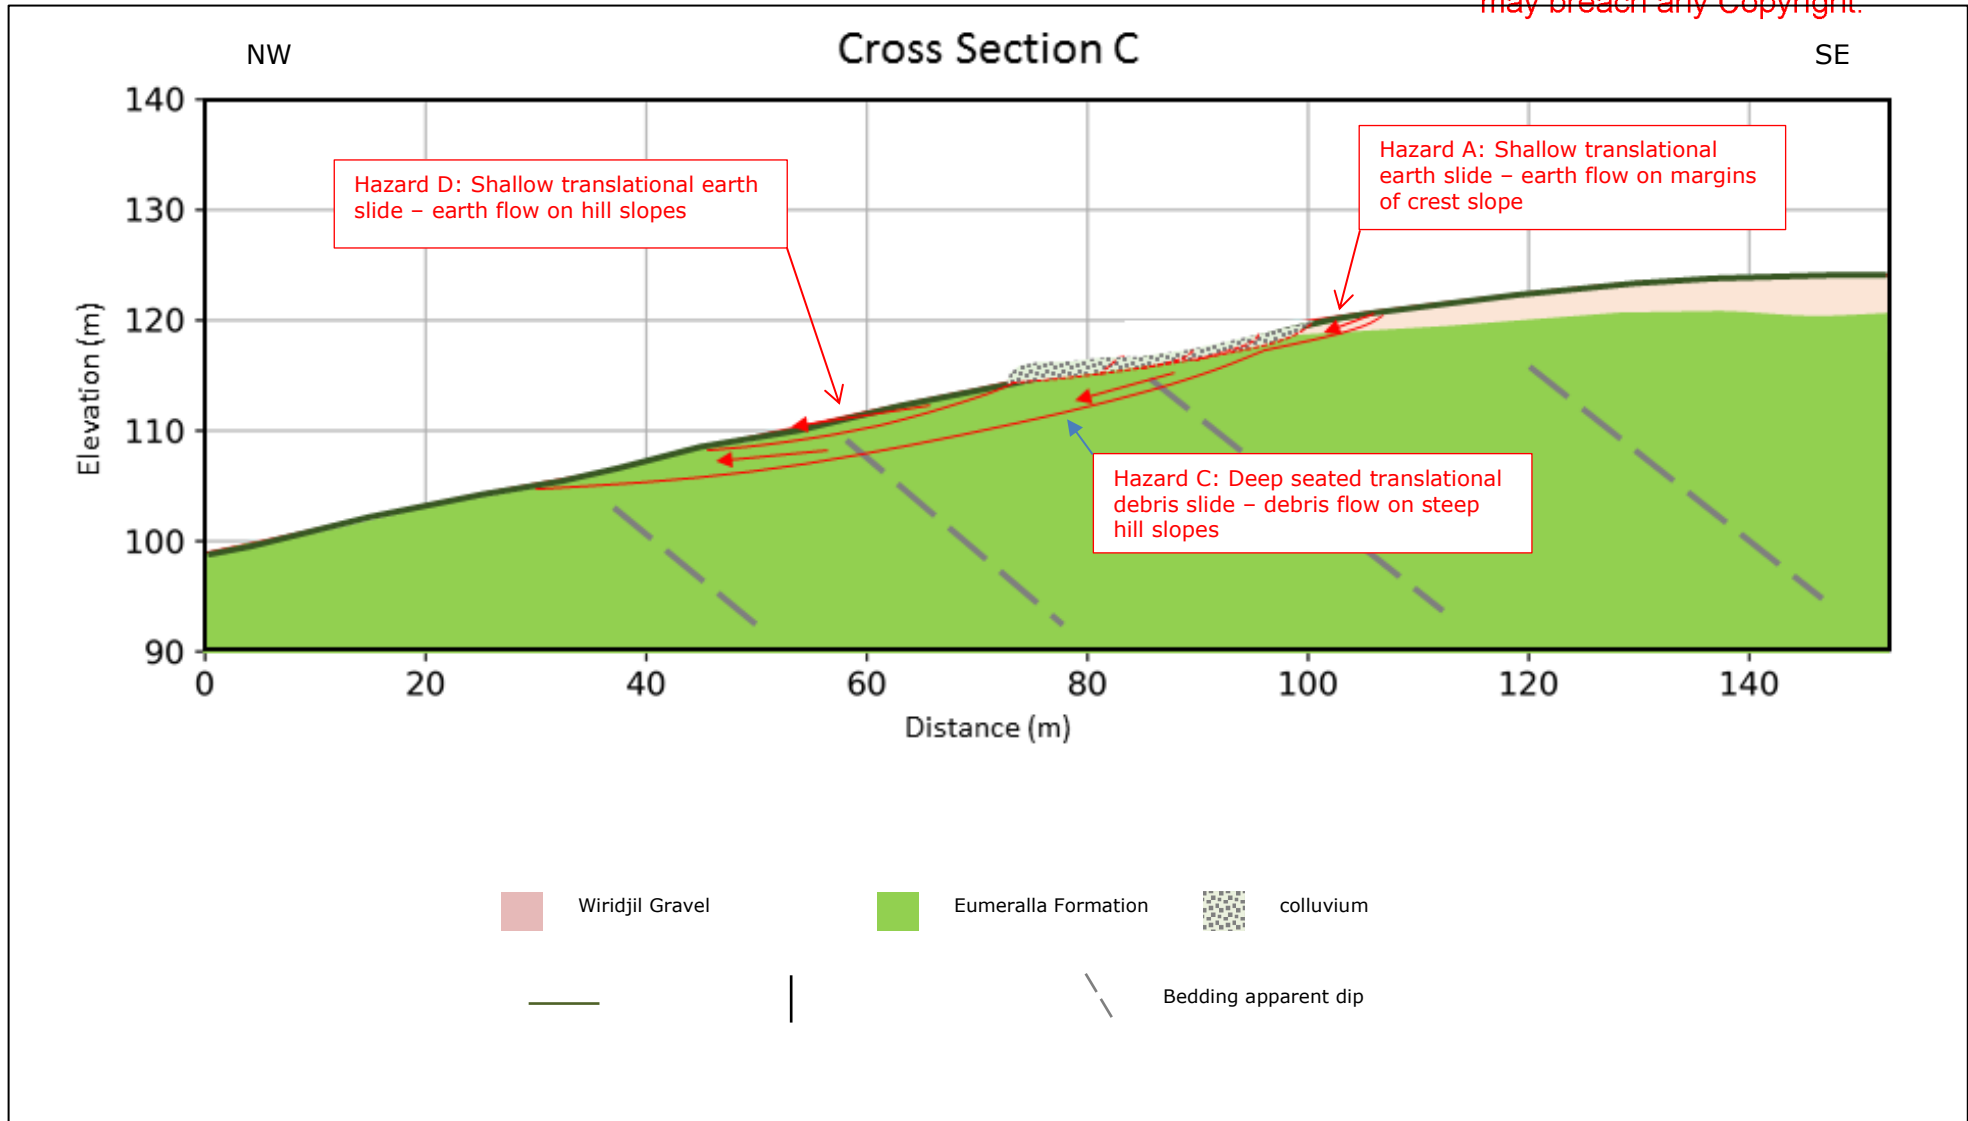
**Figure 9: Cross-section C representing the local geological model**

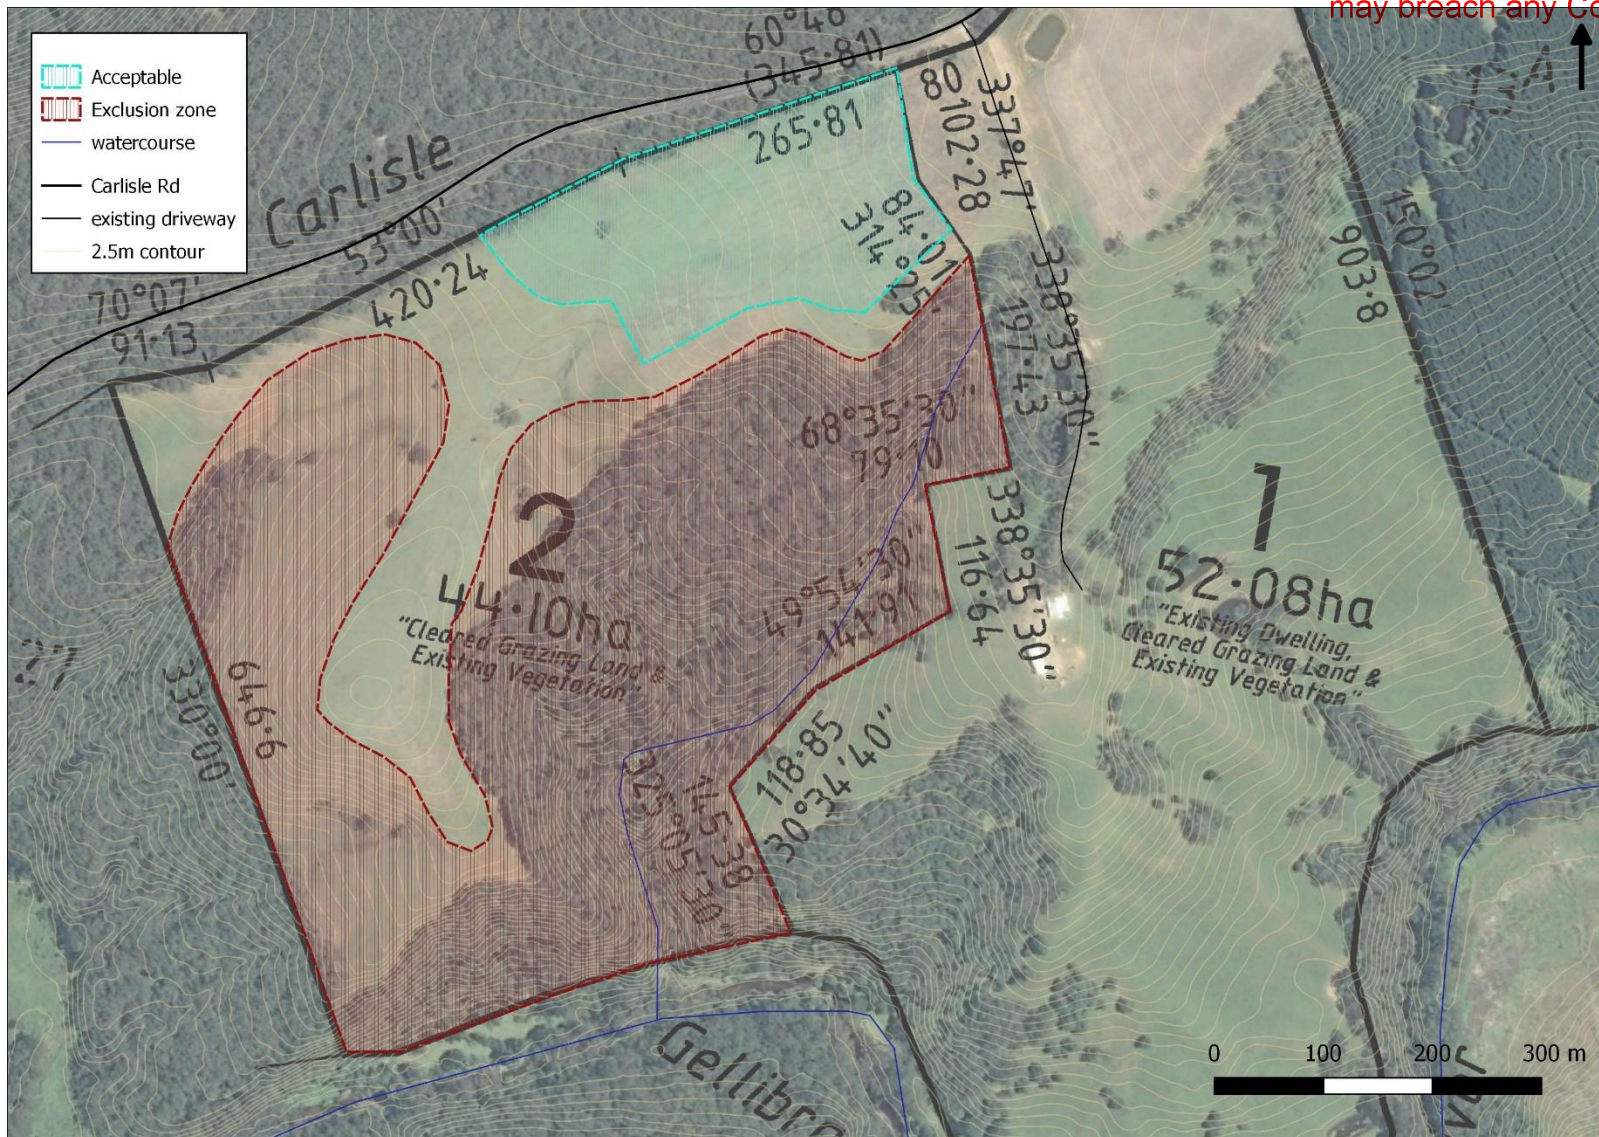
The 6 ha area marked as *Acceptable* in Figure 10 is the portion of the proposed subdivision assessed as being able to achieve an ACCEPTABLE risk level and suitable for future development. All other areas (including the excluded zone) should only be considered for development subject to the findings of a detailed Landslip Risk Assessment conducted by a suitably qualified person with experience in slope stability.

Figure 10: Recommended development zones

Large areas of the subject site either exhibit signs of existing slope instability, existing or historical landslides or susceptible landslide conditions. These areas (area marked as *exclusion zone* in Figure 10) should be excluded from all future development. The excluded area is considered unsuitable for any future structural development.

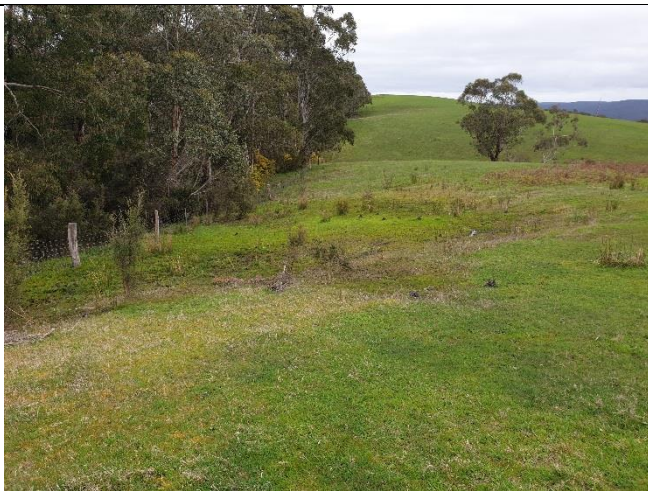
Photo3: Existing small landslide north of the forested areas centre of the property.

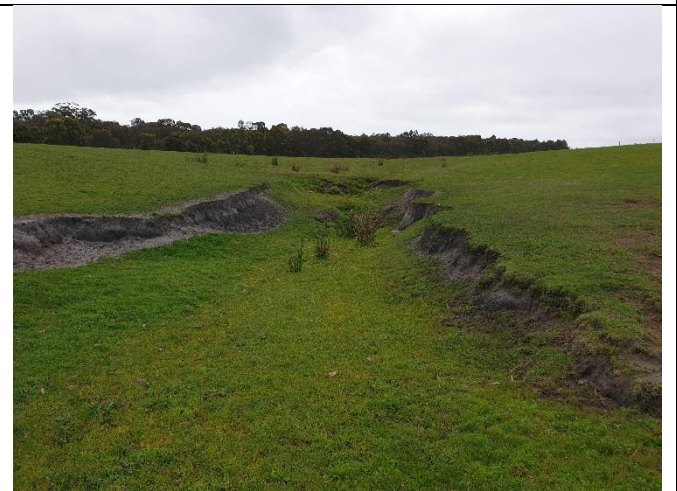
Photo4: Developing gully erosion in the centre of the property.

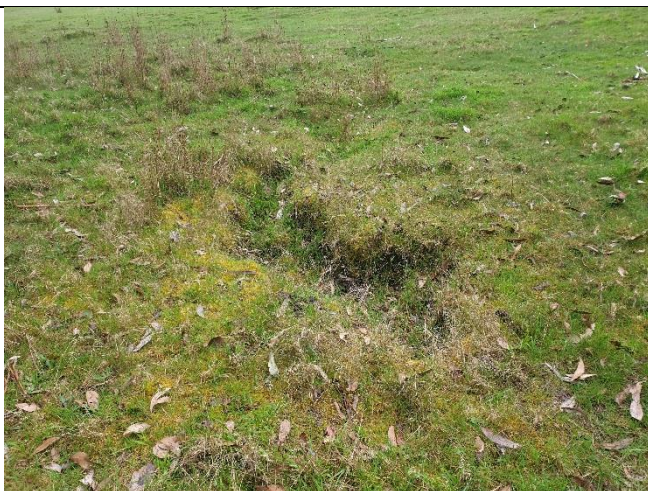
Photo5: Tunnel erosion in the north-western corner of the property.

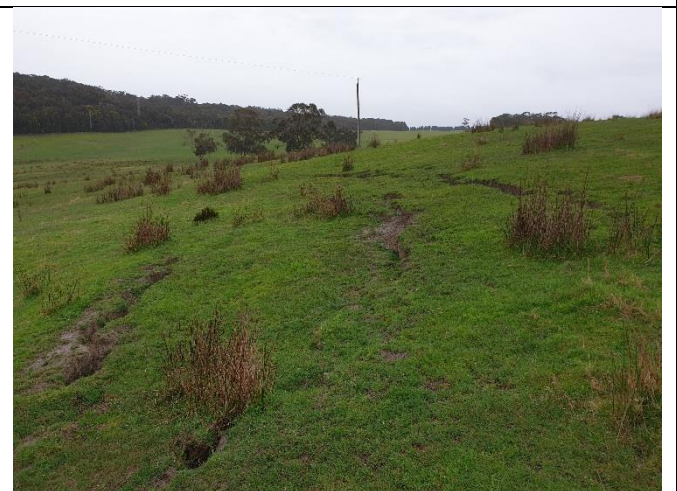
Photo6: Active successive landslide on north-west facing slopes below hill top in north-west corner of the property.

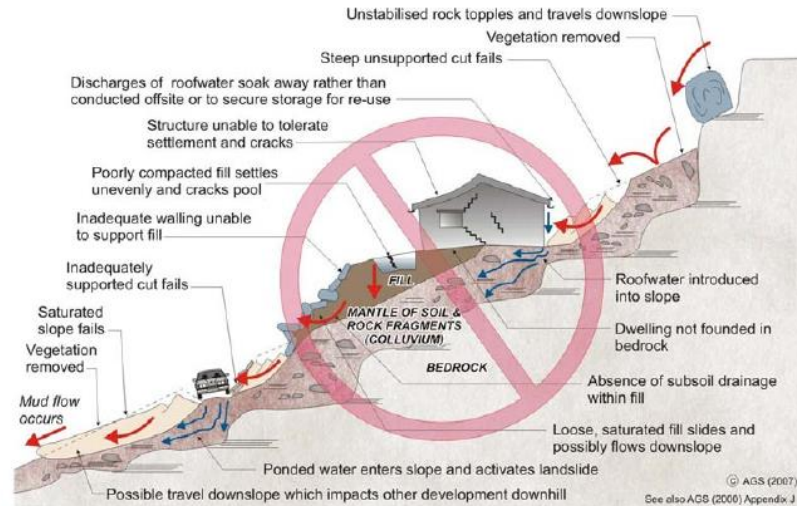
### EXAMPLES OF **POOR** HILLSIDE CONSTRUCTION PRACTICE

**Roadways and parking areas** - are unsurfaced and lack proper table drains (gutters) causing surface water to pond and soak into the ground.
