PP81/2019-1

217-219 Great Ocean Road APOLLO BAY

**Subdivision of the land into Four (4) Lots and
creation of accesses onto RDZ1**

EXHIBITION FILE

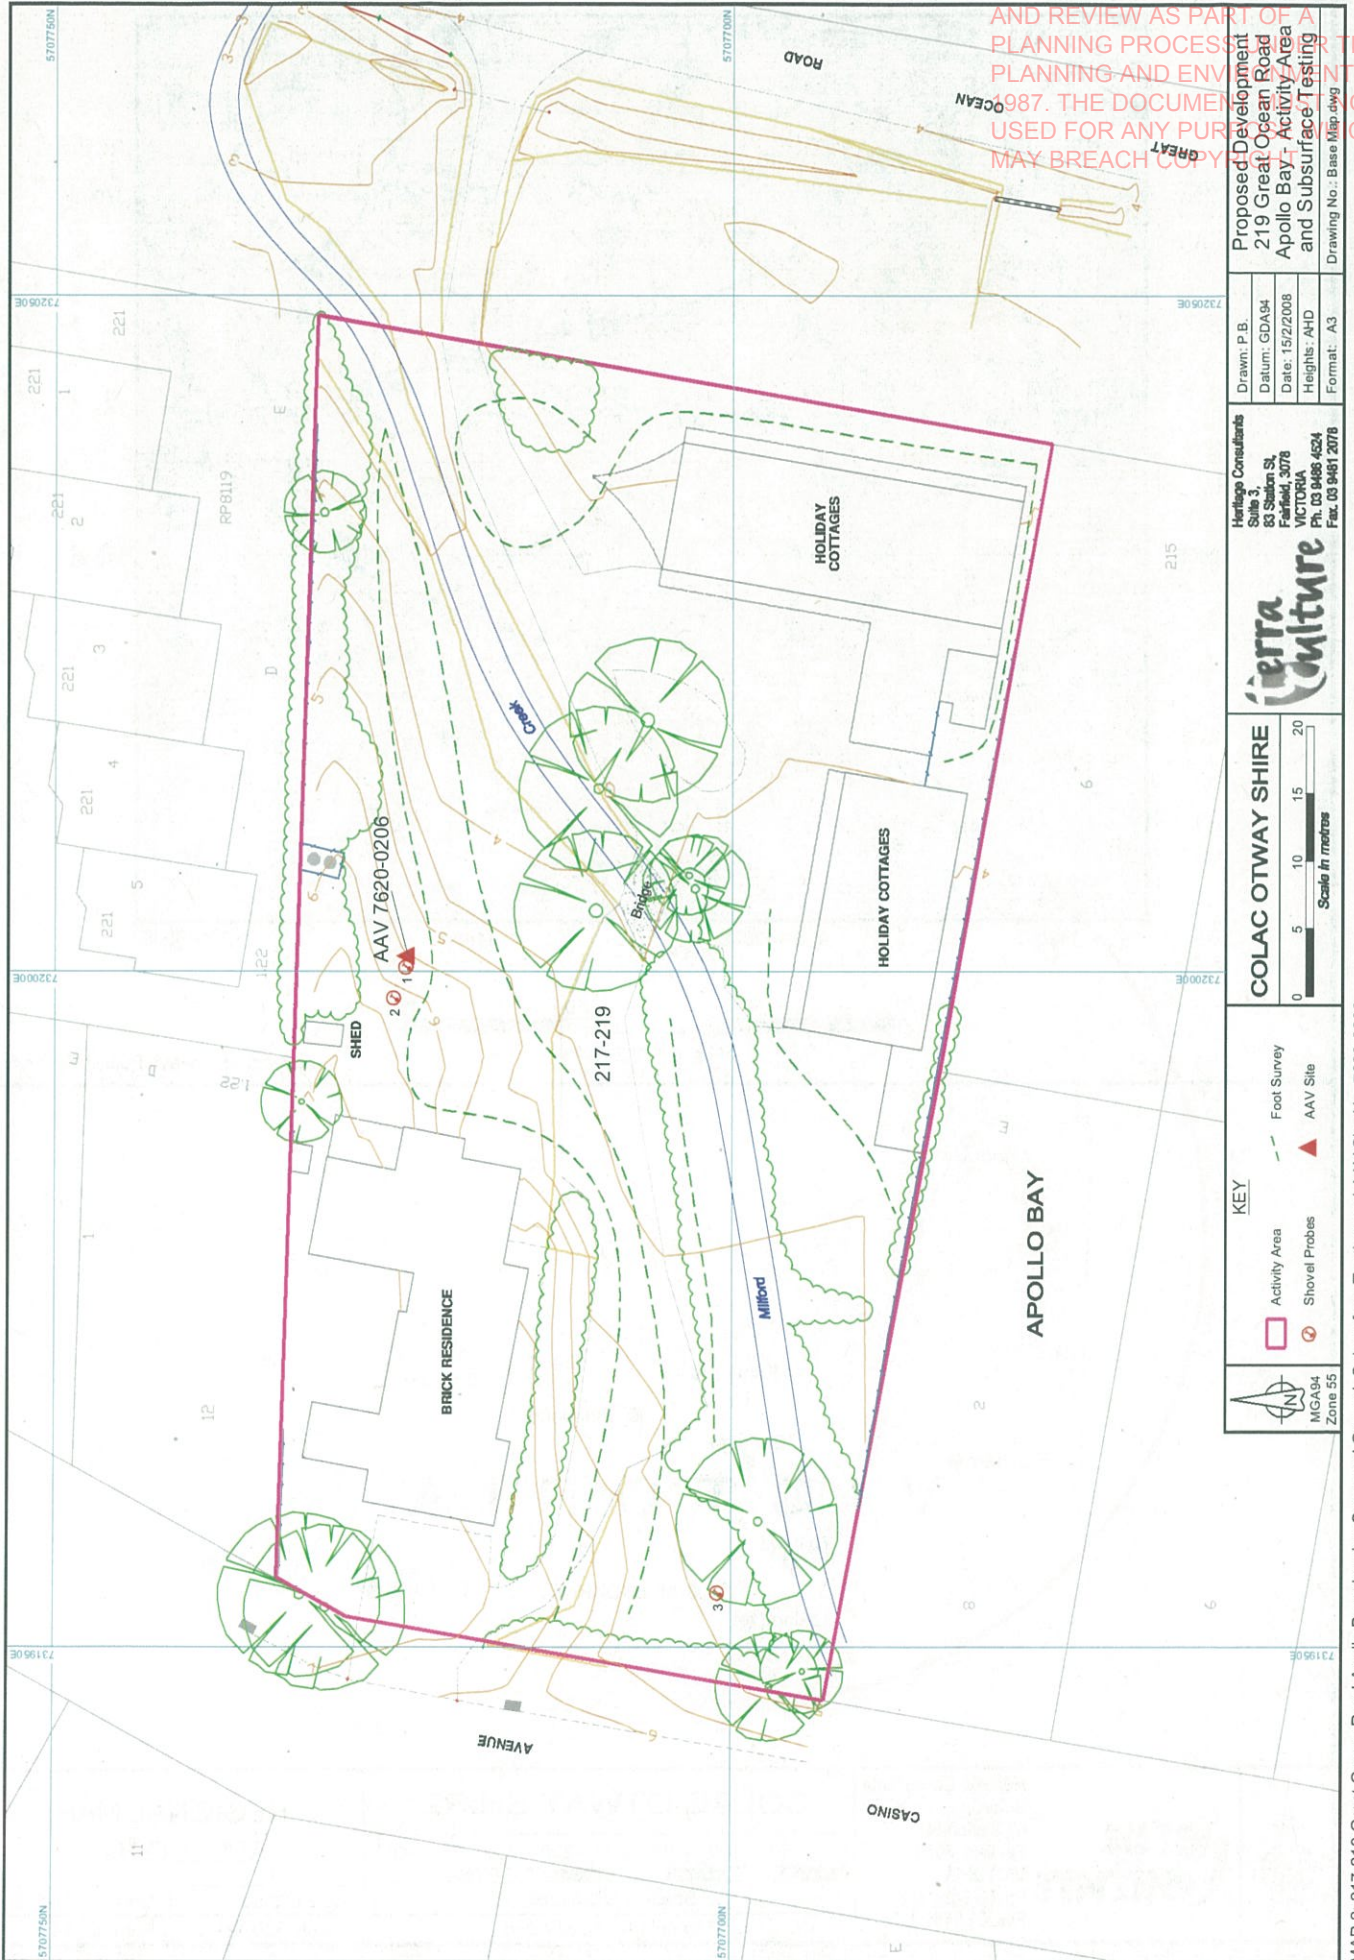
MAP 2: 217-219 Great Ocean Road Apollo Bay showing Surveyed Ground, Subsurface Testing and AAV Site No. 7620-0206.

At the same time, that this stone artefact survived the impact of the existing development (which represents intense usage for at least the last two decades) and the rural landuse prior to this is noteworthy. The artefact was found in a lawned area meters from the front entrance of the brick residence. Given its condition and context it is possible that this artefact was dispersed and reburied during construction of the brick residence, the impact of which would have easily extended to the find location. It also suggests the previous occurrence of a larger archaeological site within the vicinity and not necessarily within the activity area which could have extended as far west as Casino Street. This possibility does not warrant any further assessment because it is unlikely that the distribution extends beyond that documented during the current investigation due to the impact of the existing development and shown on Map 2.

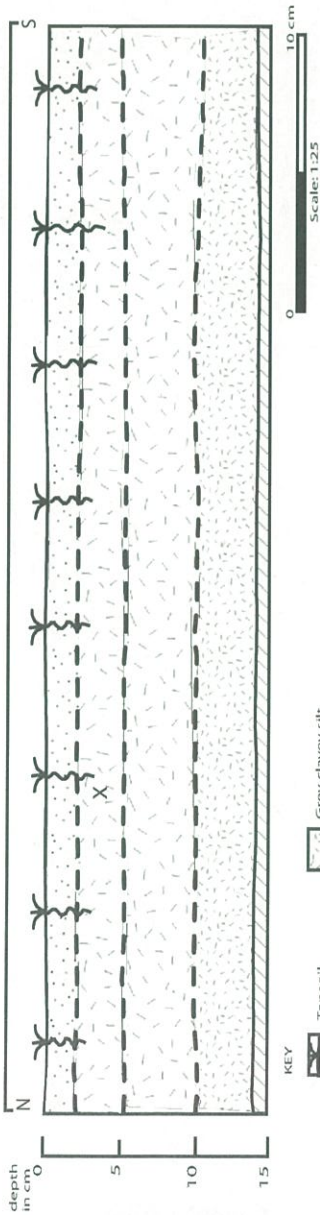
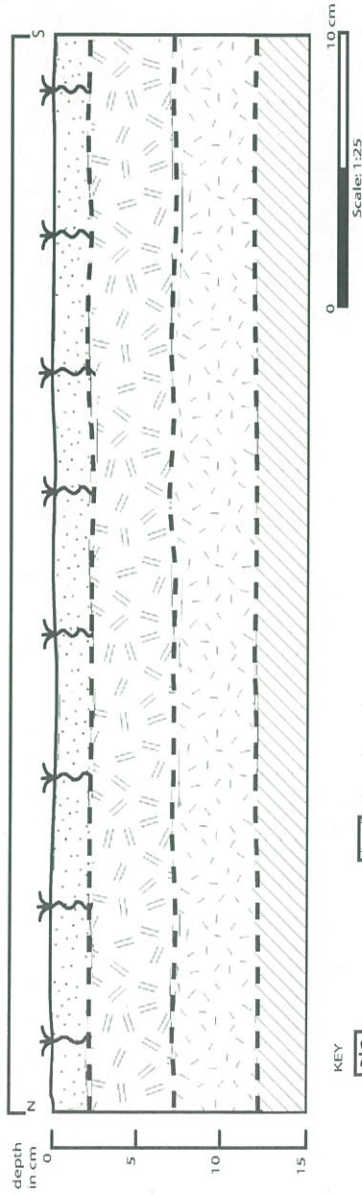
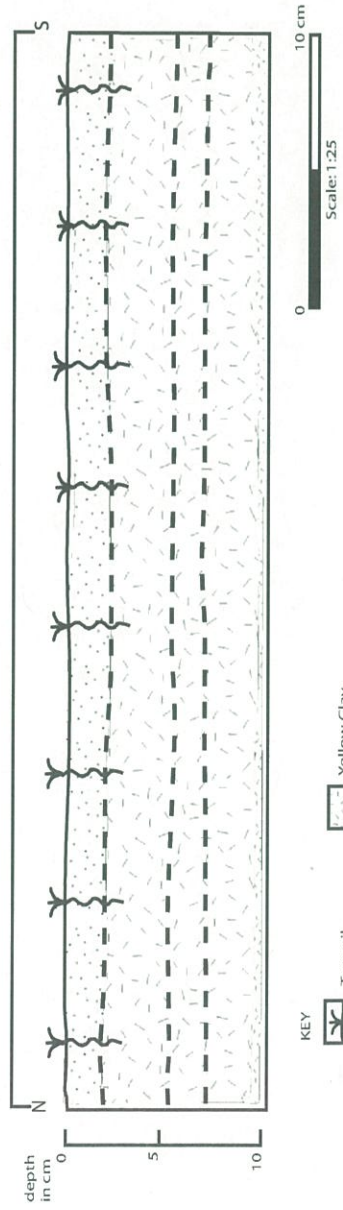
SHOVEL TEST PIT 1
EAST FACE

SHOVEL TEST PIT 2
EAST FACE

SHOVEL TEST PIT 3
MILFORD CREEK
EAST FACE

Figure 1: Stratigraphic profiles for Shovel Test Pits 1 to 3

The second pit was located 2m to the northwest of Pit 1, just a little further from the top of the slope, but on the same landform. This pit was dug to establish whether or not the single artefact found in Pit 1 belonged to a more extensive distribution which may have had an expression at this location and also to further investigate the local stratigraphy. Despite its proximity to Pit 1, the stratigraphy proved to be different with no additional archaeological material. In this pit the grey silty clay had been mixed with the yellow clay for the entire depth of the excavation save for the top 2cm or so.

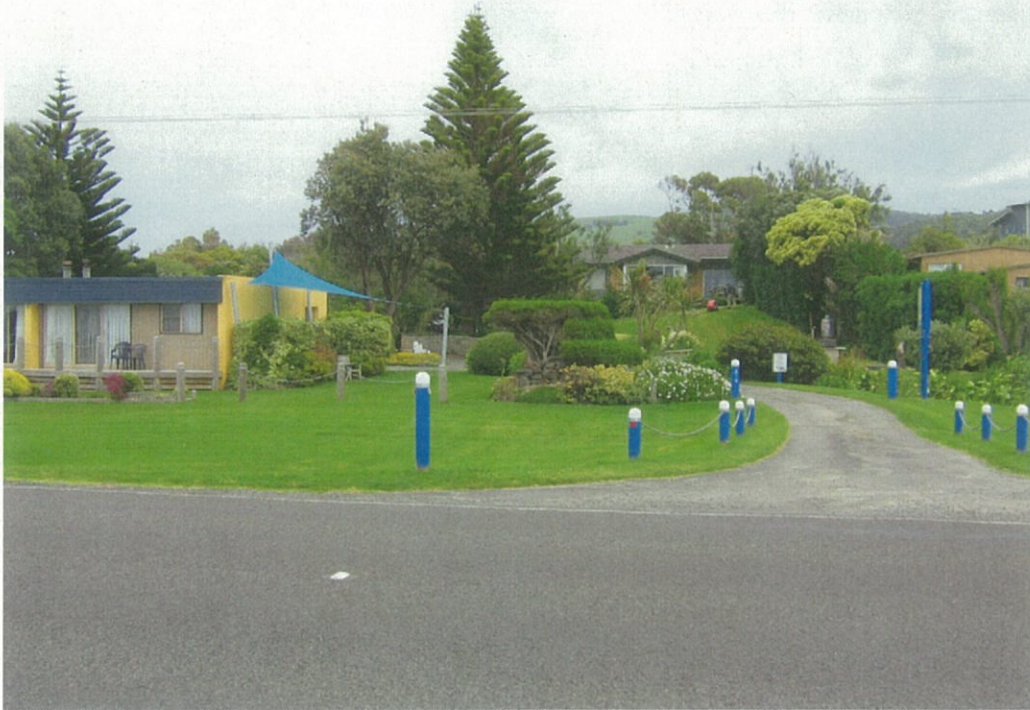
Plate 1: The activity area 217- 219 GOR looking west at the front of the property. The holiday cottages 'Bayside Gardens' are on the LHS. The brick residence can be seen in the middle ground on the RHS. Note the heavy landscaping.

Existing conditions maps supplied by the sponsor show that the existing buildings cover more than half of the activity area. These buildings are a large brick residence on the northern side of the creek and the holiday cottages on the southern side of the creek (Plate 1, Appendix 2) The brick residence takes up almost all of the north western quarter of the activity area and, originally built as a holiday house, is over twenty years old (Philip Callister pers com). The house has been benched into the side of the hill and the southern wall and adjoining lower rooms occupy space where there was once hill side. The house is either on a concrete slab or brick and concrete footings. The open space around the brick residence is heavily landscaped.

- construction of an access road from the Great Ocean Road to the holiday cottages;
- levelling of ground on the southern side of the creek to accommodate the holiday cottages (Plate 1);
- the construction of verandas, carports, outdoor seating and other garden landscaping;
- the construction of the local sewer (Plate 2) which would have cut a wide and deep trench across the property;
- the installation of stormwater drainage that exists along the creek banks (Plate 8) and other underground services;
- landscaping around and construction within the Milford Creek channel including foot bridges.

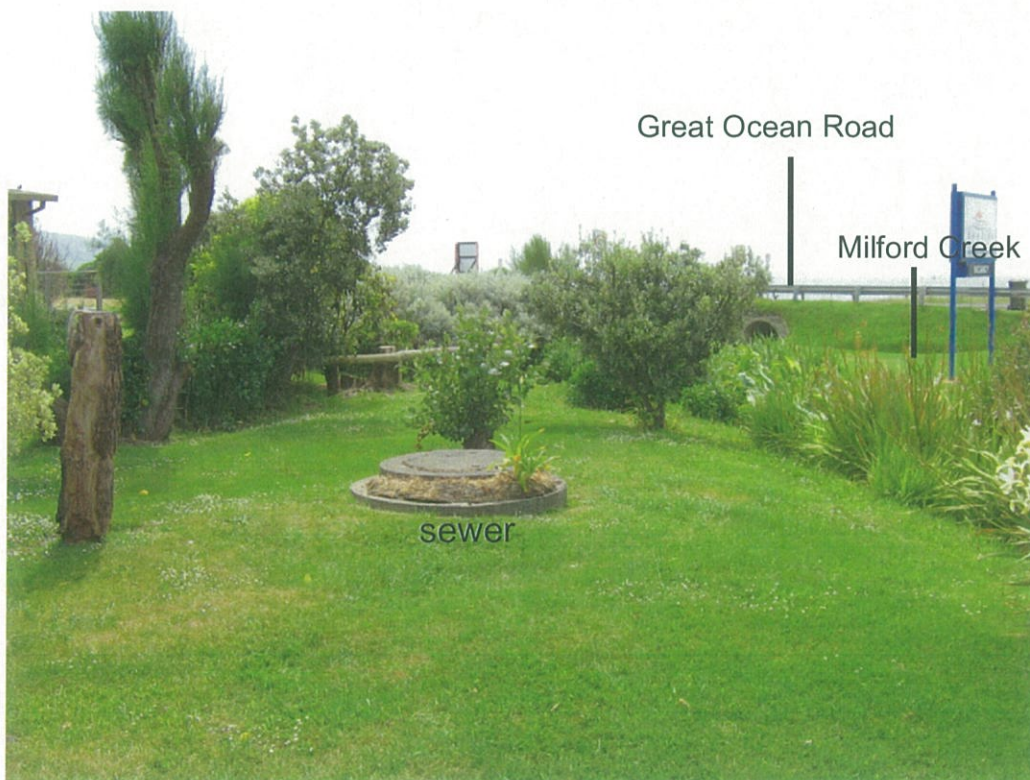
Plate 2: The activity area looking east towards the Great Ocean Road. Milford Creek is on the left. An inlet to the sewer is located in the middle of the lawn (between Milford Creek and the boundary fence) which is at the front of the brick residence.

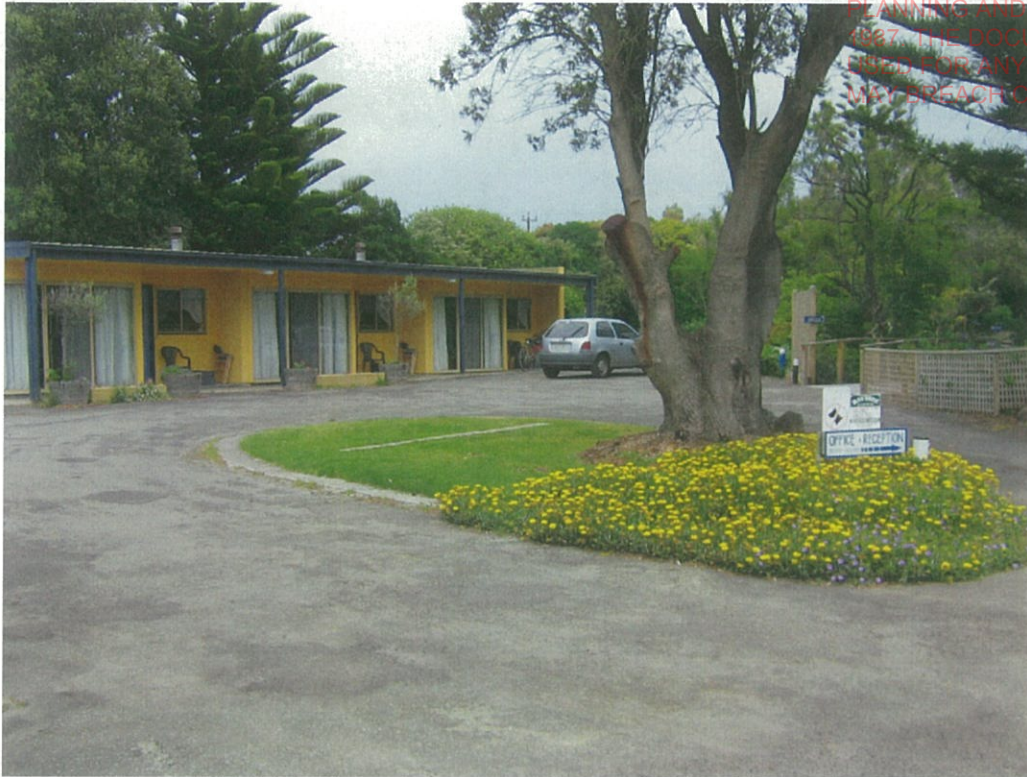
Plate 3: The Bayside Gardens holiday cottages showing gravel drive way and landscaping. These cottages occupy low lying land on the southern side of Milford Creek.

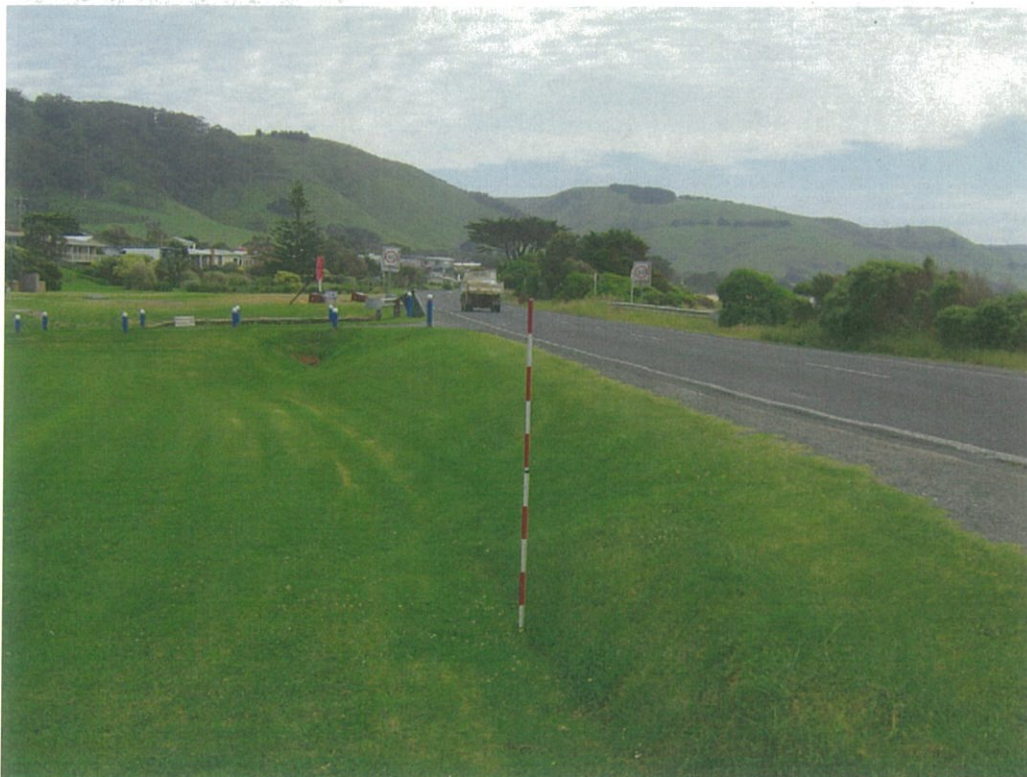
Plate 4: The Great Ocean Road road reserve near the outlet of Milford Creek. Note how the road has been raised above natural ground level.

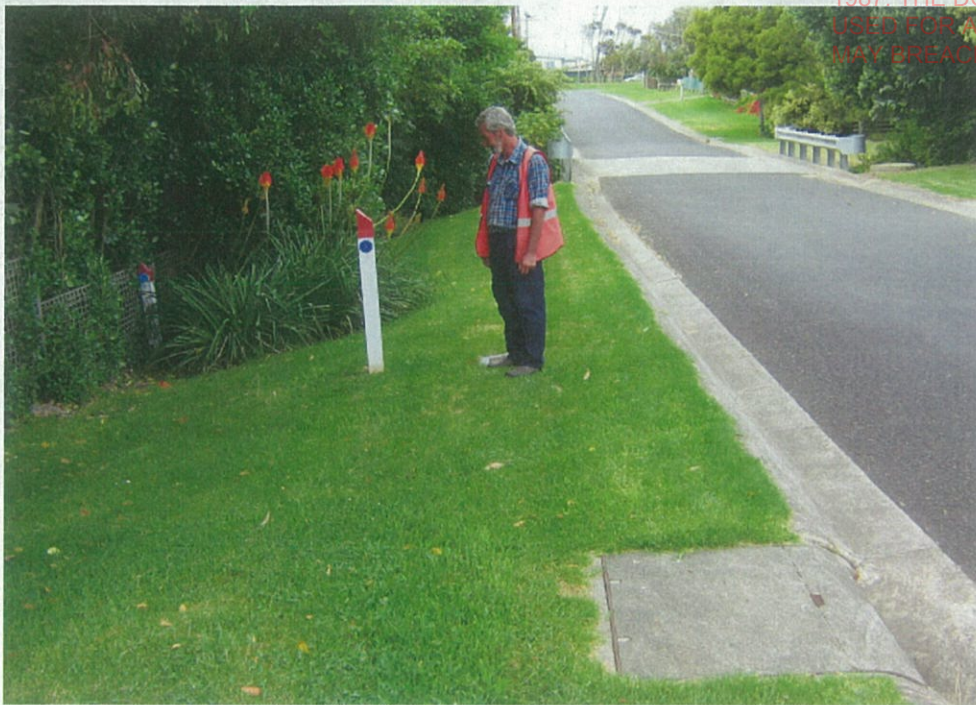
Plate 5: This is Casino Street showing the concrete kerbing and bitumenised road surface. A bridge over Milford Creek can be seen in the distance.

The activity area lies between the GOR ROW and Casino Street. A wide reserve separates the western boundary of the activity area from the edge of the bitumen (Plate 4). This reserve was well grassed at the time of the assessment but more importantly sits below the road level which has been artificially raised and is subject to inundation (Philip Callister per com.). The Apollo Bay foreshore with its low dunes and wide beach is on the other side of the GOR. Casino Street runs north-south to the rear of the activity area and is a bituminised road with concrete curbing storm water drainage and a narrow grassed reserve (footpath) (see Plate 5).

The alignment of the local sewer runs north south through the activity area. The sewer is visible on Casino Avenue (Plates 2 and 5) and has access points along the northern side of Milford Creek.

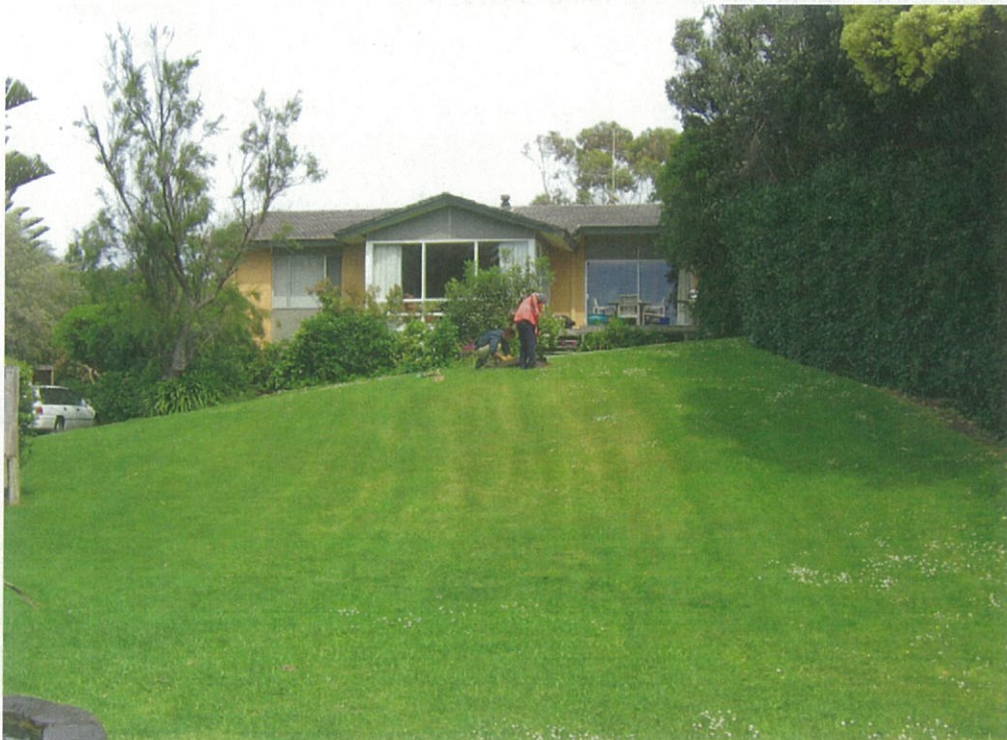
Plate 6: This is a view of the brick residence which as discussed in the text has been benched into the hillside. Shovel Test Pits 1 and 2 were excavated at the top of the slope where there is near level ground. Services are buried beneath this area.

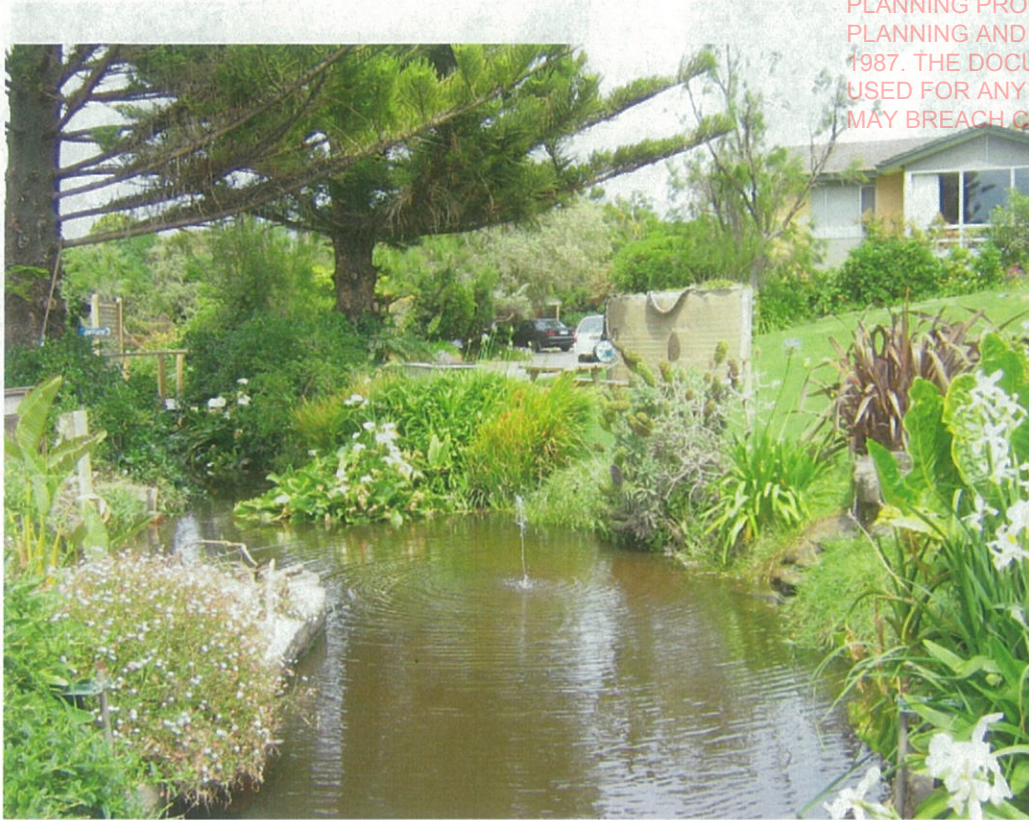
Plate 7: Milford Creek has been heavily landscaped. A lawned area and brick residence on higher ground can be seen on the RHS.

The creek channel and its banks have been heavily modified and have foot bridges, a pond with a low stone wall, waterwheel sculpture and plantings (Plate 7). The adjacent barbeque and setting areas are grassed. Stormwater pipes are visible along the banks. In profile, the channel varies but takes on a basic 'u' shape with steep banks that are typically bare of any vegetation. The low dam and other works have served to change the form of the creek, the amount of water it retains and the likelihood that the banks are sensitive for *in situ* Aboriginal archaeological material.

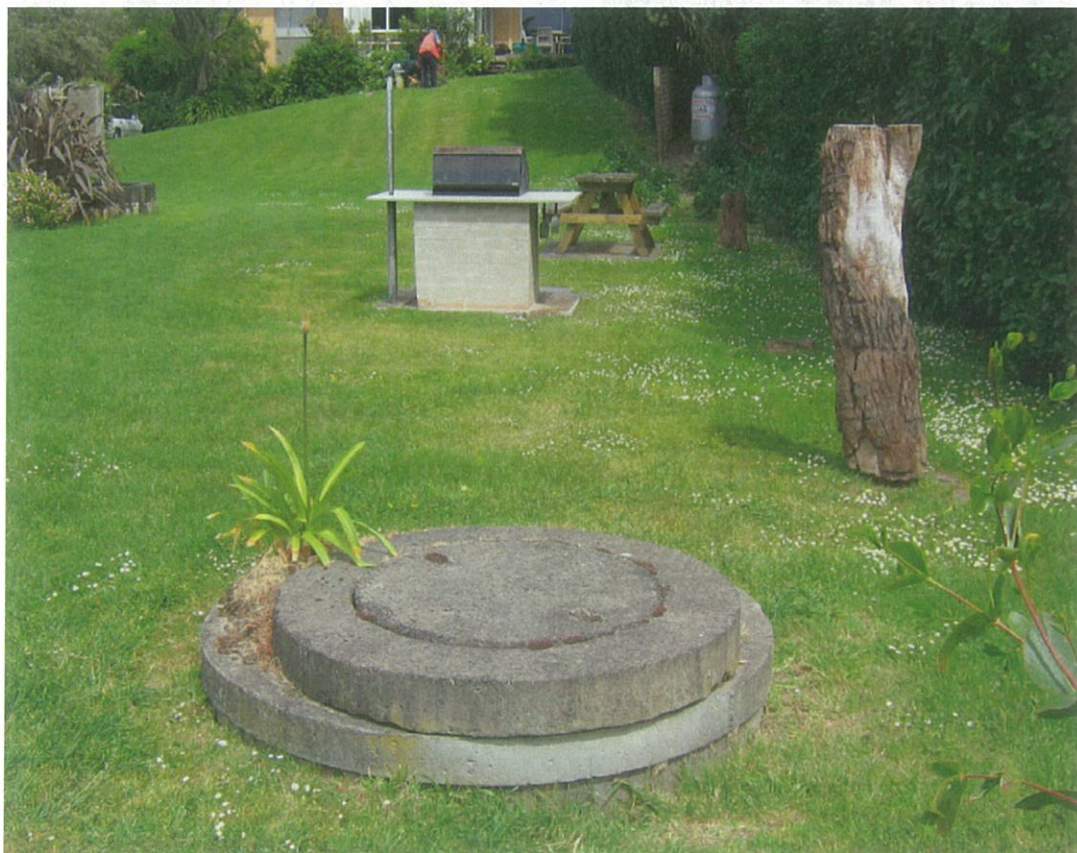
Plate 8: This shows the relationship between existing services, landscaping and Shovel Test Pit 1 and 2. Note the change of the level of the ground and even cover of lawn.

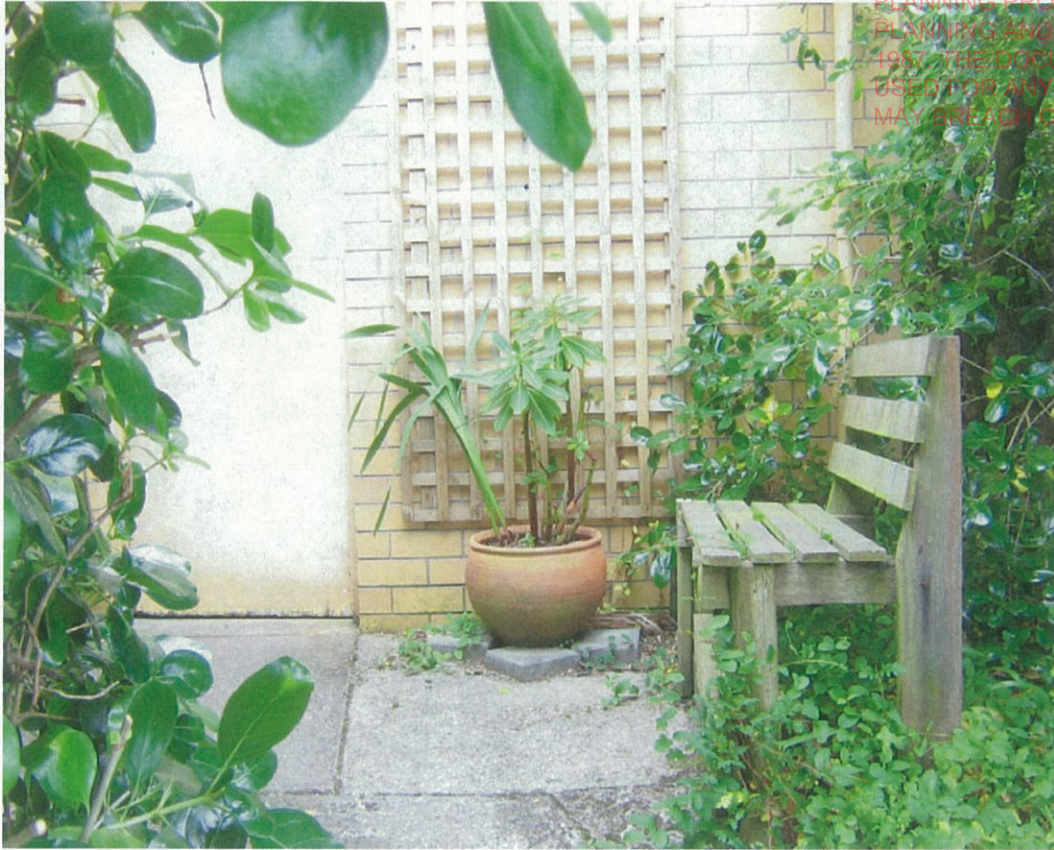
Plate 9: Entrance to the rooms on the southern side of the brick residence which have been dug into the hillside. ie these rooms are below the natural ground levels.

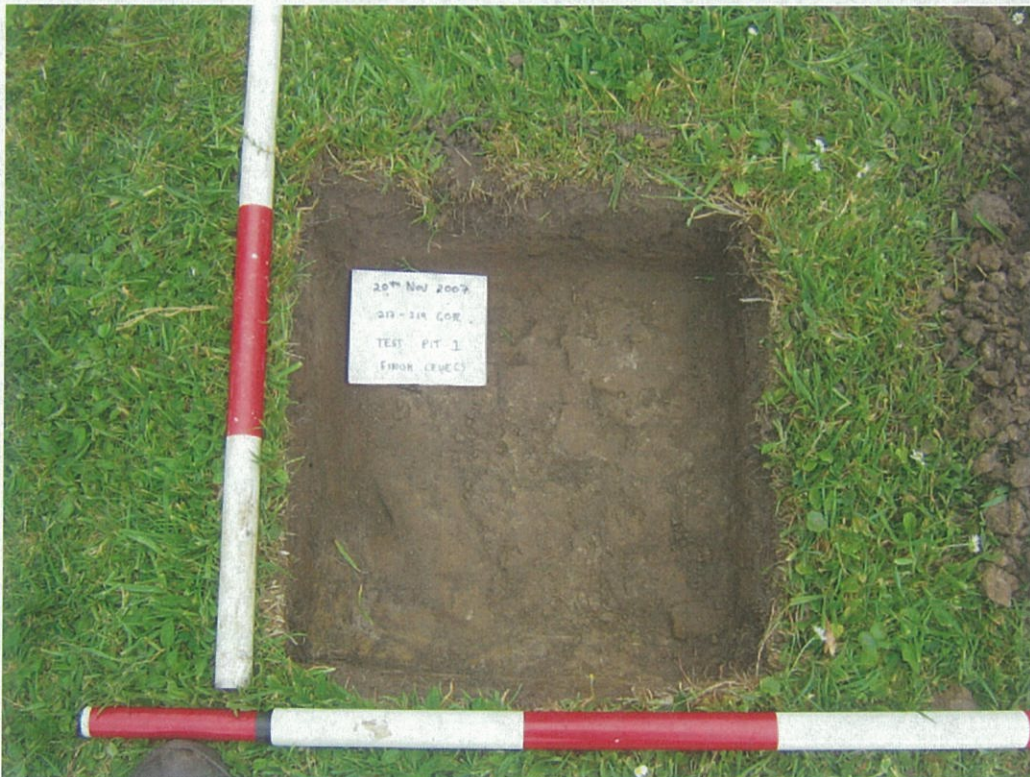
Plate 10: Finish of Shovel Test Pit 1. Yellow blocky clay can be seen in the north-western corner.

A single stone artefact was discovered during the excavations at ca 5cm below the surface in Shovel Test Pit 1, which was located at the top the slope of the low hill near the front entrance to the brick residence. This site has been registered as Milford Creek 1 (AAV 7620-0206). The artefact was a small flaked piece made on brown quartzite. The flaked piece is probably a by-product of the manufacture of stone artefacts (free hand flaking?) within the vicinity, but not necessarily within the activity area. This artefact was 'loose' in the surrounding sediments, clean of surface sediment when found and clearly not *in situ*. If this site was denser, additional artefactual stone material would have been expected in Shovel Test Pit 1 and in the nearby Shovel Test Pit 2. The sieved sediments proved to be sterile.

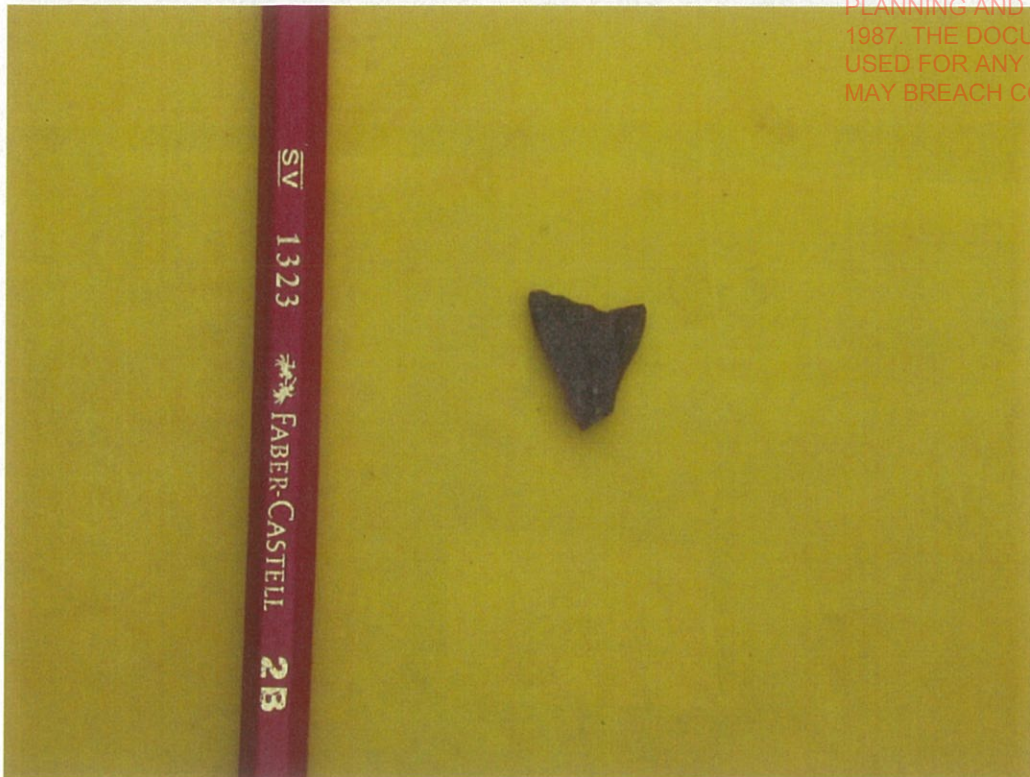
Plate 11: The isolated stone artefact from Shovel Test Pit 1. Milford Creek 1 7620-0206. This is a very small artefact made on brown quartzite.

The stone artefact found that is AAV 7620-0206 is not a formal tool type nor does it represent a distinctive artefact technology. Isolated artefacts and low density stone artefact scatters as sites or associated with shell middens are common in the Apollo Bay area and in this sense the site is typical of the local record. For these reasons this artefact cannot be regarded as significant from an archaeological perspective.

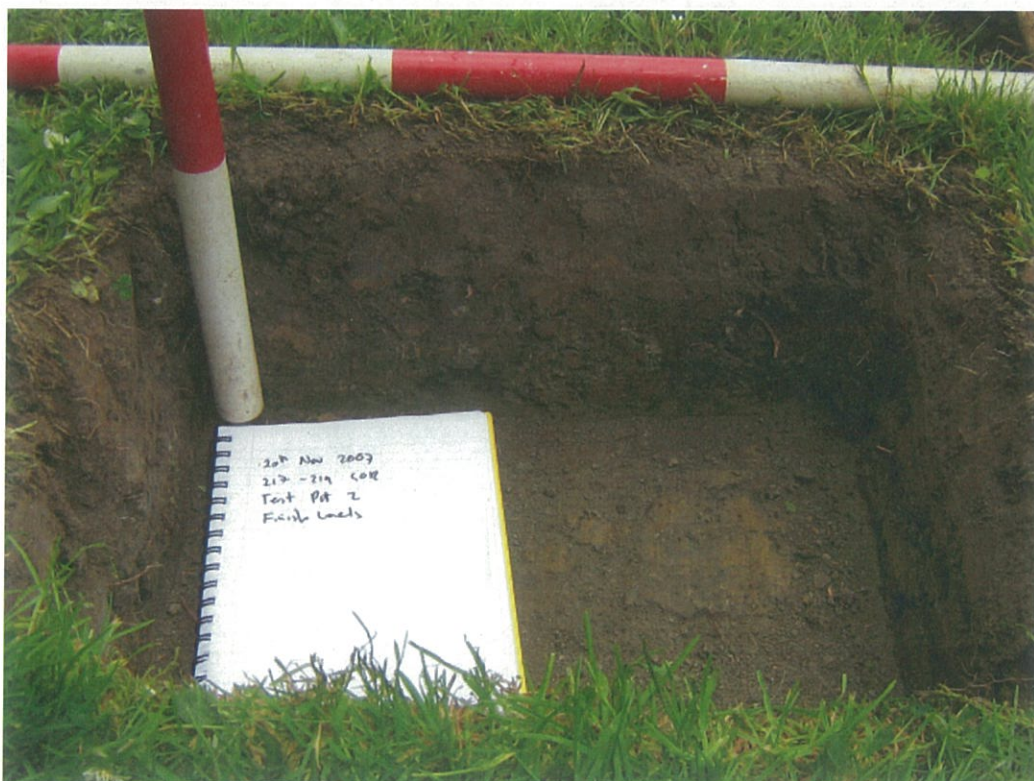
Plate 12: Finish level of Shovel Test Pit 2.

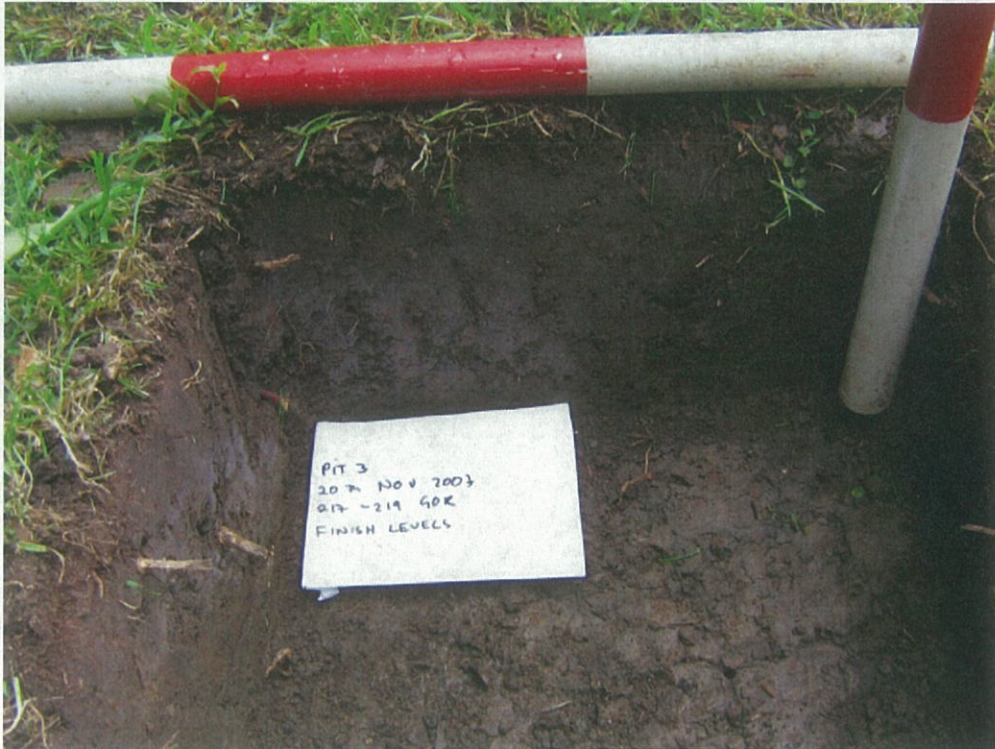
Plate 13: Finish level of Shovel Test Pit 3 which was located adjacent to Milford Creek.

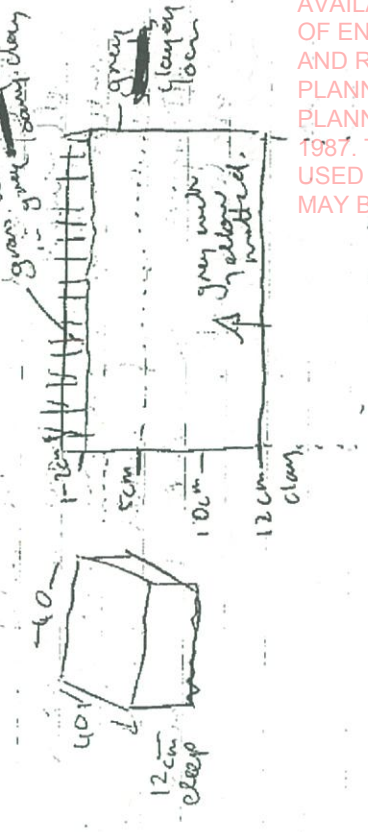
Pit I stratigraphy
 Layer I - grass roof - grey clayey loam
 Layer 2 - grey clayey loam

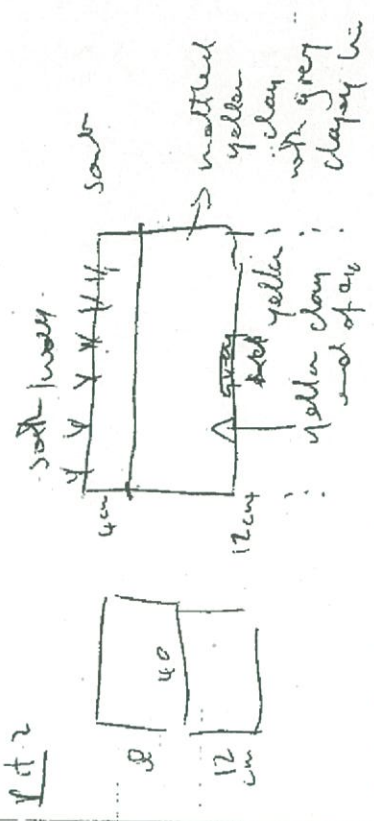
Pit 2 had a very similar strat to Pit 1 but the yellow clay appears at shallower levels. The mix of yellow + grey clayey loam indicates or suggests that the ground has been previously disturbed

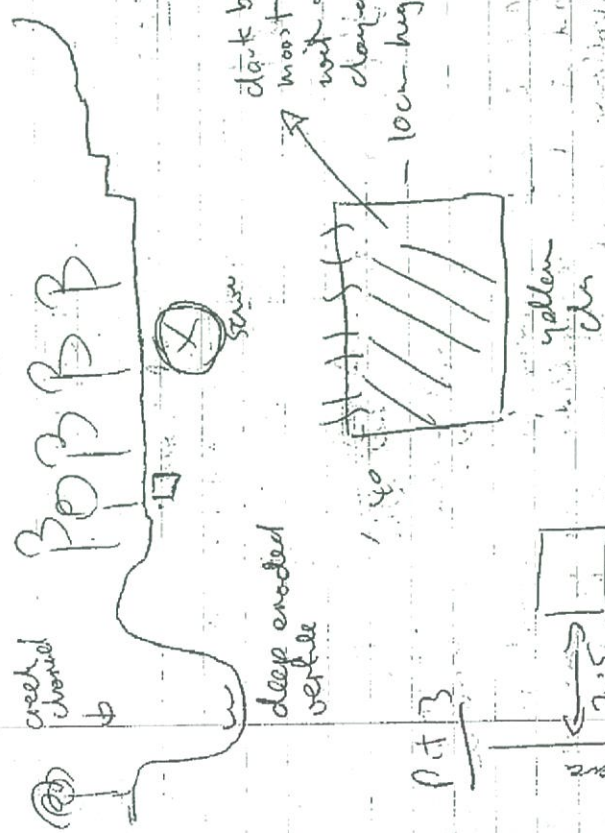
Pit 3 is located in open space near the creek channel about 6m from the edge of the bank. It is 40 cm square by about 10 cm deep to a yellow clay.
