Apollo Bay, Skenes Creek & Marengo CIP

Issues and Opportunities Paper: Coastal

Tract Consultants Pty Ltd

23 June 2019

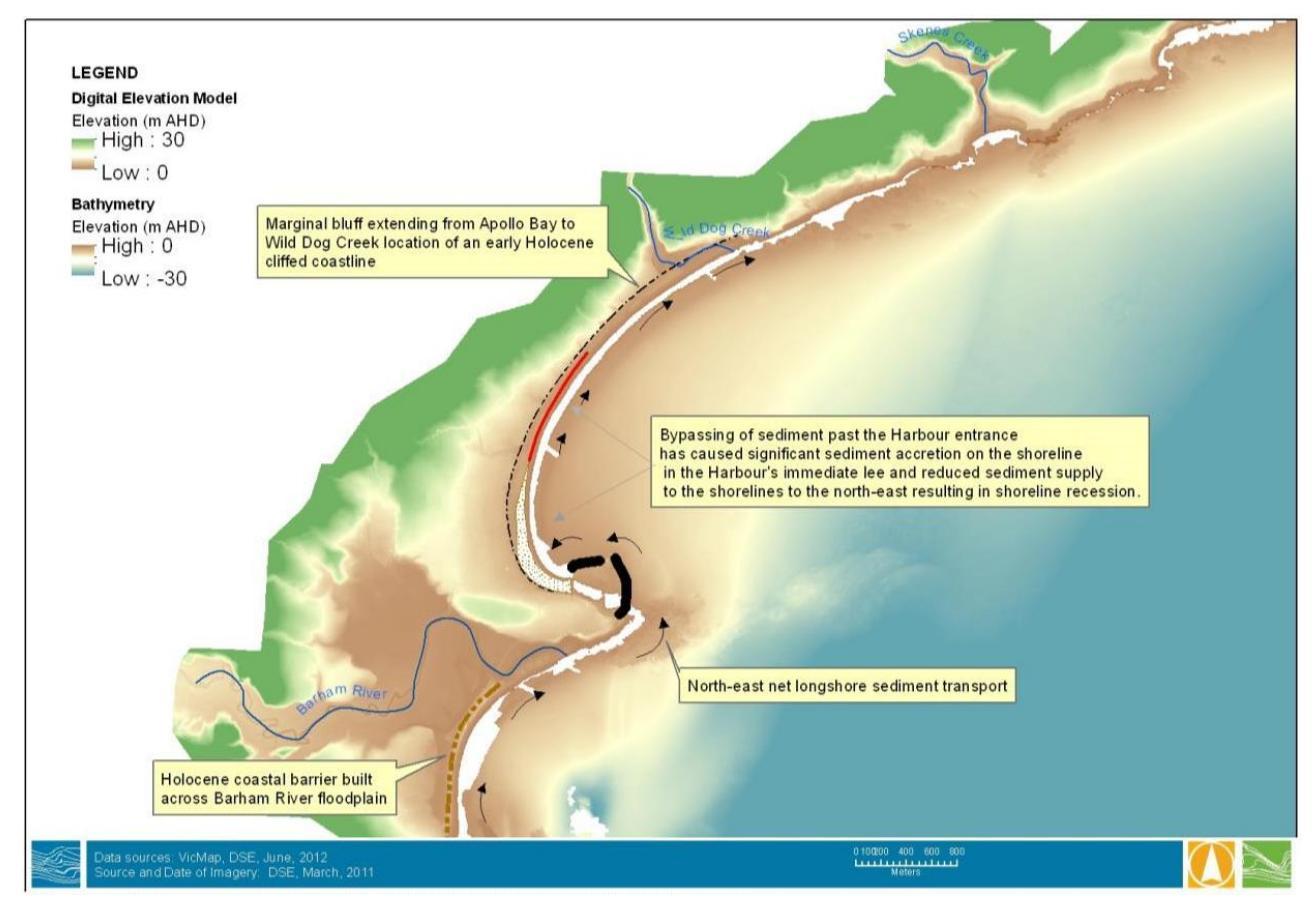
FIGURE 2-1 OVERVIEW OF COASTAL PROCESSES AND GEOMORPHOLOGY (WATER TECHNOLOGY, 2012)

Apollo Bay is located at the foot of the Otway Ranges which consist of uplifted Cretaceous sedimentary formations reaching elevations of approximately 300 m above sea level behind Apollo Bay. The Cretaceous sediments are rich in feldspar rather than quartz and therefore the erosion of these formations does not supply appreciable quantities of sand sized sediments to the coastline. The littoral sediments comprising the sand bars, beaches and dunes in the region are therefore derived from sediments drifted shoreward from the floor of Bass Strait following the end of the last glacial phase and subsequent marine transgression. The main features of the coastal geomorphology and processes of the study area are displayed in Figure 2-1 and discussed below.

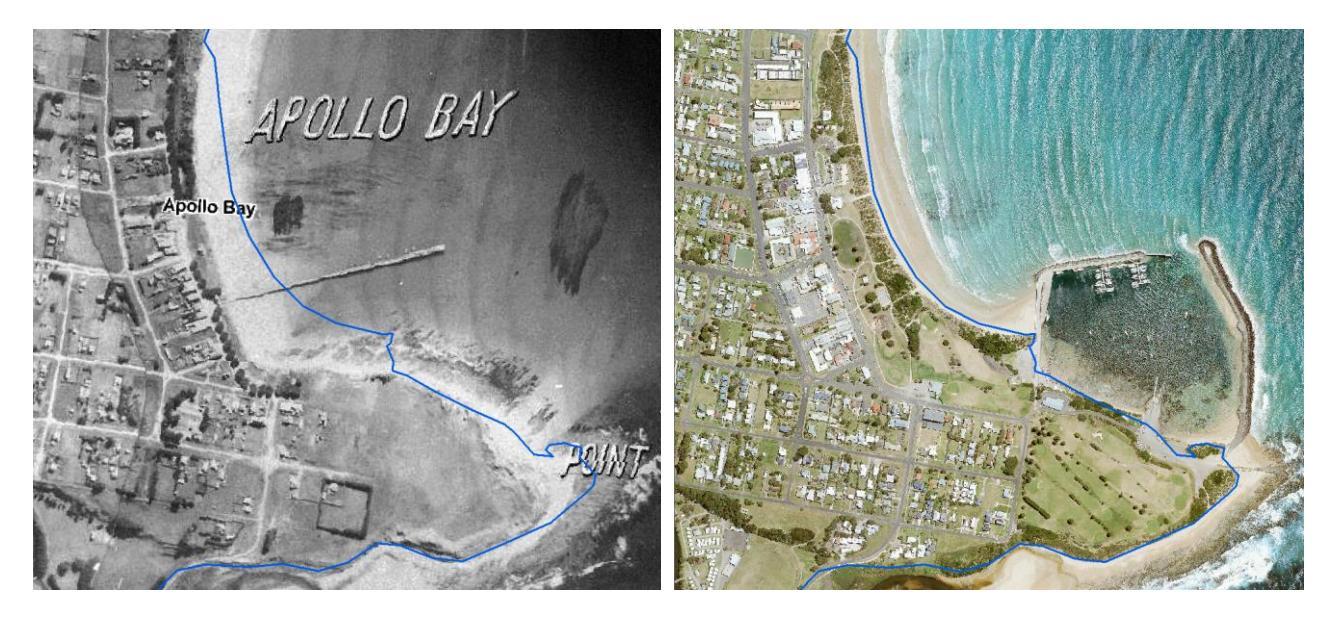
FIGURE 2-2 APOLLO BAY COASTLINE BEFORE HARBOUR CONSTRUCTION (LEFT) COMPARED TO 2014 (RIGHT). BLUE LINE REPRESENTS THE COASTLINE AT APPROXIMATELY 2.5 M AHD (VIC COAST LIDAR, 2007).

The construction of the Harbour in the 1950s changed sediment transport patterns of the area as outlined in Section 2.2. There has been significant shoreline advancement of the coast in the town centre to Cawood Street (Figure 2-2). Rates of advancement averaged 0.8 metres per year at times and have stabilised from 1980s onwards (CES, 2005). Recent stabilisation is due to a reduction in the sediment capture by the harbour

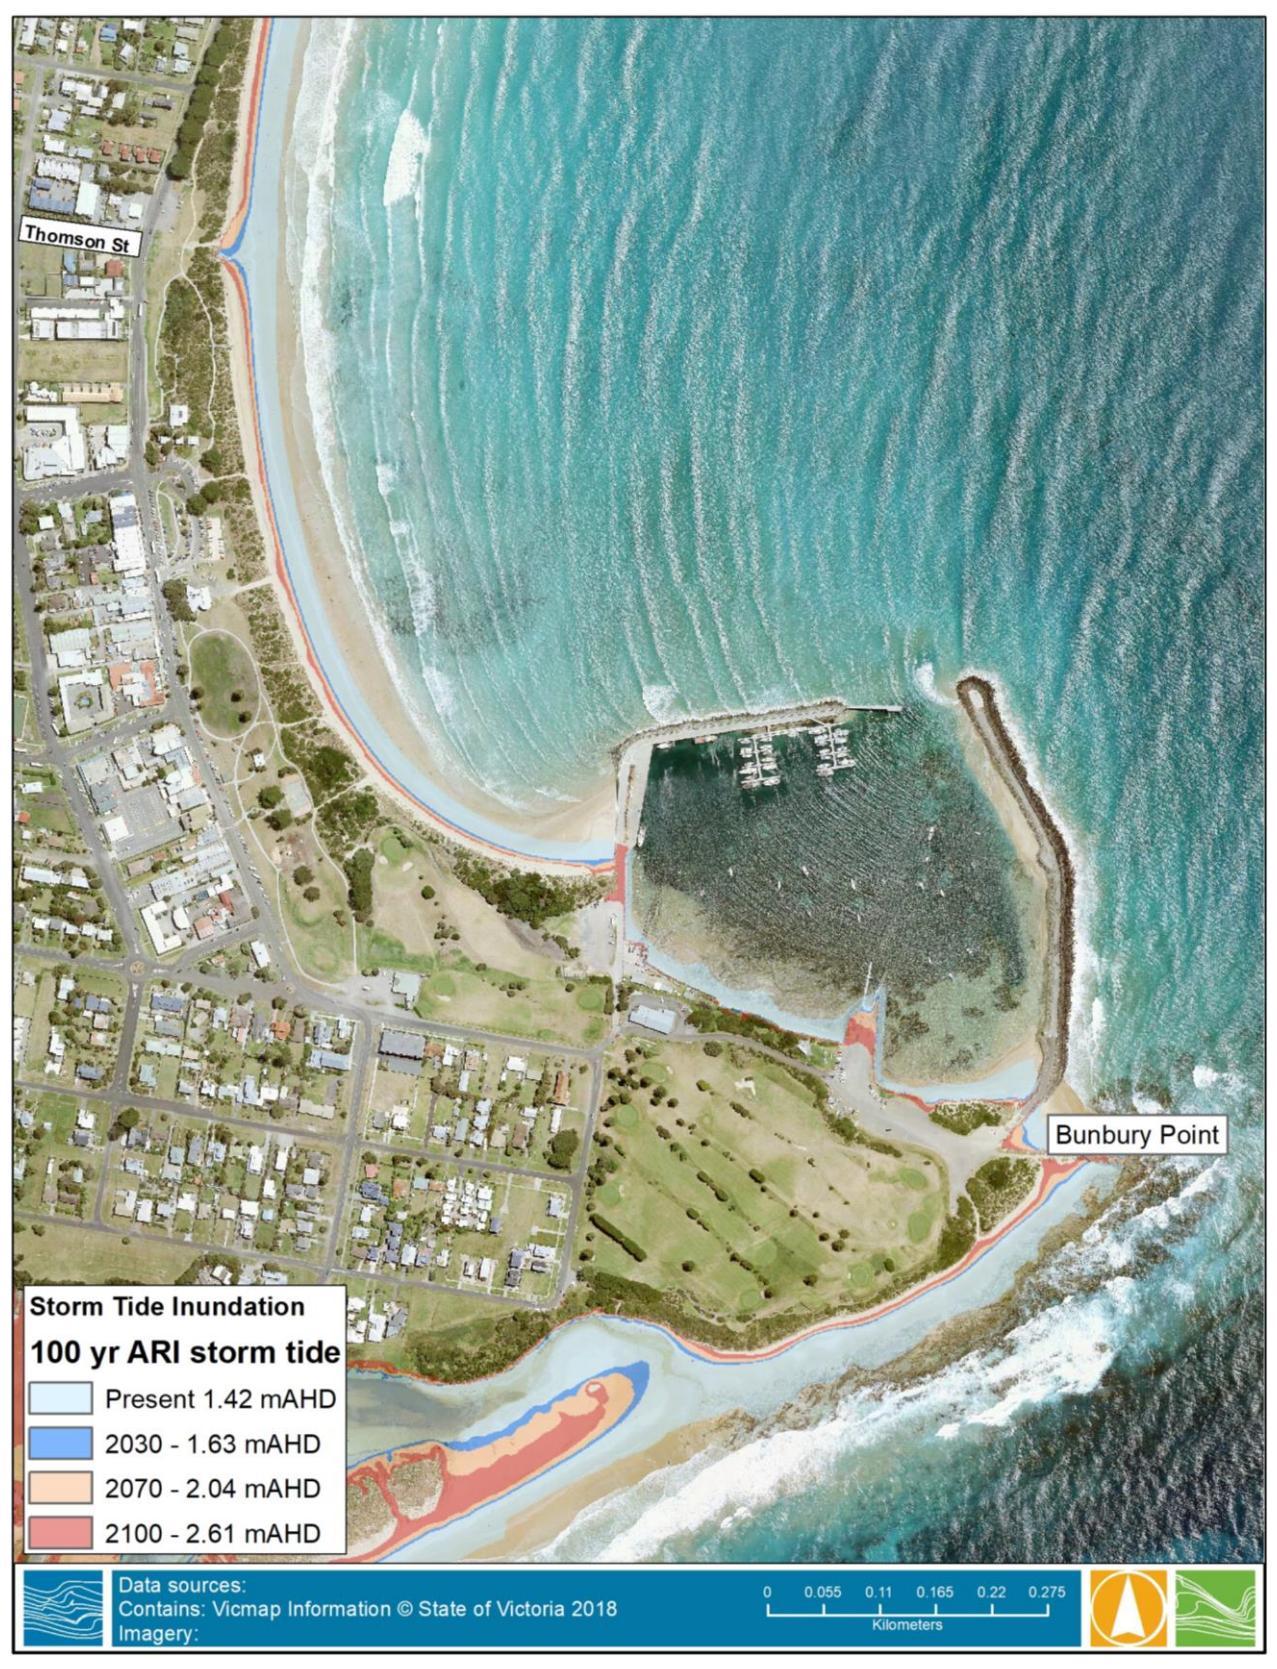
FIGURE 2-3 APOLLO BAY INUNDATION AND RISK. ASSETS AT RISK INCLUDE CAR PARKS AND LOW-LYING AREAS OF THE INNER HARBOUR

The areas predicted to be inundated by the present day to projected 2100 100-year ARI Storm Tide are shown in Figure 2-3. The levels inundated represent areas where topographical LiDAR levels provided by the Department of Sustainability and Environment (DSE, 2009) are below the projected storm tide.

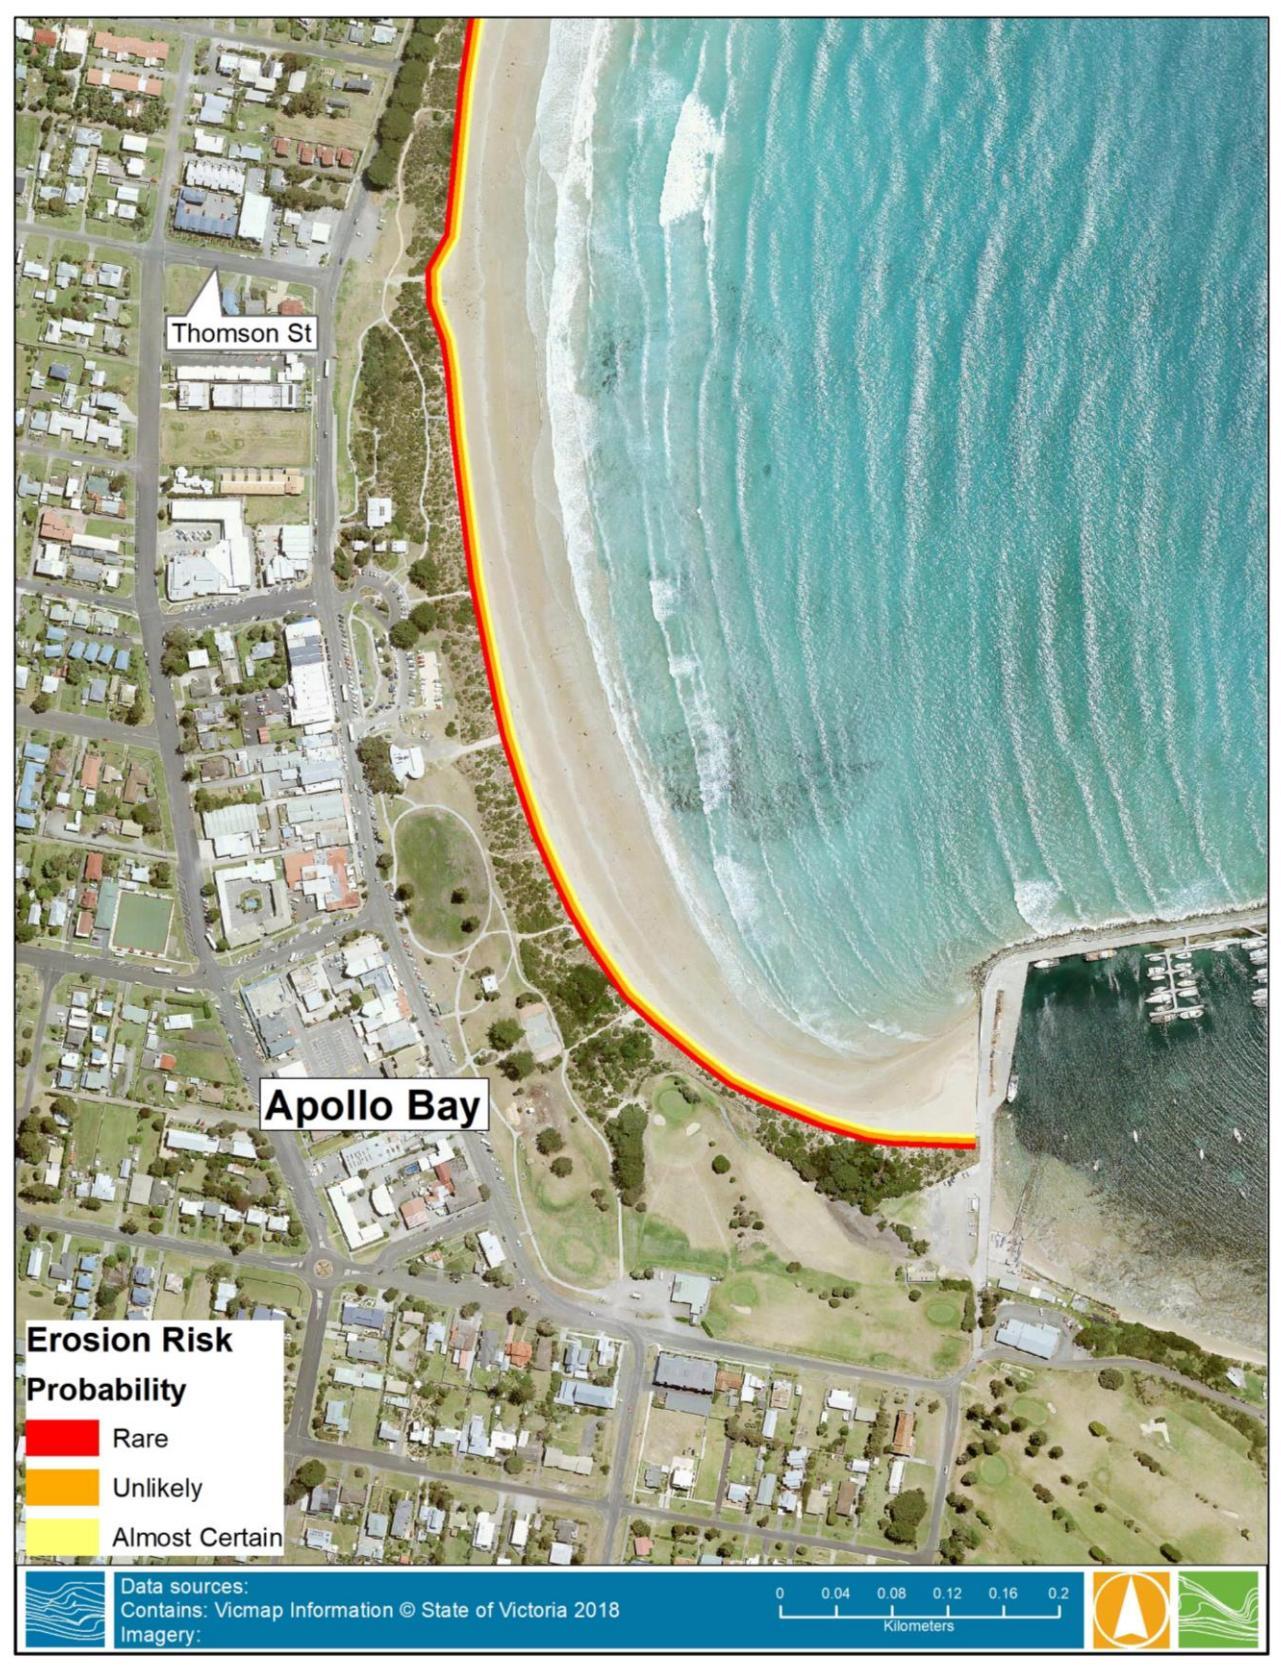
FIGURE 2-4 APOLLO BAY EROSION RISK (WATER TECHNOLOGY, 2012)

GHD (2018) provided an estimation of dune erosion in 2018 due to storm events in June and found that between 6.7 and 18.1 m³/m of erosion had occurred, coinciding with a foreshore retreat of up to 1 m. With sea level rise this rate of recession would increase. Long-term recession of the Apollo Bay Foreshore Reserve was assessed by Water Technology (2013) based on the Bruun Rule (1962). Rates of recession for sandy shorelines can be in the range of 40-80 m for predicted sea level rise over the coming century. This amount of shoreline recession would return the coastline to its position prior to Harbour construction (Figure 2-2) unless hard coastal defences and/or increased sand nourishment were utilised. According to updated calculations of shoreline recession based on Water Technology (2012) methods, the rate of shoreline recession over the next 10 years would be between 1 m (almost certain) to 4 metres (rare) (GHD, 2018). Erosion risk calculated by Water Technology (2012) for almost certain, unlikely, and rare events is presented in (Figure 2-4).

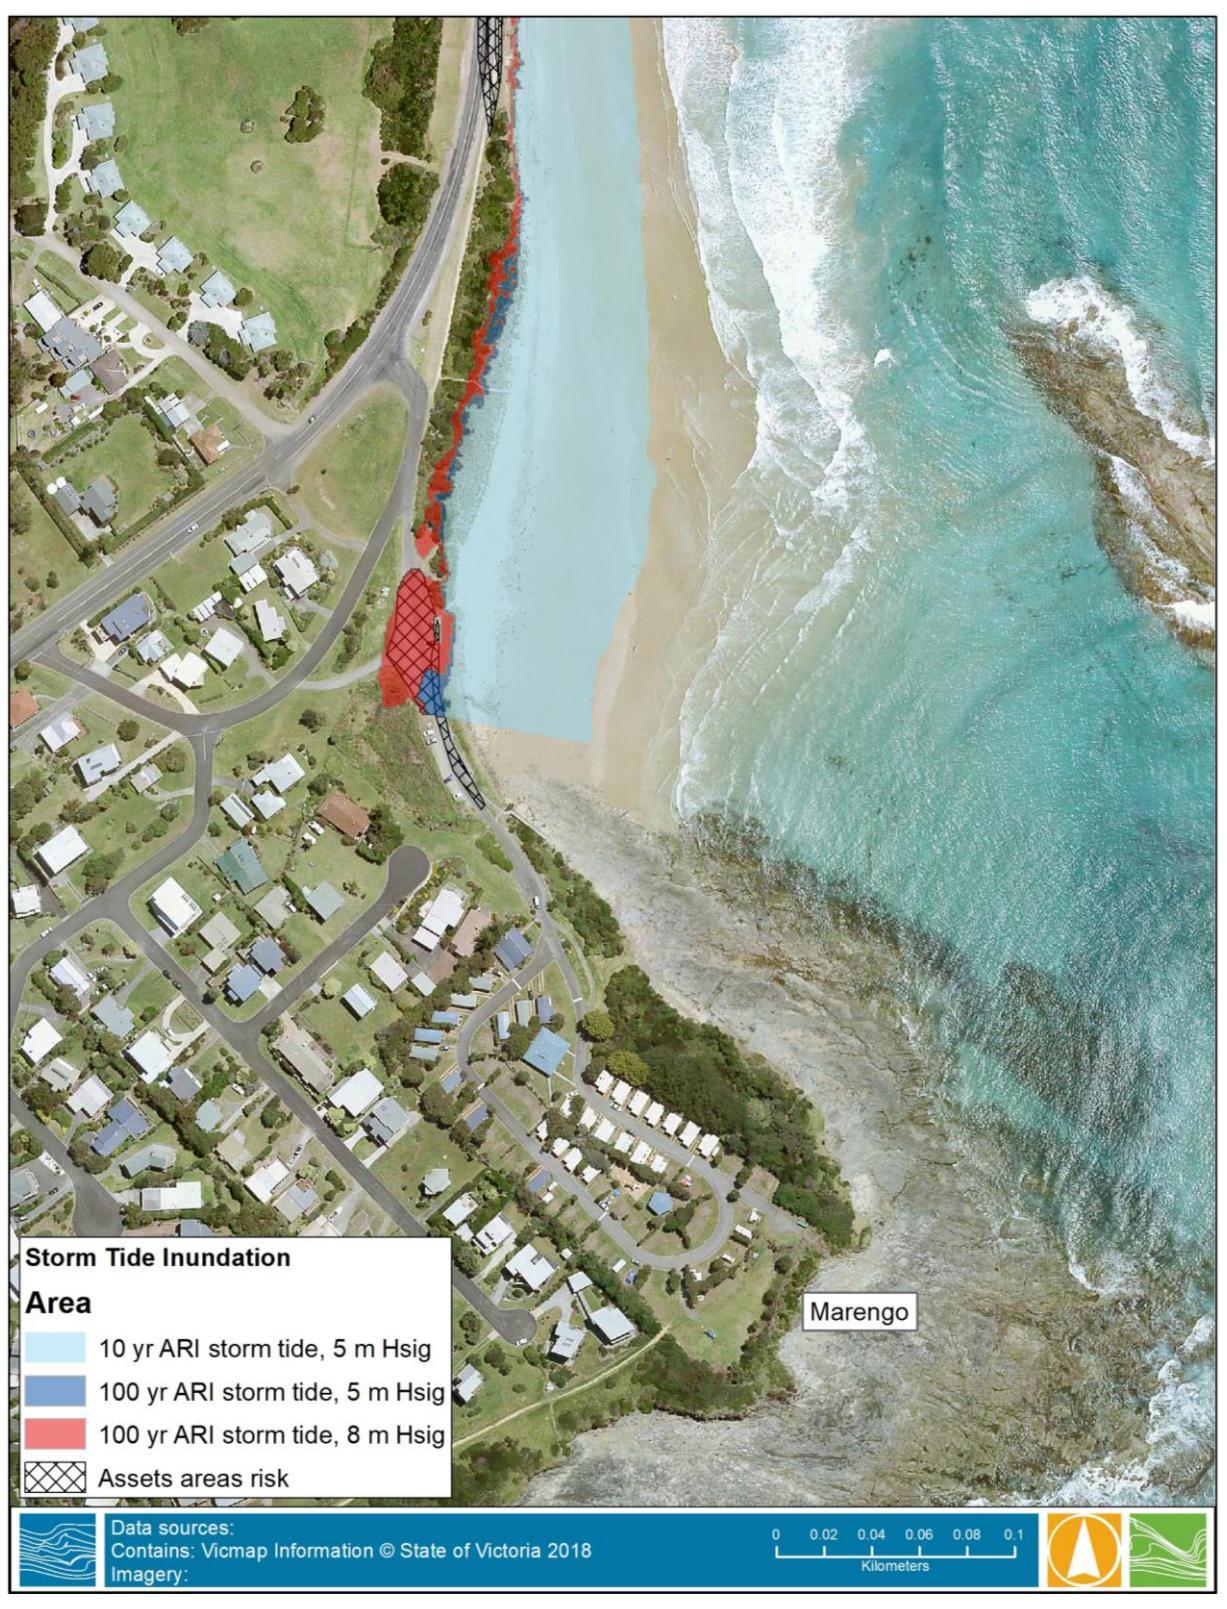
FIGURE 2-5 MARENGO INUNDATION AND RISK, EXISTING CAR PARK ASSETS AT RISK ARE SHOWN (ADAPTED FROM WATER TECHNOLOGY, 2012)

Marengo is well protected by coastal cliffs along the headland. An area of vulnerability lies where Mounts Bay Beach and Marengo meet. The car park here would be rarely inundated (greater than 100-year ARI - Figure 2-5). The area slopes up from the coast and the latest LiDAR data suggests that most of the carpark would be above the rare inundation line (Figure 2-6). An *in-situ* survey referenced to a local (AHD) benchmark would be required to confirm the exact elevation of the carpark before determining potential infrastructure risk. Marengo photo locations are presented in (Figure 3-8)

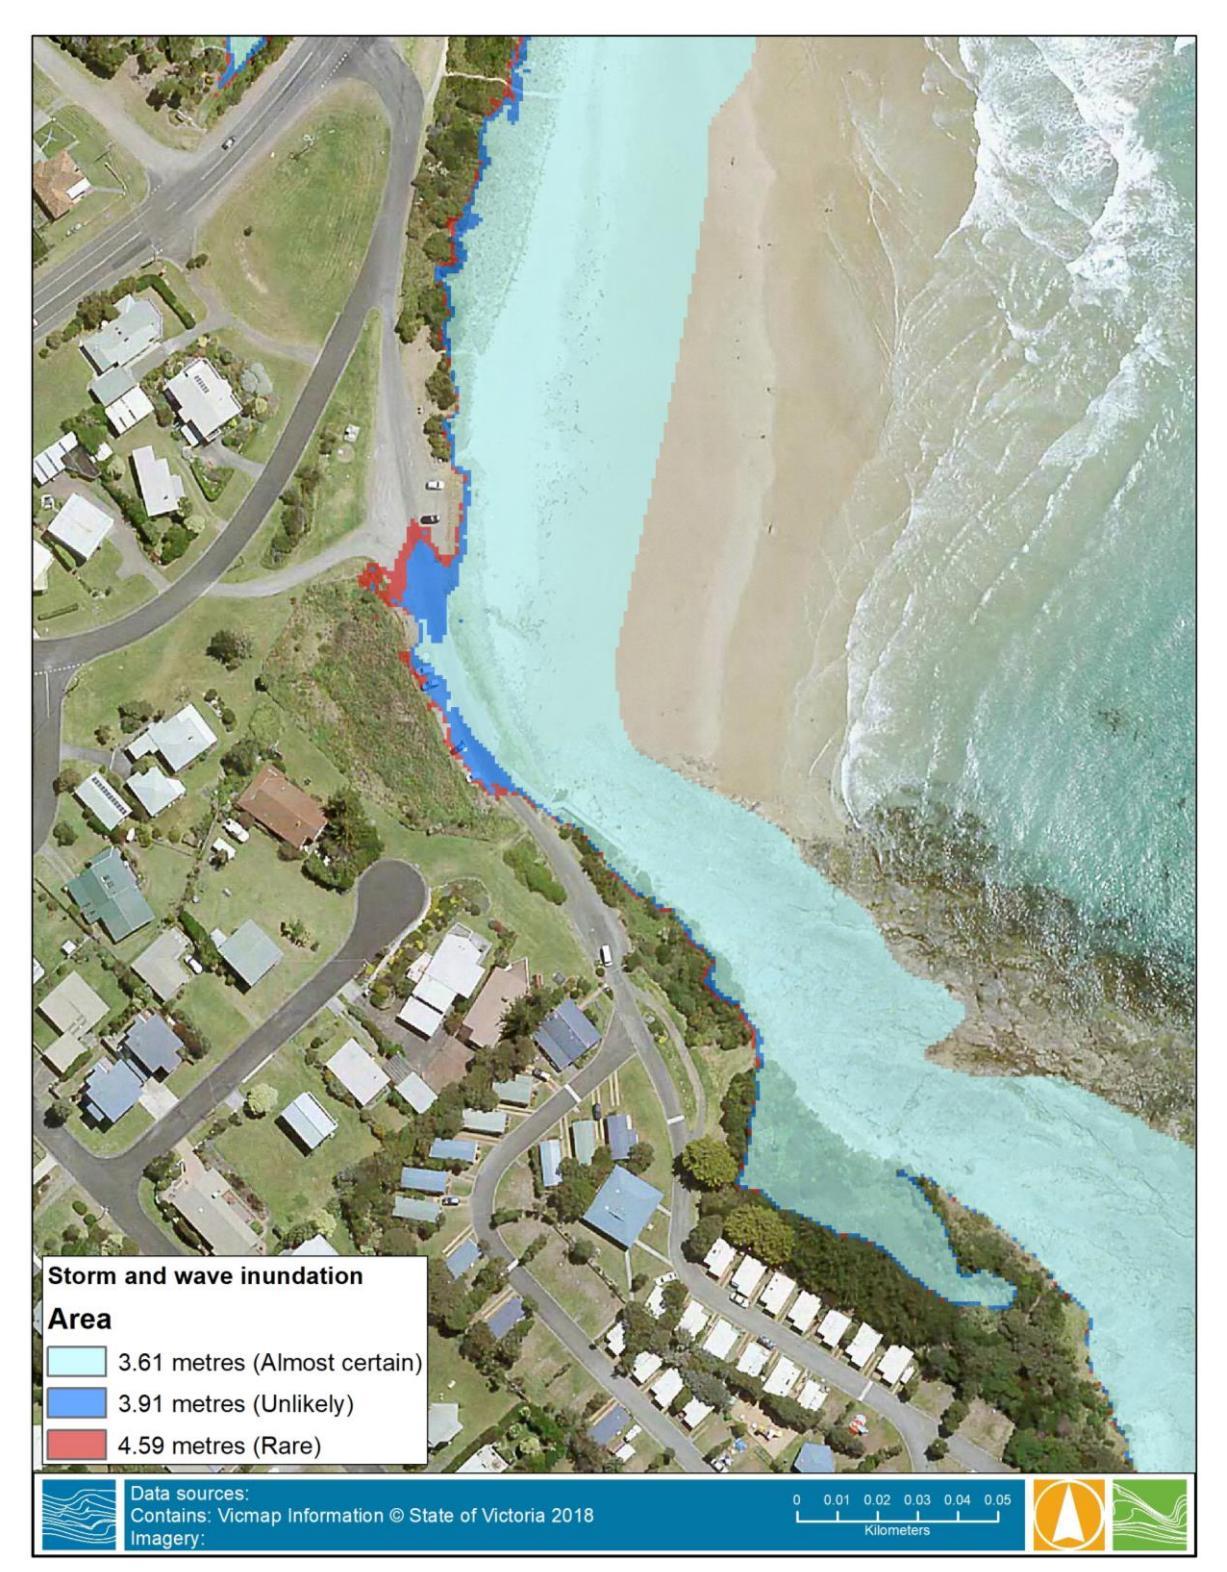
FIGURE 2-6 MARENGO INUNDATION FROM STORM-TIDE AND WAVE RUNUP ACCORDING TO THE UPDATED 2007 LIDAR SURVEY.

Water Technology (2012) assessed the inundation risk to the area bordering Marengo and Mounts Bay and found that the carpark and dunes within the CIP study area would be inundated in cases where peak storm tide inundation and wave runup reached between 3.9 and 4.6 m (AHD), based on a 100 year ARI storm tide and corresponding significant wave heights of 5 - 8 m (Figure 2-5). Analysis of updated LiDAR with the same elevations from the Water Technology (2012) report, indicates that inundation would not cover the entire carpark area (Figure 2-6).

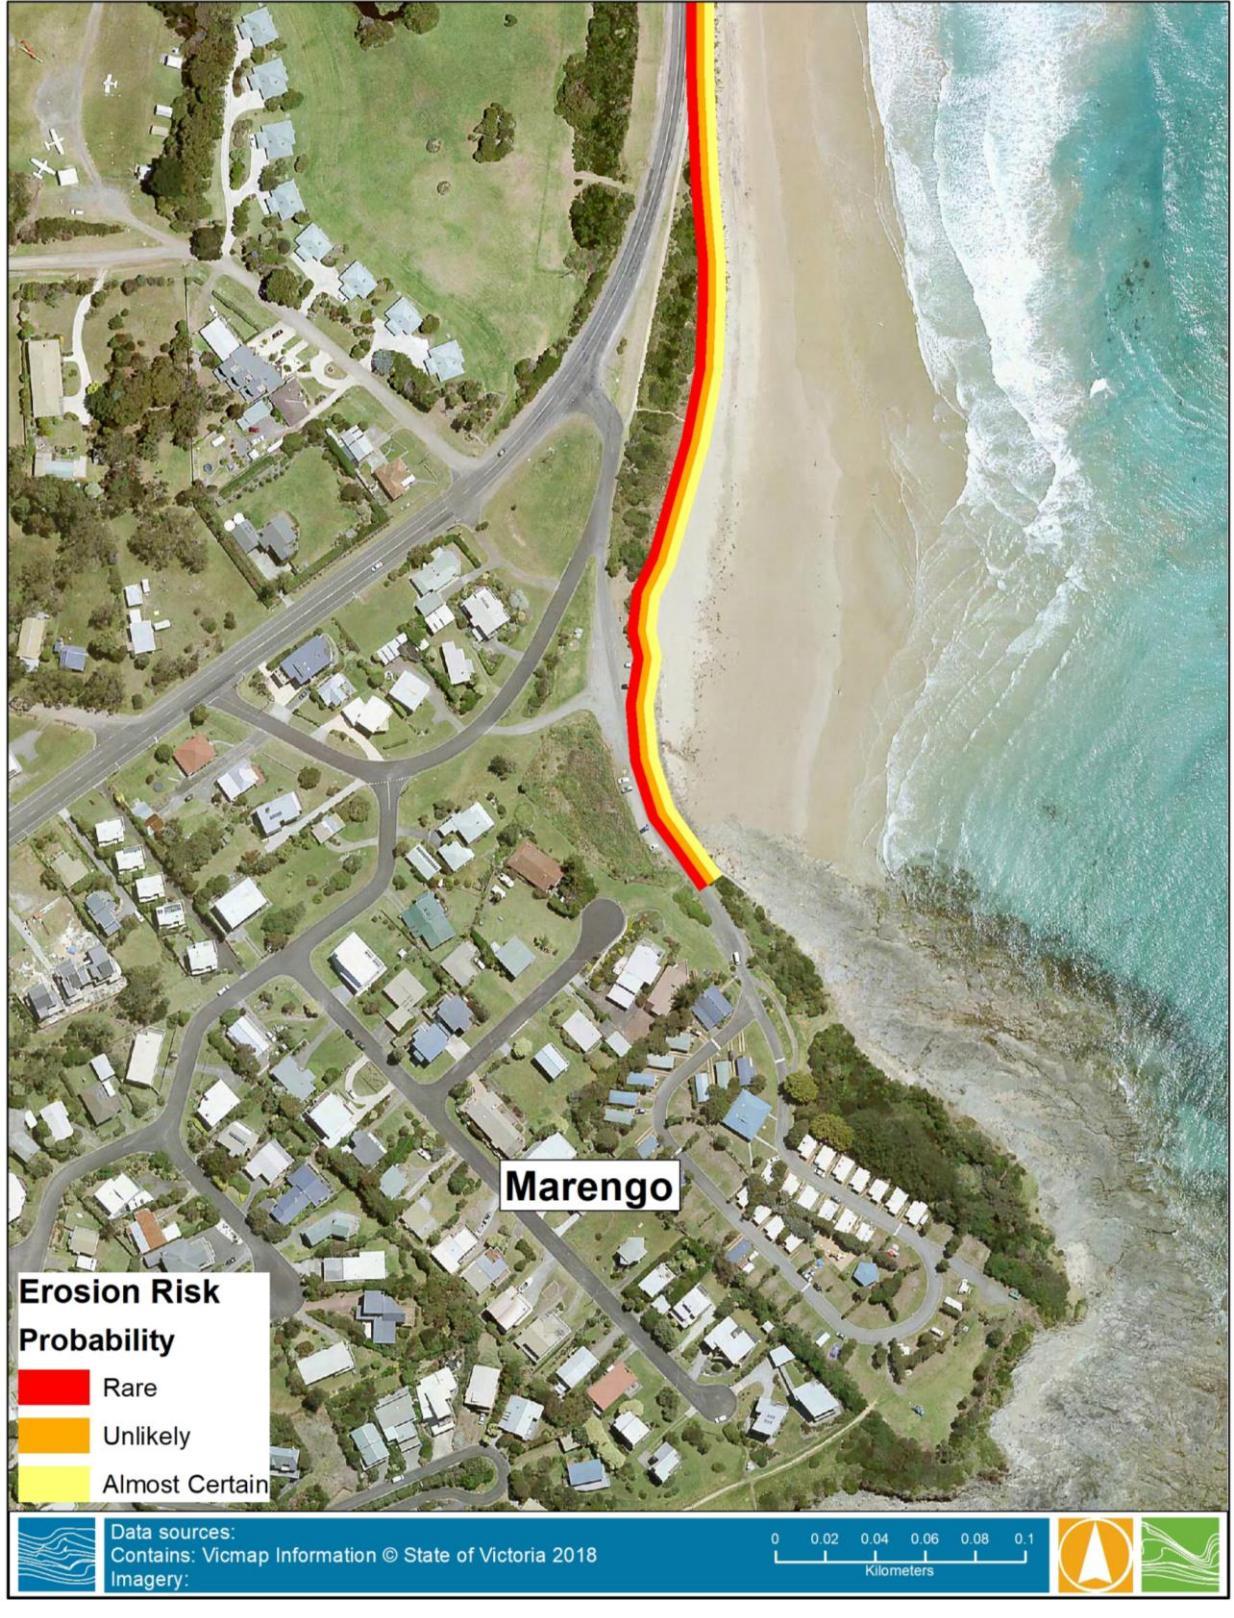
FIGURE 2-7 MARENGO EROSION RISK (WATER TECHNOLOGY, 2012)

Erosion risk previously calculated by Water Technology (2012) for almost certain, unlikely, and rare events is presented in (Figure 2-7).

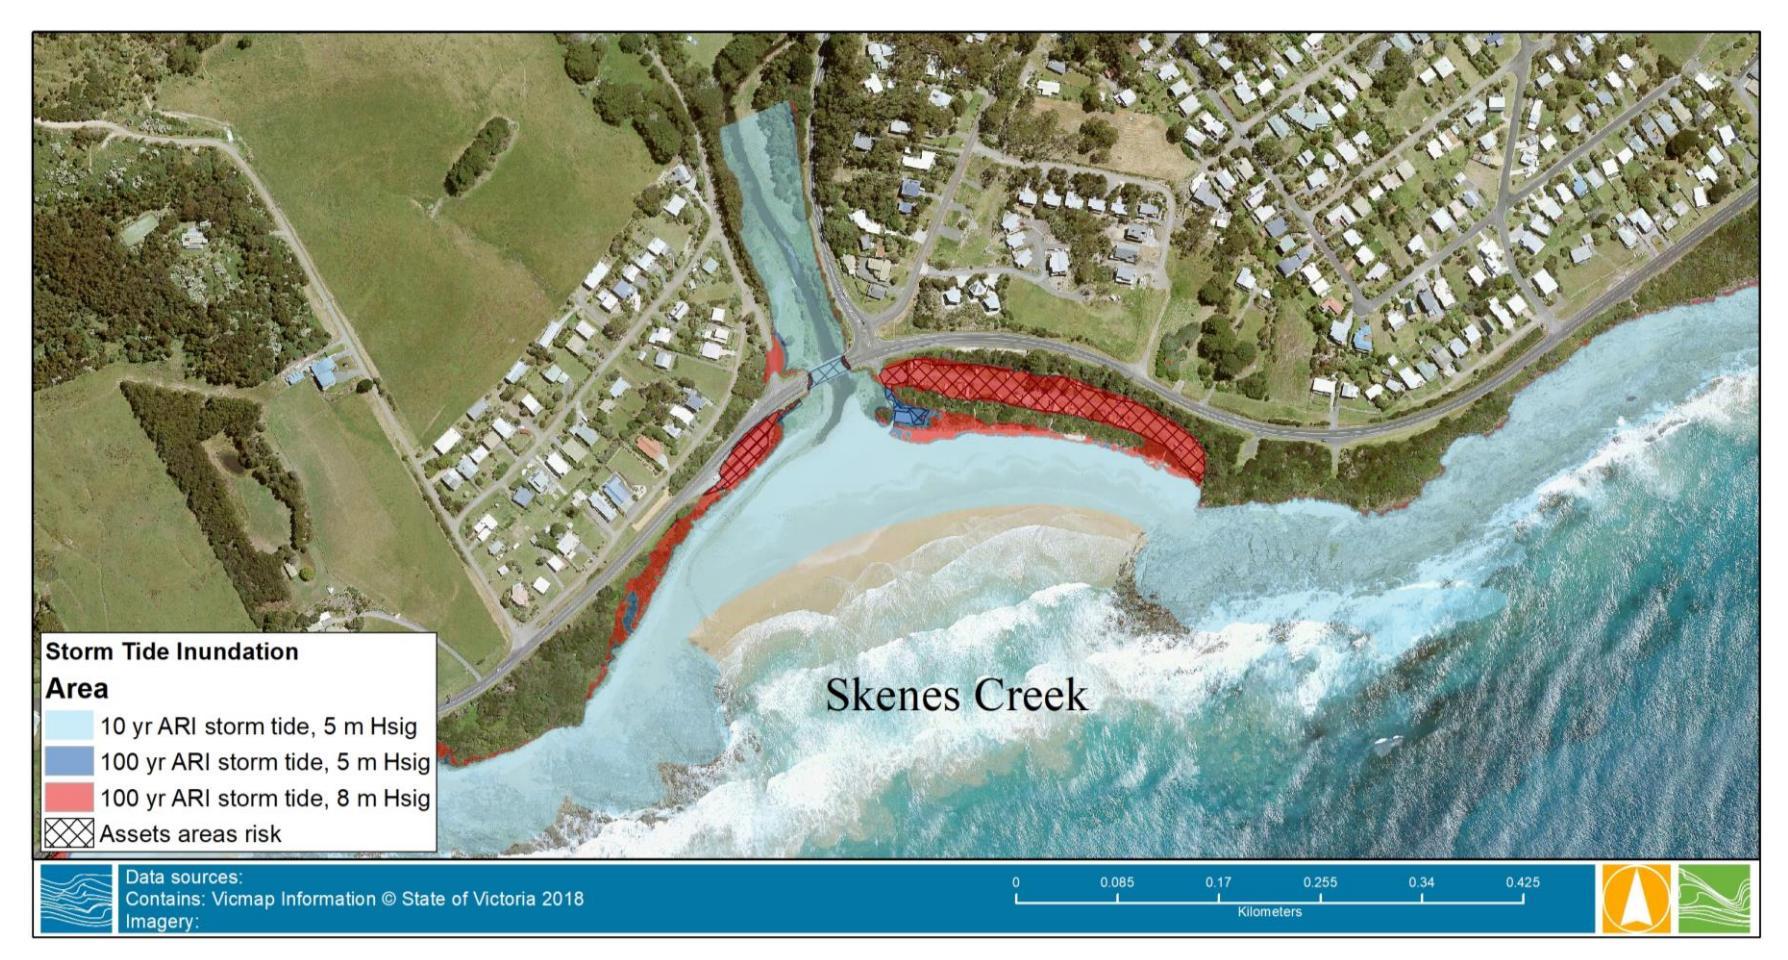
FIGURE 2-8 SKENES CREEK INUNDATION AND RISK TO ASSETS (ADAPTED FROM WATER TECHNOLOGY, 2012).

Skenes Creek provides a number of opportunities for new development, although a balance is required between inundation risk and resilience/cost of infrastructure. The picnic area to the north of the bridge is within the "almost certain" inundation zone for storm tide and wave runup (Figure 2-8). Although a better indication of risk for this area is considering storm tide only owing to its protection from wave action (Figure 2-9).

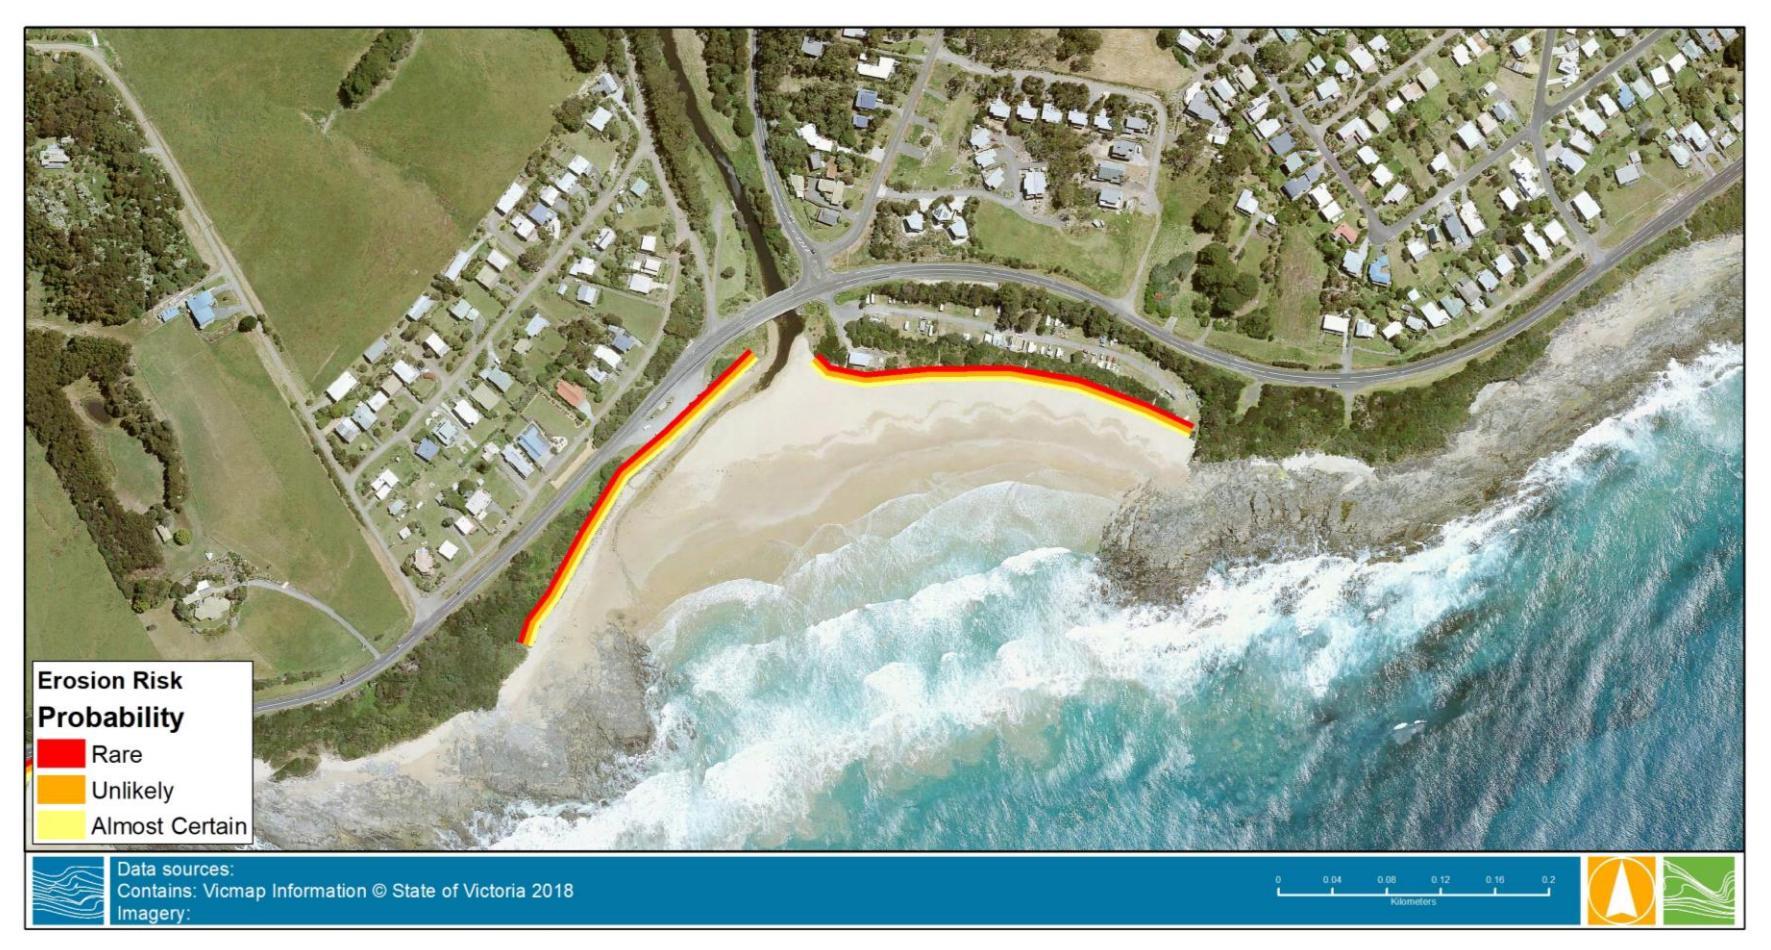
FIGURE 2-10 SKENES CREEK EROSION RISK (WATER TECHNOLOGY, 2012)

Corresponding erosion risk calculated by Water Technology (2012) is presented in (Figure 2-10).
