Wye River / Separation Creek

Post-bushfire building survey findings

Report EP16924

Report to the Victorian Country Fire Authority

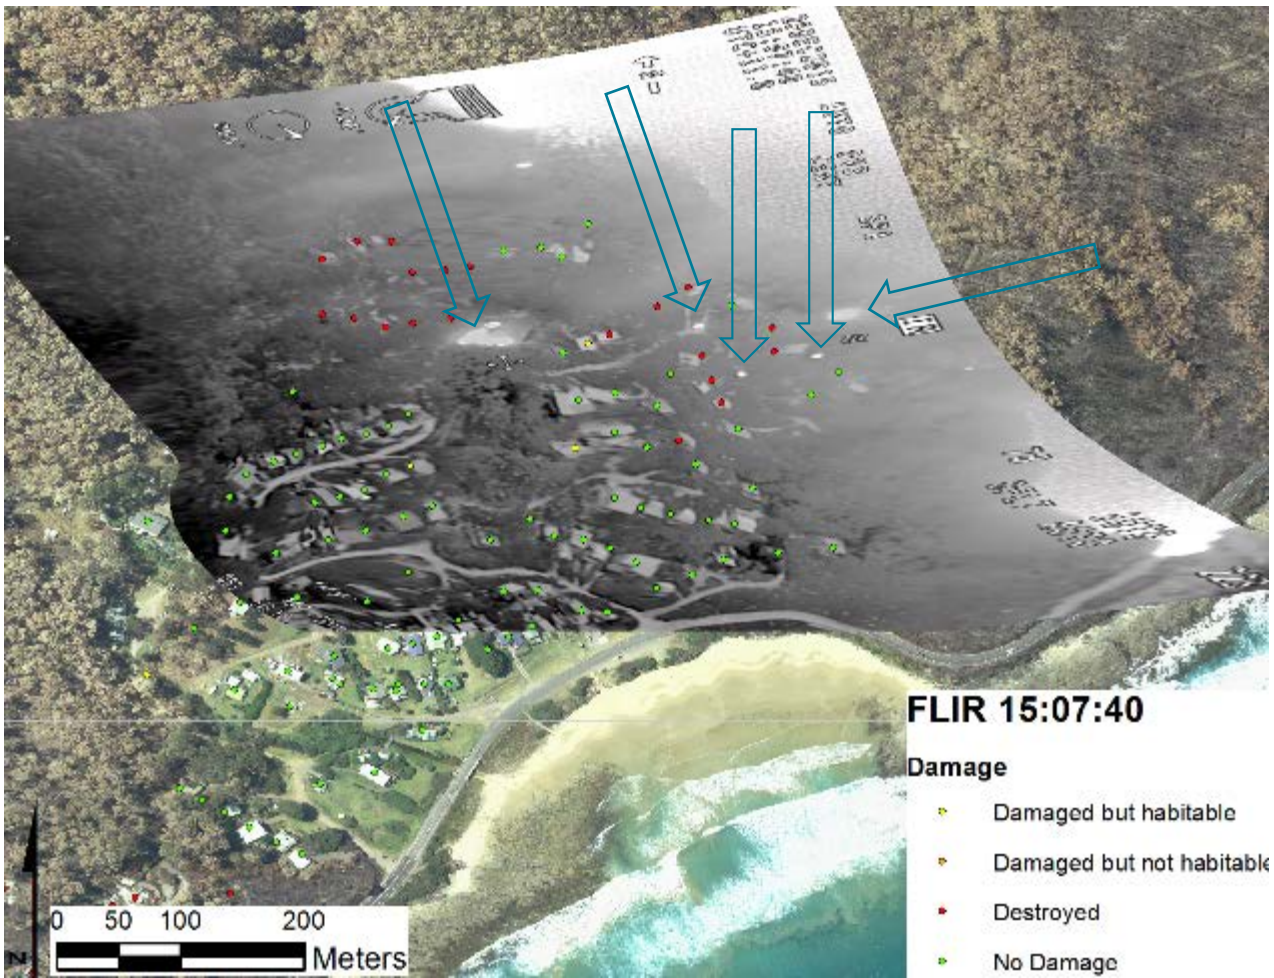
Figure 16: 15:07:40 Separation Creek fire arrival.

At 15:07:40 five spot fires were active within Separation Creek. One of these developed below the corner of Bass Avenue and Harrington Street, and a further four developed in the vicinity of Mitchell Grove. These spot fires are indicated by the blue arrows in Figure 16.

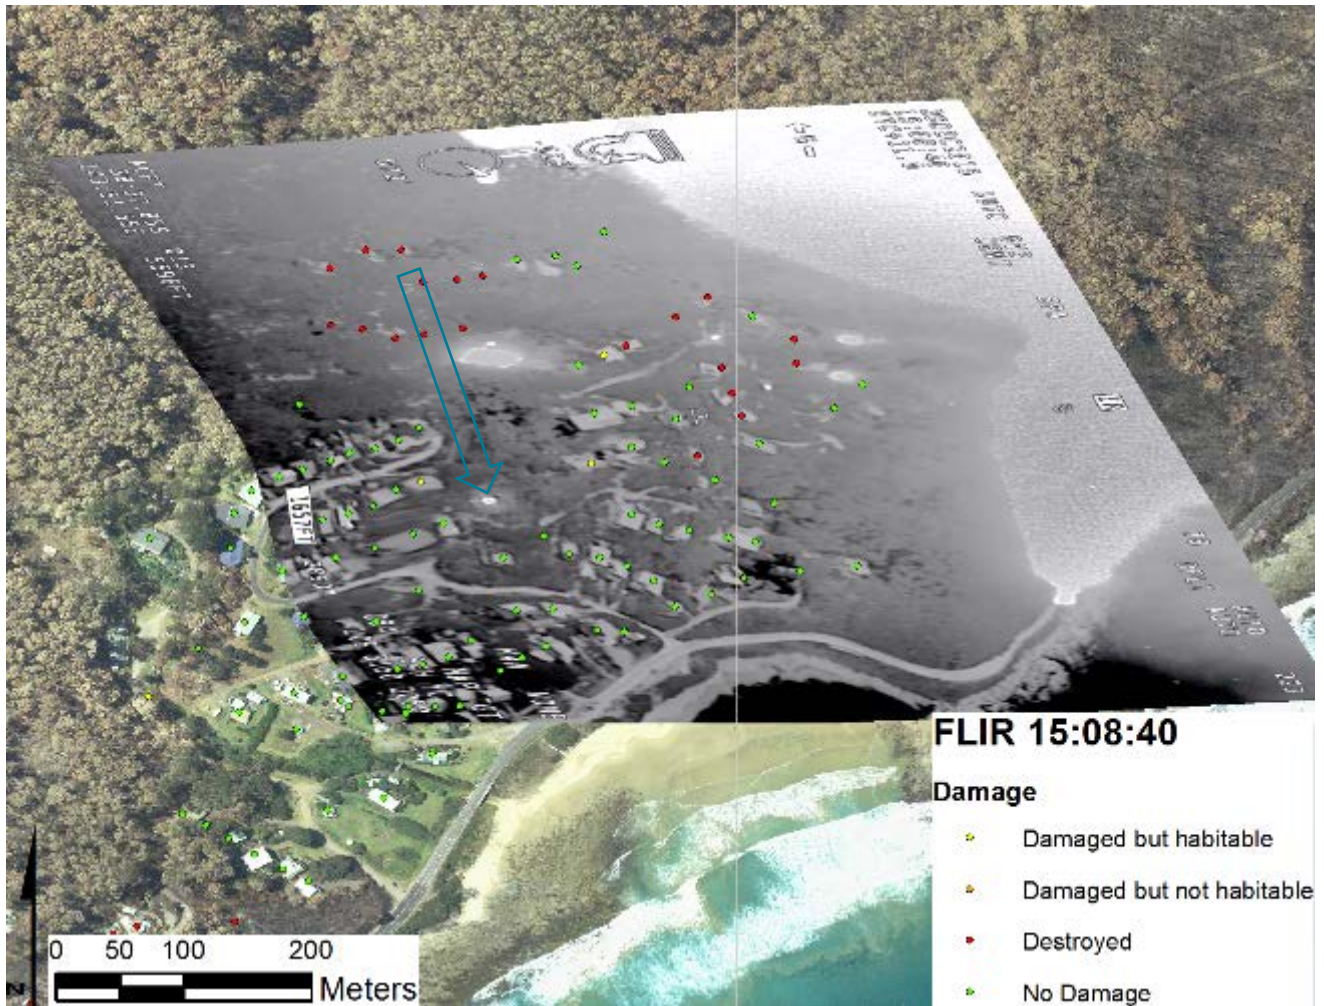
Figure 17: 15:08:40 Separation Creek fire arrival.

Figure 17 is a similar image one minute later showing the development of these spot fires and a further break out (marked with a blue arrow) in a vacant block on Olive Street approximately 400 metres ahead of the advancing fire front. The fire below the corner of Bass Avenue and Harrington Street was in a densely vegetated gully. The fire spread rapidly upslope towards the approaching main fire front. It appears that the smoke from each of these fires was drawn east towards the approaching fire front.

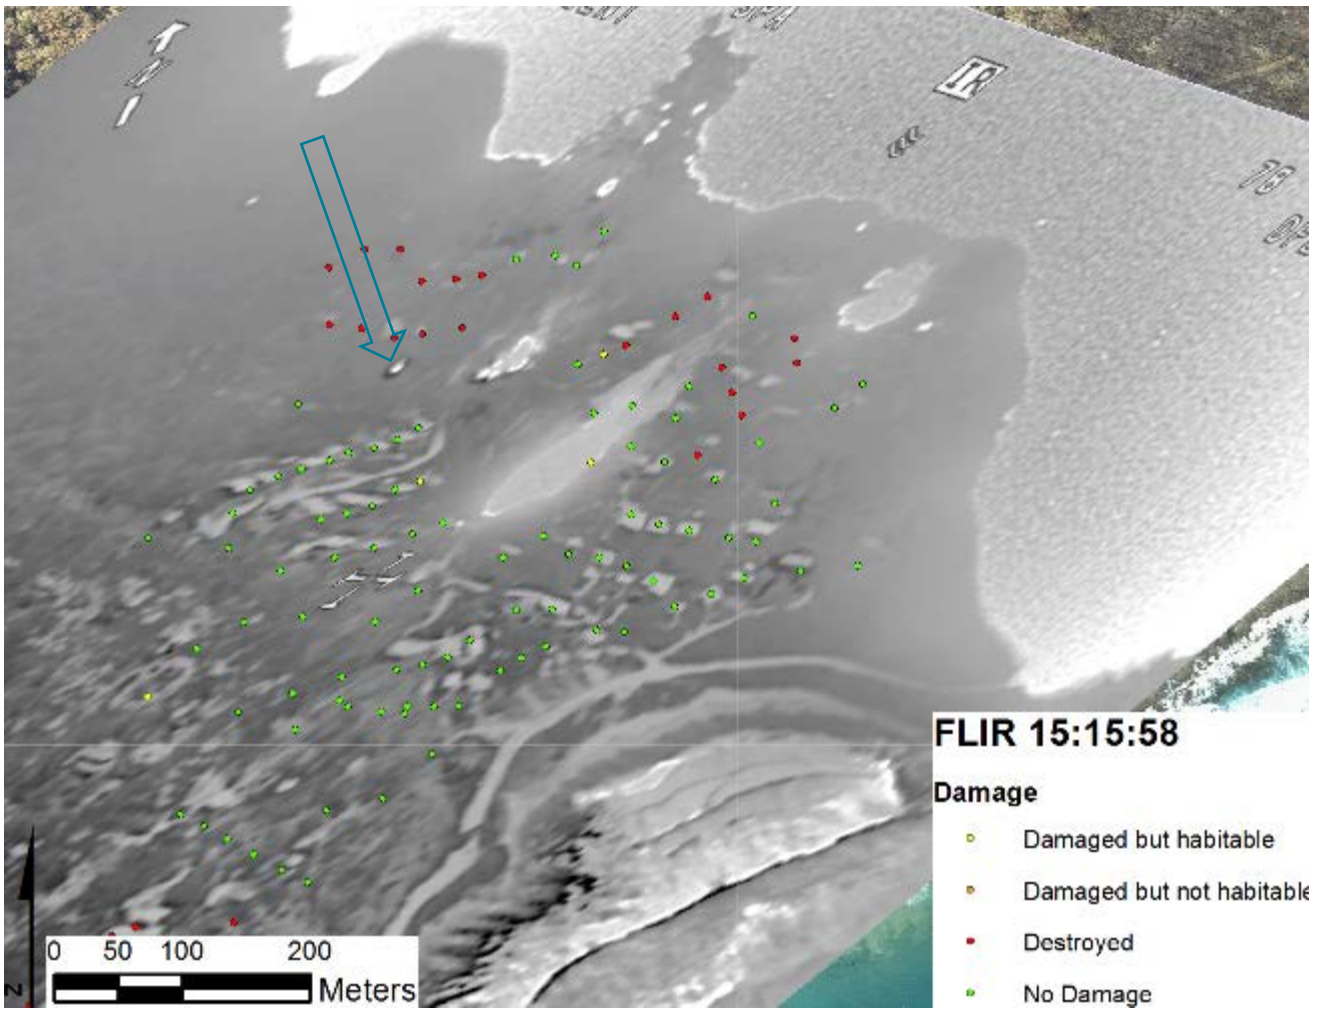
Figure 18: 15:15:58 Separation Creek fire arrival.

Figure 18 shows the same scene seven minutes later. All of the spot fires developed rapidly and were drawn back towards the advancing fire front. The fires near Mitchell Grove appears to also have developed rapidly. A new spot fire has developed adjacent to Bass Avenue and is marked by a blue arrow. The spot fire identified by the blue arrow in Figure 17 adjacent to Olive Grove has developed the most rapidly most likely due to a combination of slope and vegetation structure.

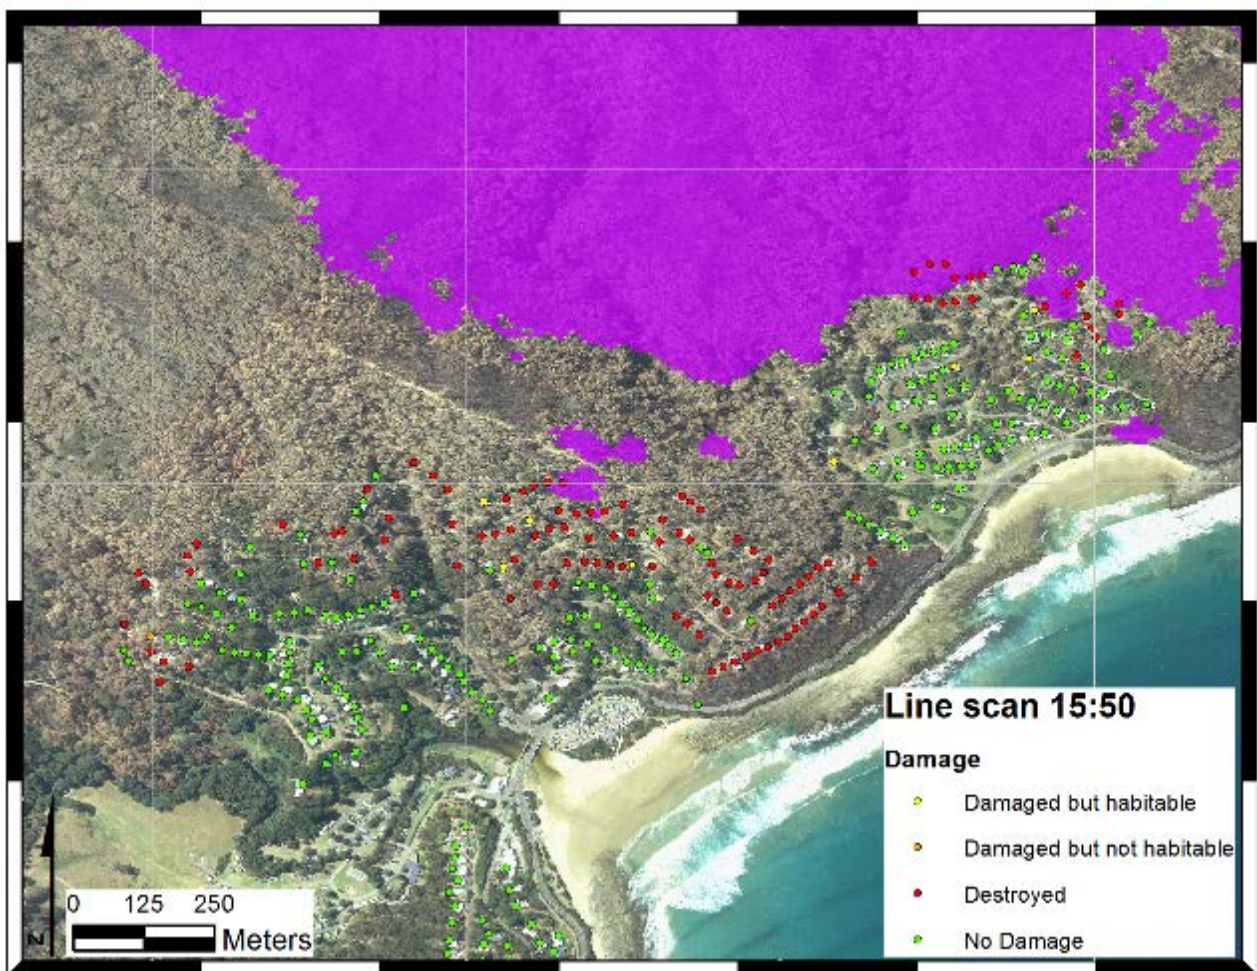
Figure 19: 15:50 Line scan.

The first line scan, taken once the fire had arrived in the townships at 15:50, is shown in Figure 19. The fire front arrived at the back of Separation Creek and started to burn downslope and merge with developing spot fires within Separation Creek. This fire activity appears to involve multiple houses.

The first spot fires developed along the ridge behind the perimeter of the Wye River township, adjacent to houses, a few hundred metres ahead of the advancing fire front.

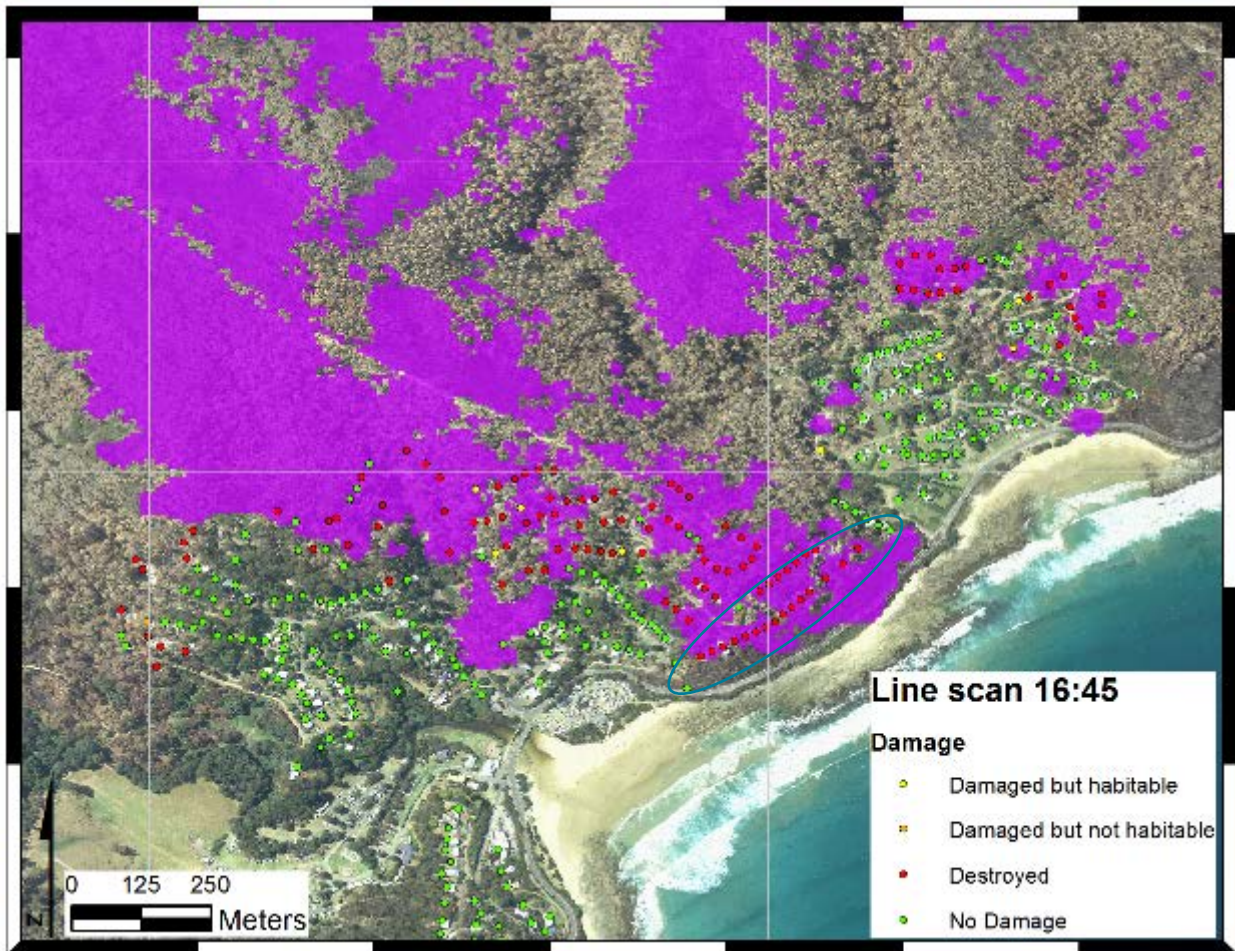
Figure 20: 16:45 Line scan.

Figure 20 is the second line scan taken 55 minutes later. The scan shows that the fire front moved past Separation Creek, with heat signatures evident from many of the burning houses in Separation Creek. Five additional spot fires seem to have developed within Separation Creek that appear to have led to some house damage but no complete losses, possibly due to the fire-fighting activities around these isolated spot fires. The main heat signatures are from the combustion of houses within Separation Creek, indicating that nearly all houses lost in the region are at this time ignited. The two regions where extensive house losses occurred would most likely have been too difficult to access due to the large number of simultaneous house fires in close proximity.

This line scan (Figure 20) also shows the Wye River township in the middle of a fine fuel burn through phase. The combination of ground observations and this image suggests that the area was impacted with embers emanating from behind the township, creating many simultaneous ignitions of surface fuels throughout the fire-affected areas of the Wye River township. This mass ignition and rapid fine fuel spread would have presented a major hazard to fire fighters and residents (if present) in this region. The foreshore area below Iluka Avenue (marked with a blue circle) appears to have developed from a series of spot fires that merged and ran upslope into and past houses along the street.

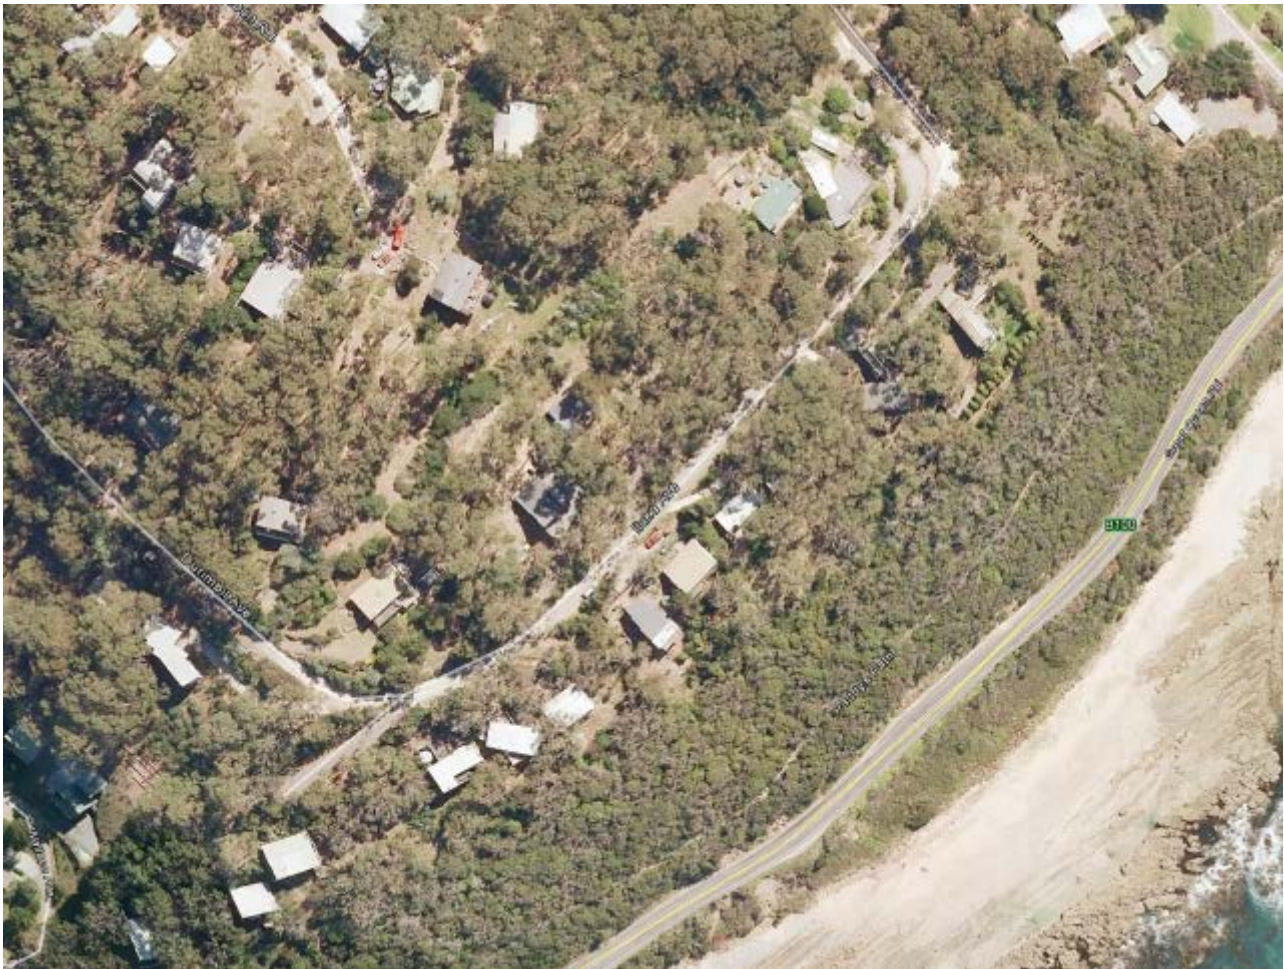
Figure 21 is a pre-fire image of this region highlighting the extent and separation distance between the houses and vegetation. The slope in this coastal vegetation is such that flame fronts formed against the prevailing wind with enough intensity to generate radiation levels and possible flame contact sufficient to ignite houses.

Figure 21: Image showing the location of Iluka Avenue and coastal vegetation ignited by embers.

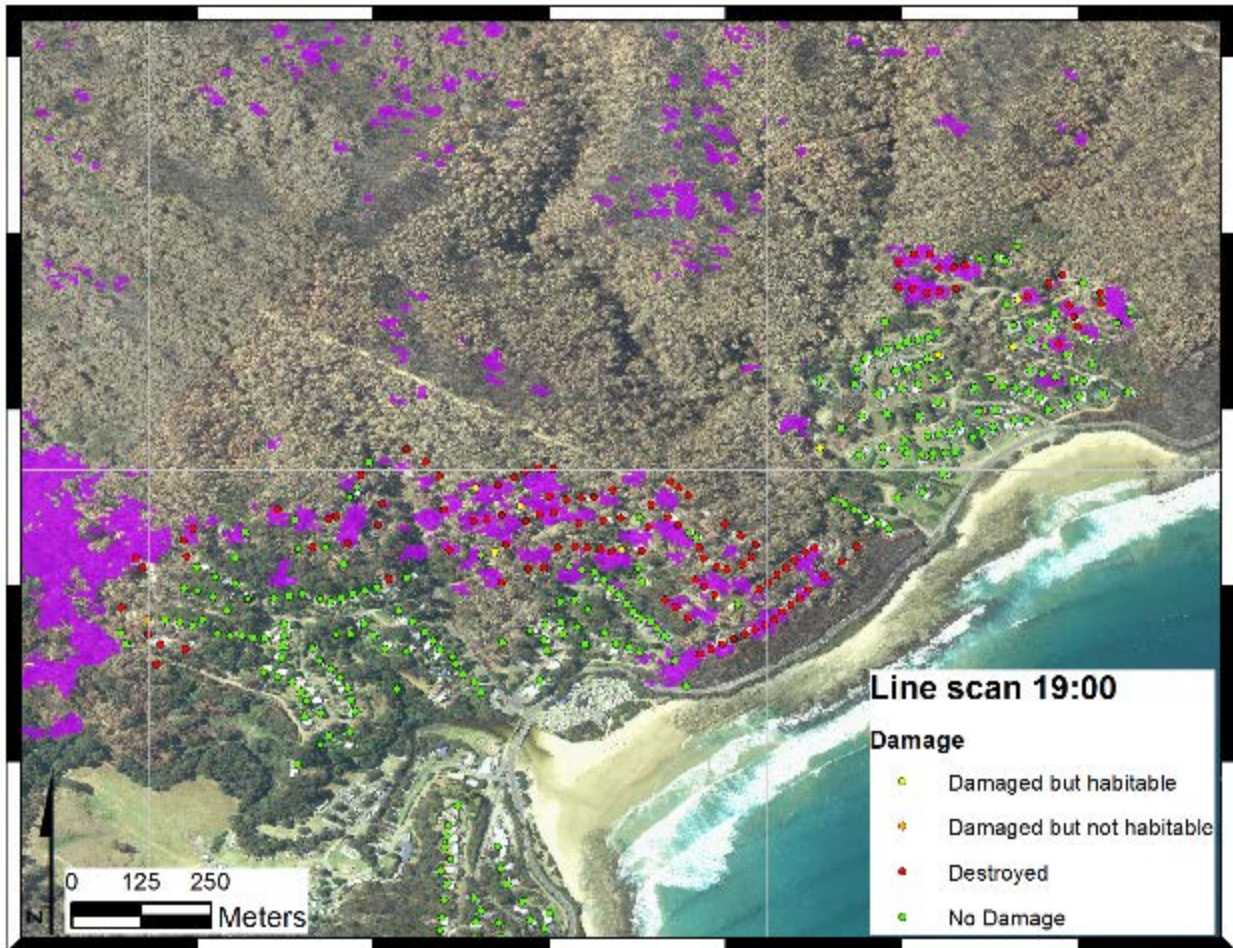
Figure 24: 19:00 Line scan.

Figure 24 was taken one hour later at 19:00. The scan shows clear heat signatures from nearly all burning houses in Separation Creek but the more defined and isolated patches indicate a reduction in overall intensity.

The fine fuel burnout phase had also passed the Wye River township except in the westerly extent, where there is a heat signature over a broad area including areas where houses were lost; these may have already ignited or were in the process of being ignited. At this stage nearly all of the fire affected houses in Wye River appear to be either ignited or were in the advanced stages of burning out.

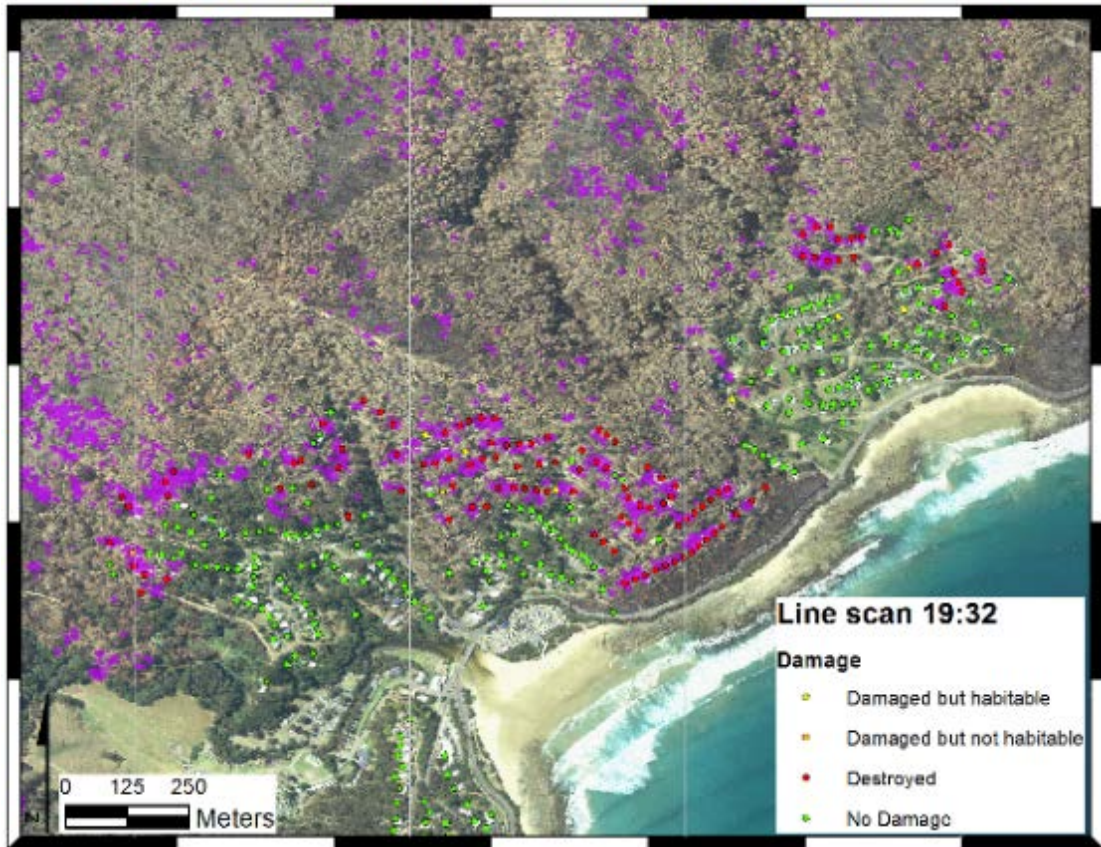
Figure 25: 19:32 Line scan.

Figure 25 was take at 19:32, 32 minutes later. This shows that all fine fuel burn out was complete with heat signatures present for nearly all houses that were lost in the fire event. These heat signatures continued to reduce in size except for those in the westerly extent of the image.

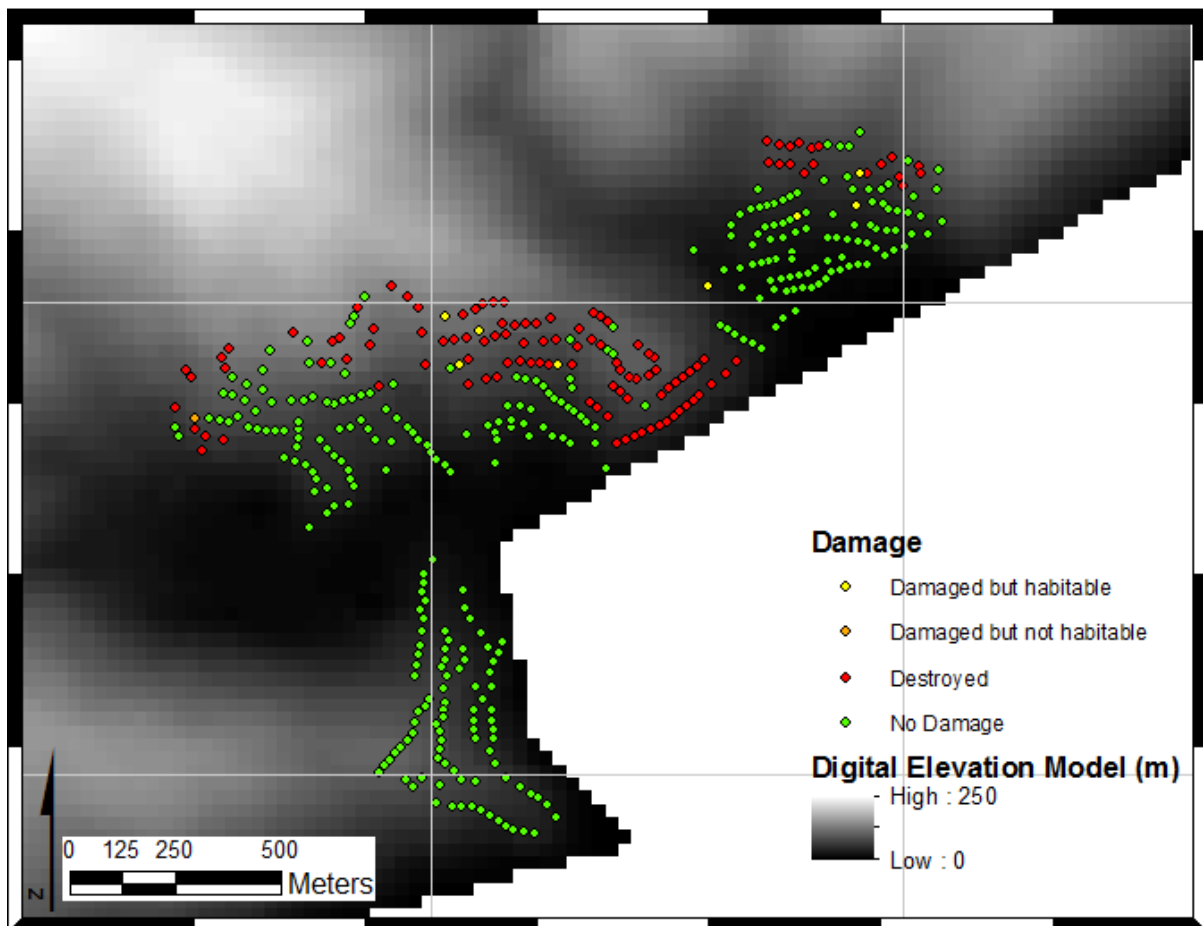
Fire-impacted areas of Wye River and Separation Creek were typically the steepest areas, which reach gradients approaching 30 degrees (Figure 29).

Figure 29: Digital elevation model for the townships of Wye River and Separation Creek showing house damage (based on Shuttle Radar Topography Mission (SRTM) data).

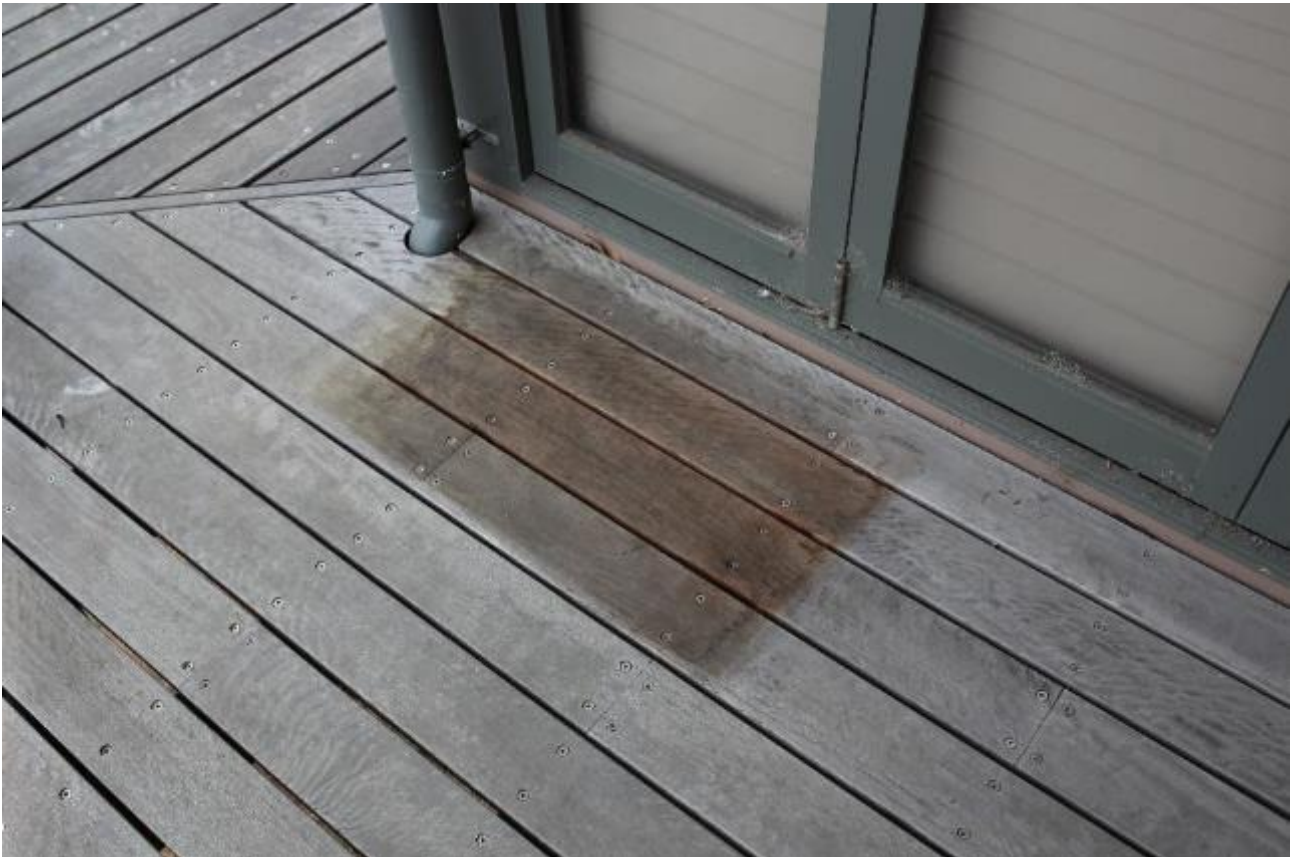
Figure 32: An example of the removal of a doormat from a deck.

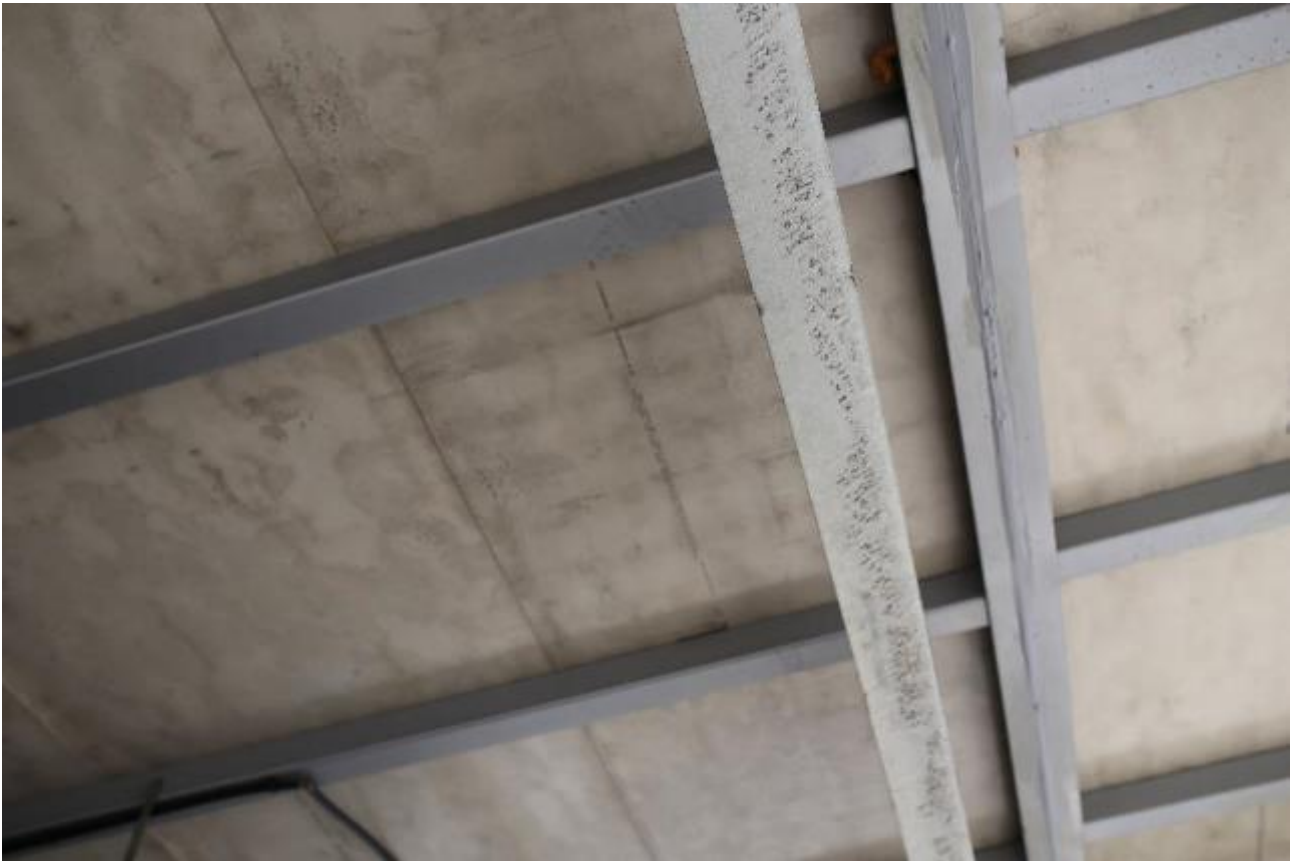
This house was built to the BAL-40 construction requirement. It is of modular construction, utilising steel for its supports and internal framing. The cladding is also metal, as is the window framing material. The underfloor area of the house is not clad, and instead uses non-combustible James Hardie Scyon flooring sheets (see Figure 36).

Figure 36: Under floor system, steel and James Hardie Scyon flooring.

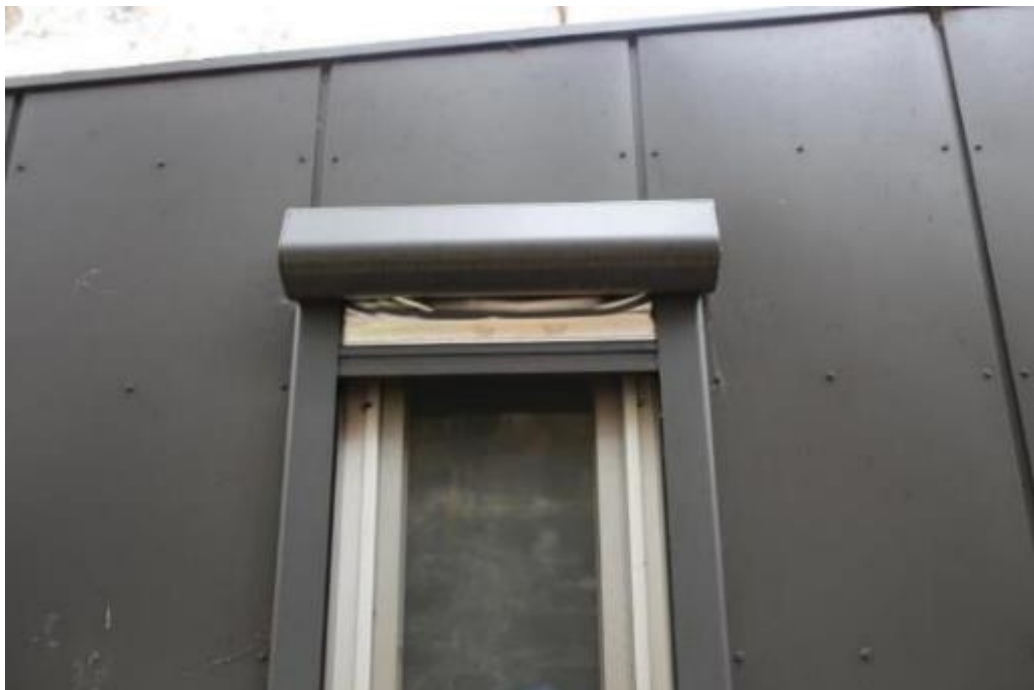
The BAL-40 compliant windows utilised a flexible pull down fire shutter as shown in Figure 43. These shutters were not deployed during fire exposure but radiation levels were not sufficient to cause damage to the exposed windows.

Figure 43: Window with pull down fire shutter.

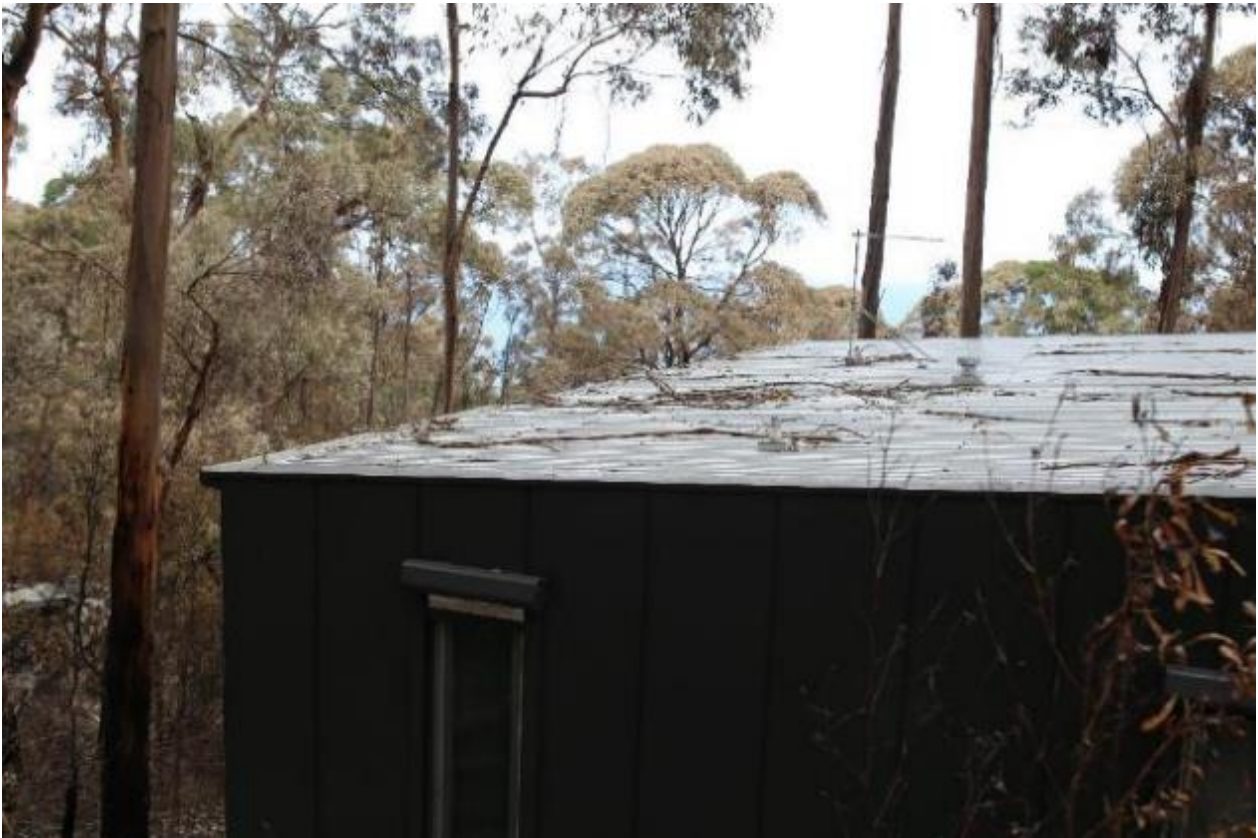
The inclusion of gutter guards and a simple roof profile also appeared to limit the likelihood of a roof ignition (Figure 44).

Figure 44: Simple roof profile with metal gutter guards.

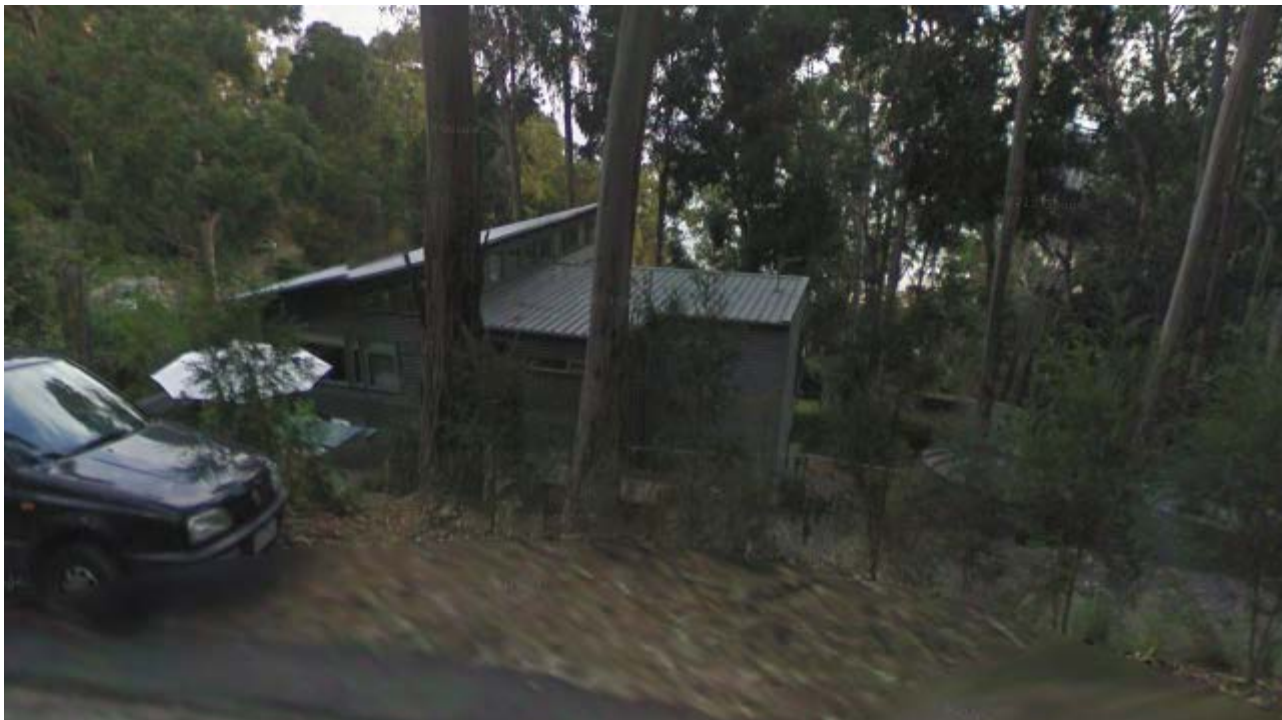
Figure 47 provides an indicative photo of the house design and surrounding vegetation elements in the years preceding the fire event. The house appears to have had a non-combustible facade and metal clad roof. It also appears to have had treated pine retaining walls running up to and under the house.

Figure 47: Indicative photo from Durimbil Avenue at February 2010 (Google Street View).

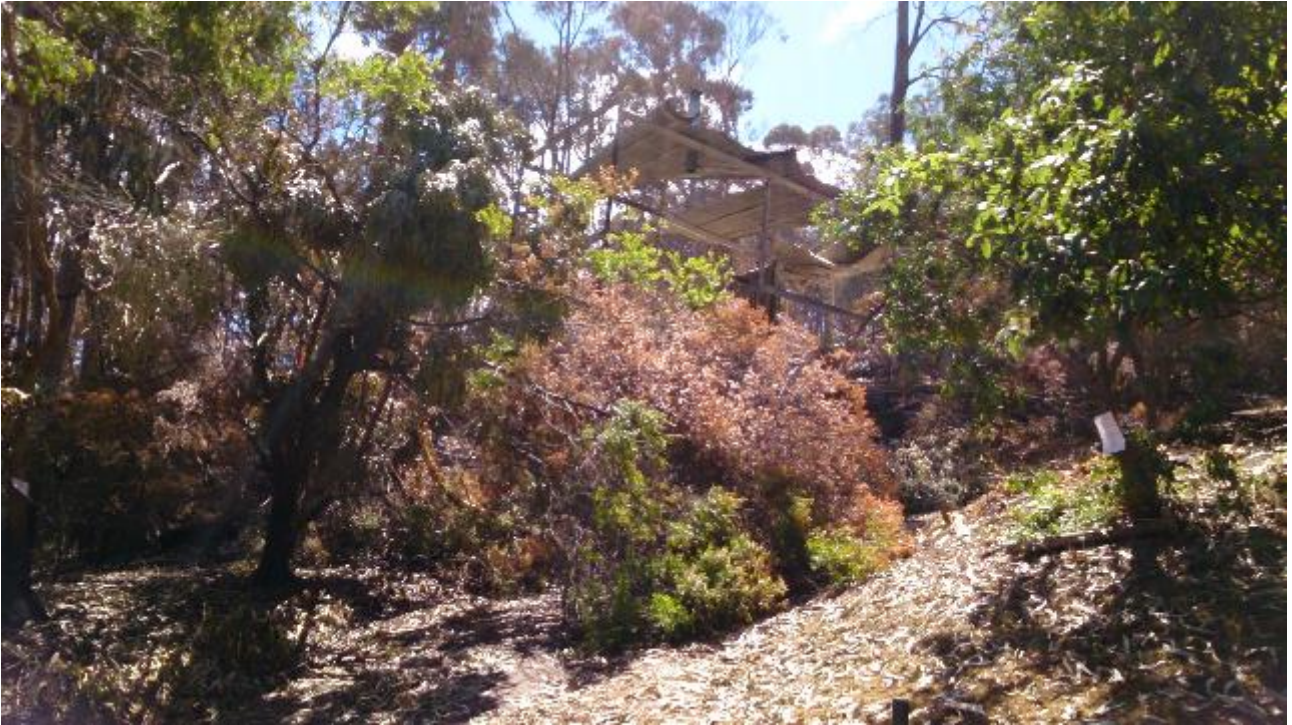
This house was exposed to a low-level surface fire, which followed the slope moving up to and past the building. This location was impacted between 15:30 and 16:45 by a fine fuel burn through. The fine fuel spread appears to have occurred below the shrubs, which received some leaf scorch as it passed (Figure 48 and Figure 49).

Figure 48: House on Durimbil Avenue showing intact elevated vegetation adjacent to building.

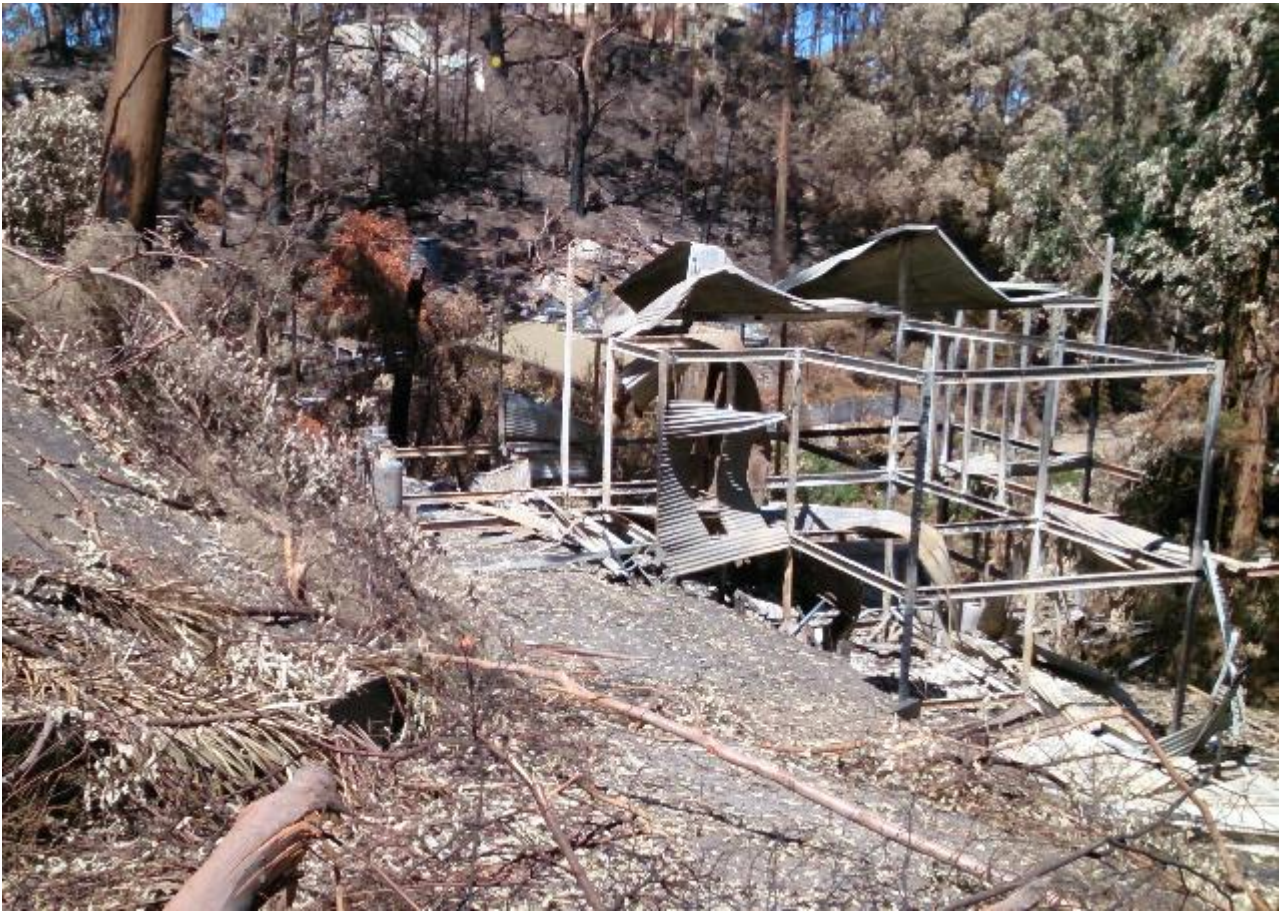
This house may have ignited from a variety of processes, if ember attack, including low-level fire spread, did not directly ignite the house it is likely that the combustion of the decking and retaining walls, and LPG pressure vessel flaring, would have caused ignition of the house.

The flaring from these pressure vessels pointed directly towards the house (Figure 52).

Figure 52: House on Durimbil Avenue showing house and location of pressure vessels.

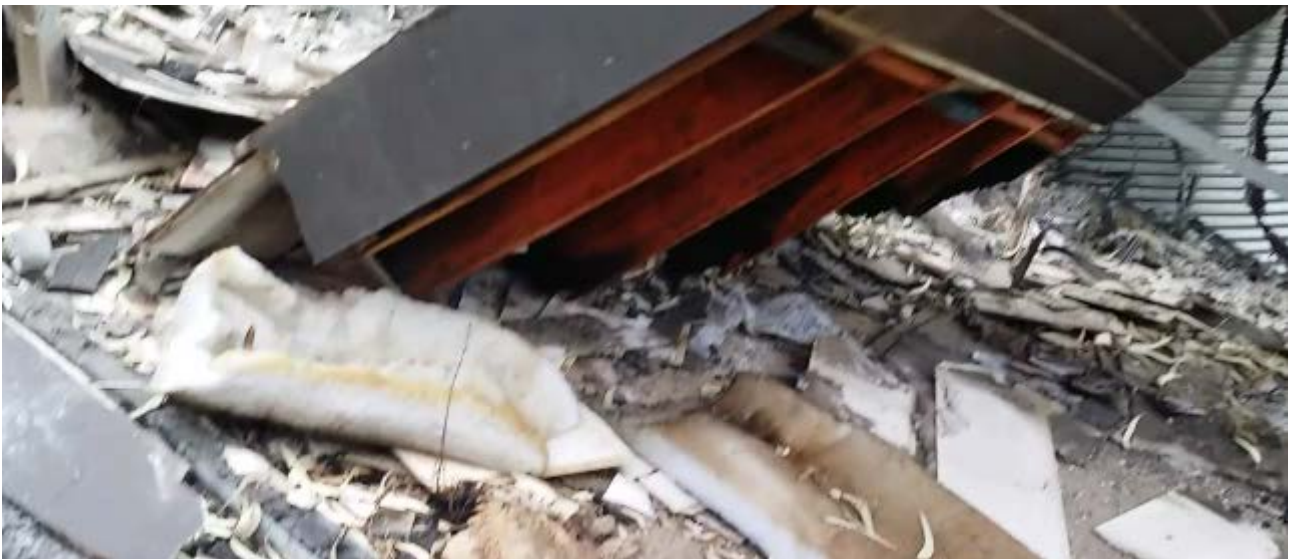
The floor system including the decks was supported by steel piers and major steel beams. Timber minor beams were evident under the non-combustible subfloor cladding (Figure 55). The decking surface was non-combustible.

Figure 55: 17 Subfloor construction.

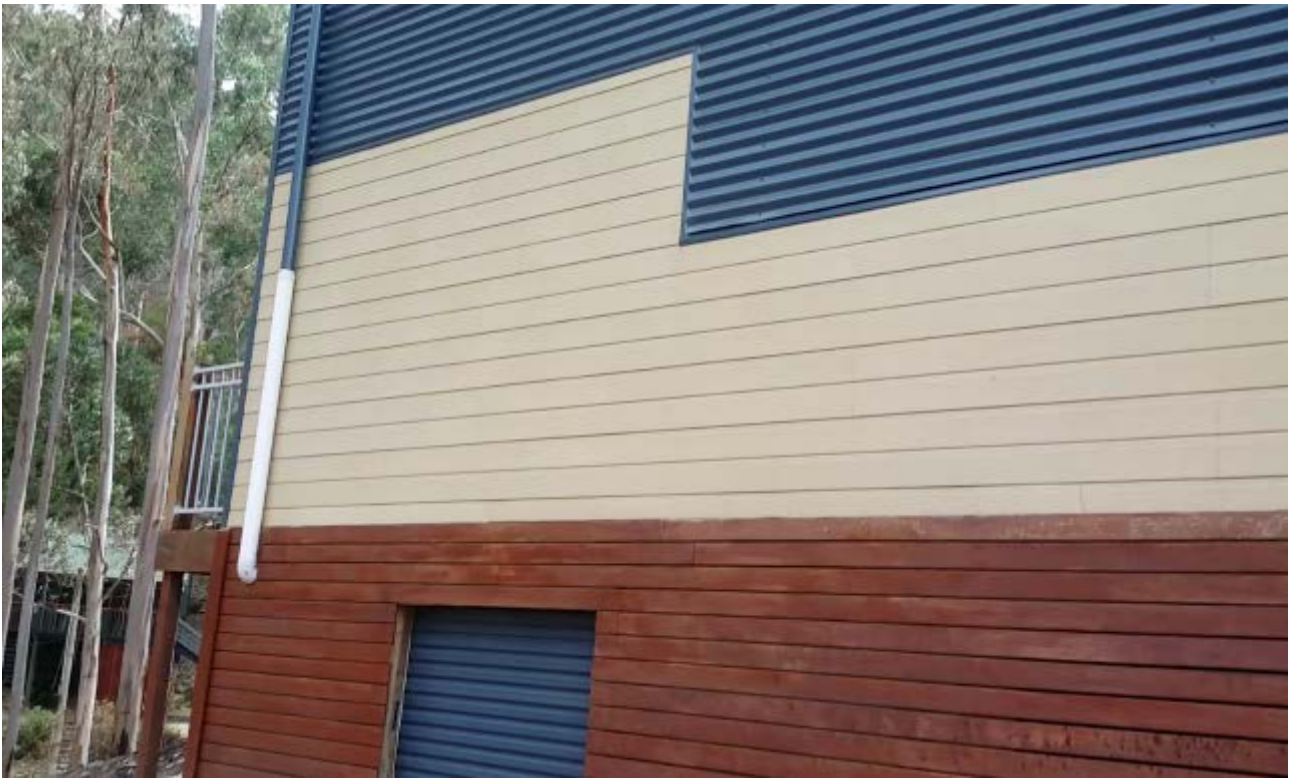
This house was completed in April 2006 and was categorised as Medium. The building is clad with two different systems, Colorbond steel and painted timber weatherboards. The house has a timber subfloor that is semi enclosed with gapped timber boards (Figure 66 to 68). The gaps between the battens is in excess of 6mm.

Figure 65: Cladding of walls and sub-floor

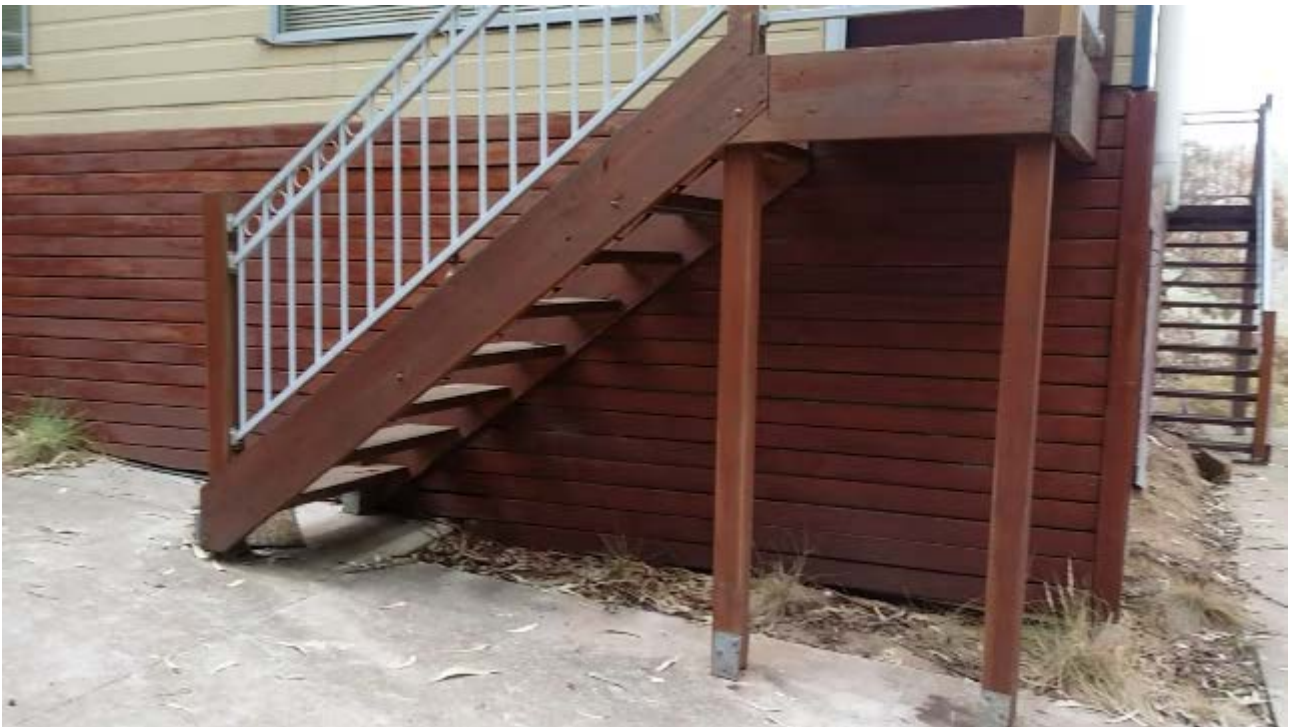
Figure 66: Concrete apron, house to surface fuel orientation, and surface fuels present after the fire.
