**Wye River and Separation Creek -
Geotechnical, Land Capability and
Wastewater Solutions**

Geotechnical Assessment

31 March 2016

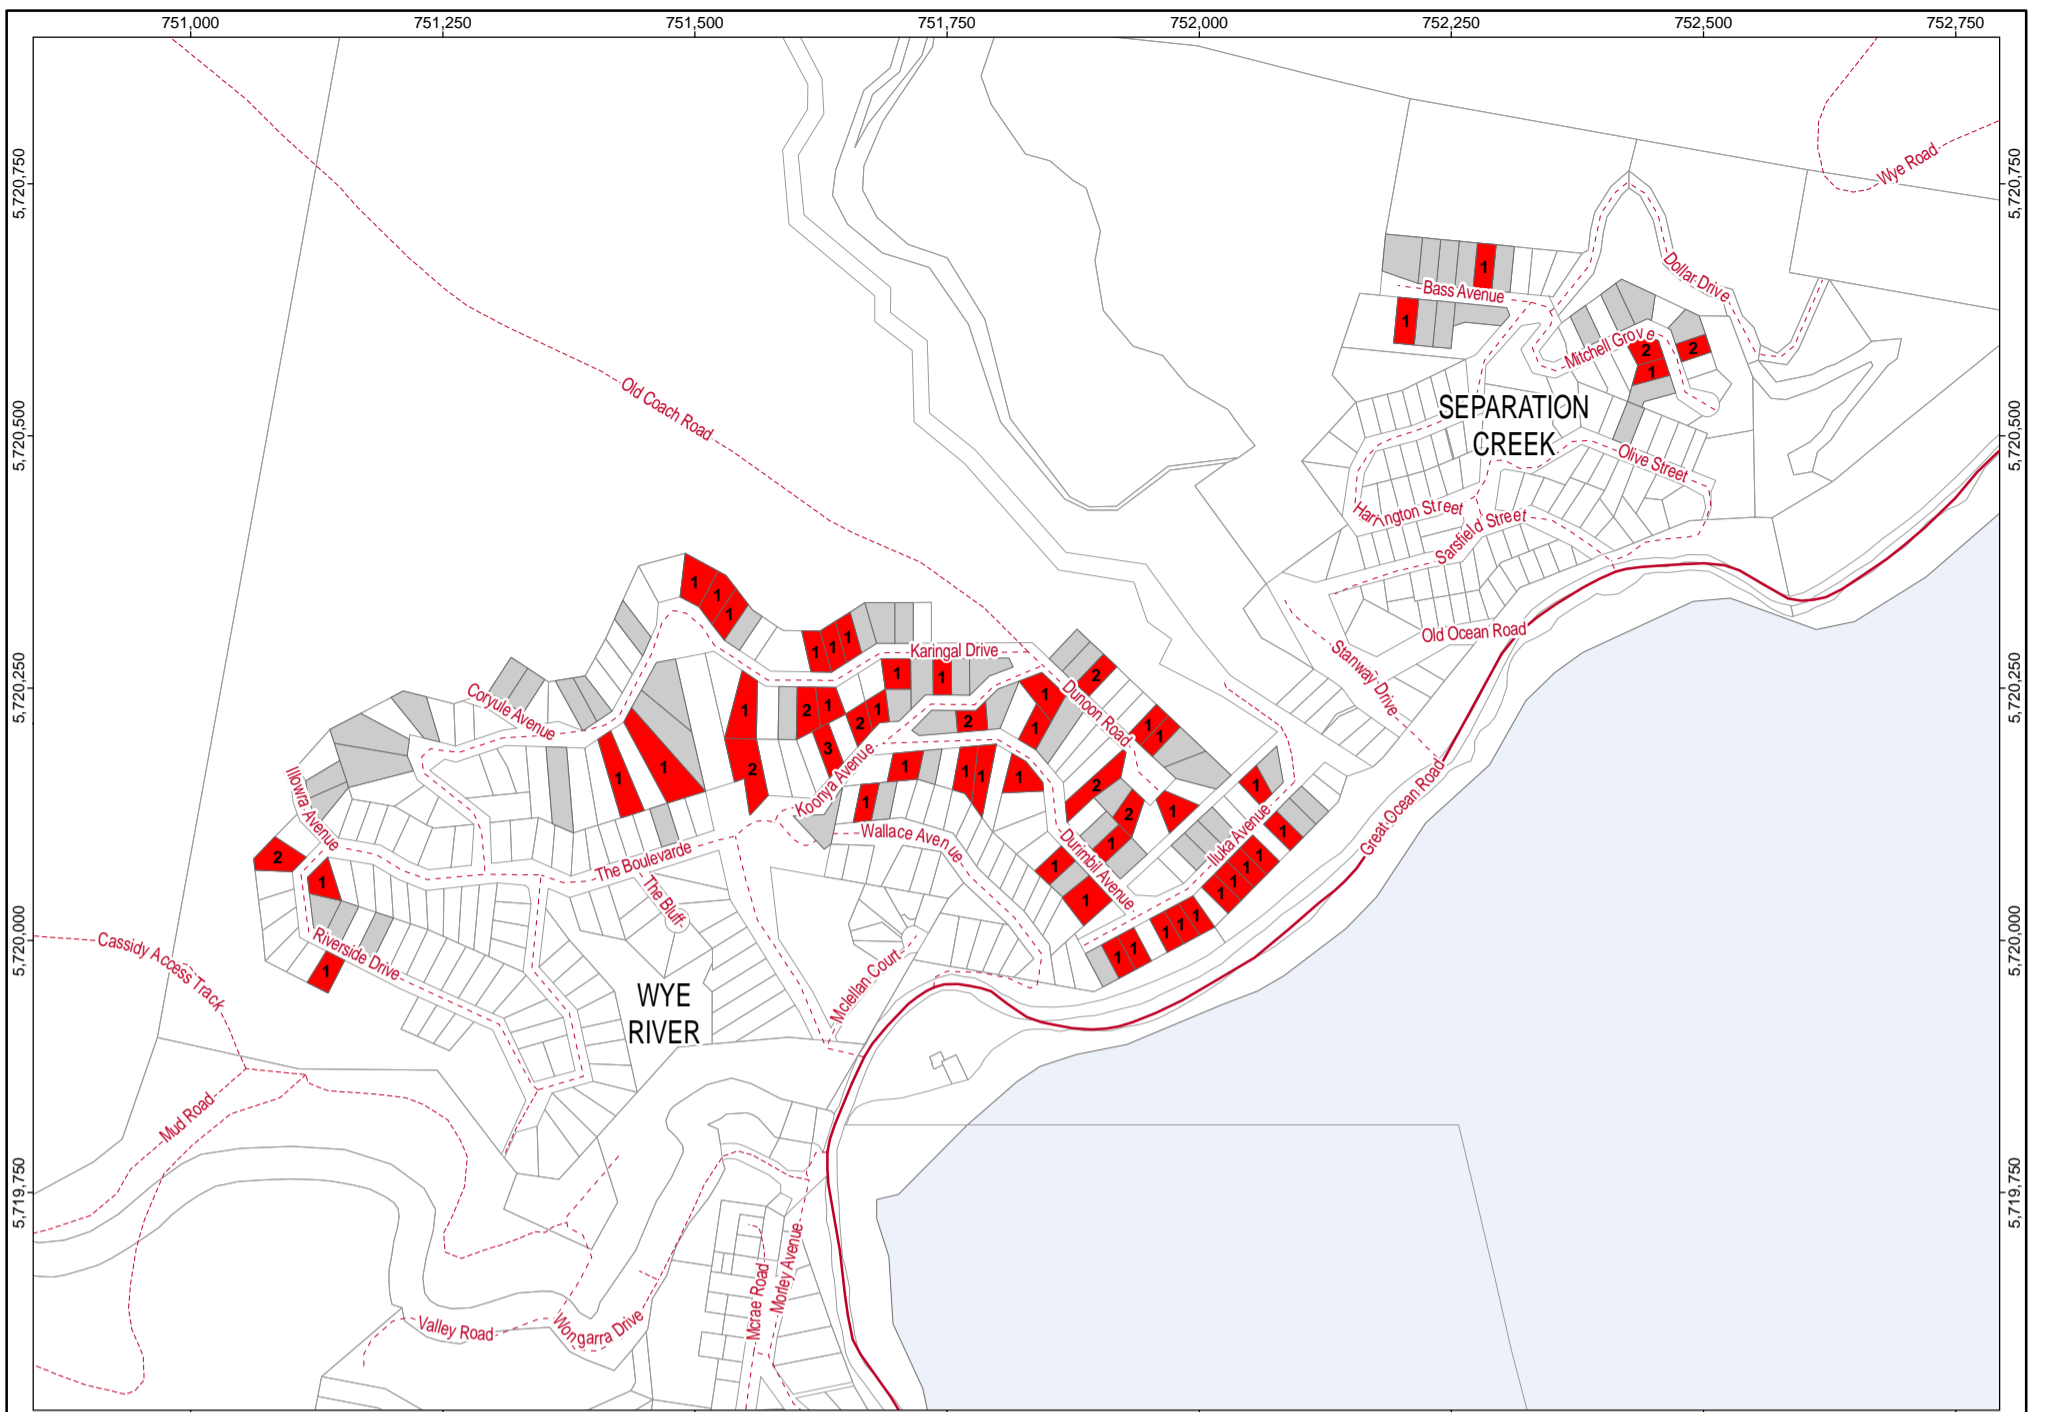
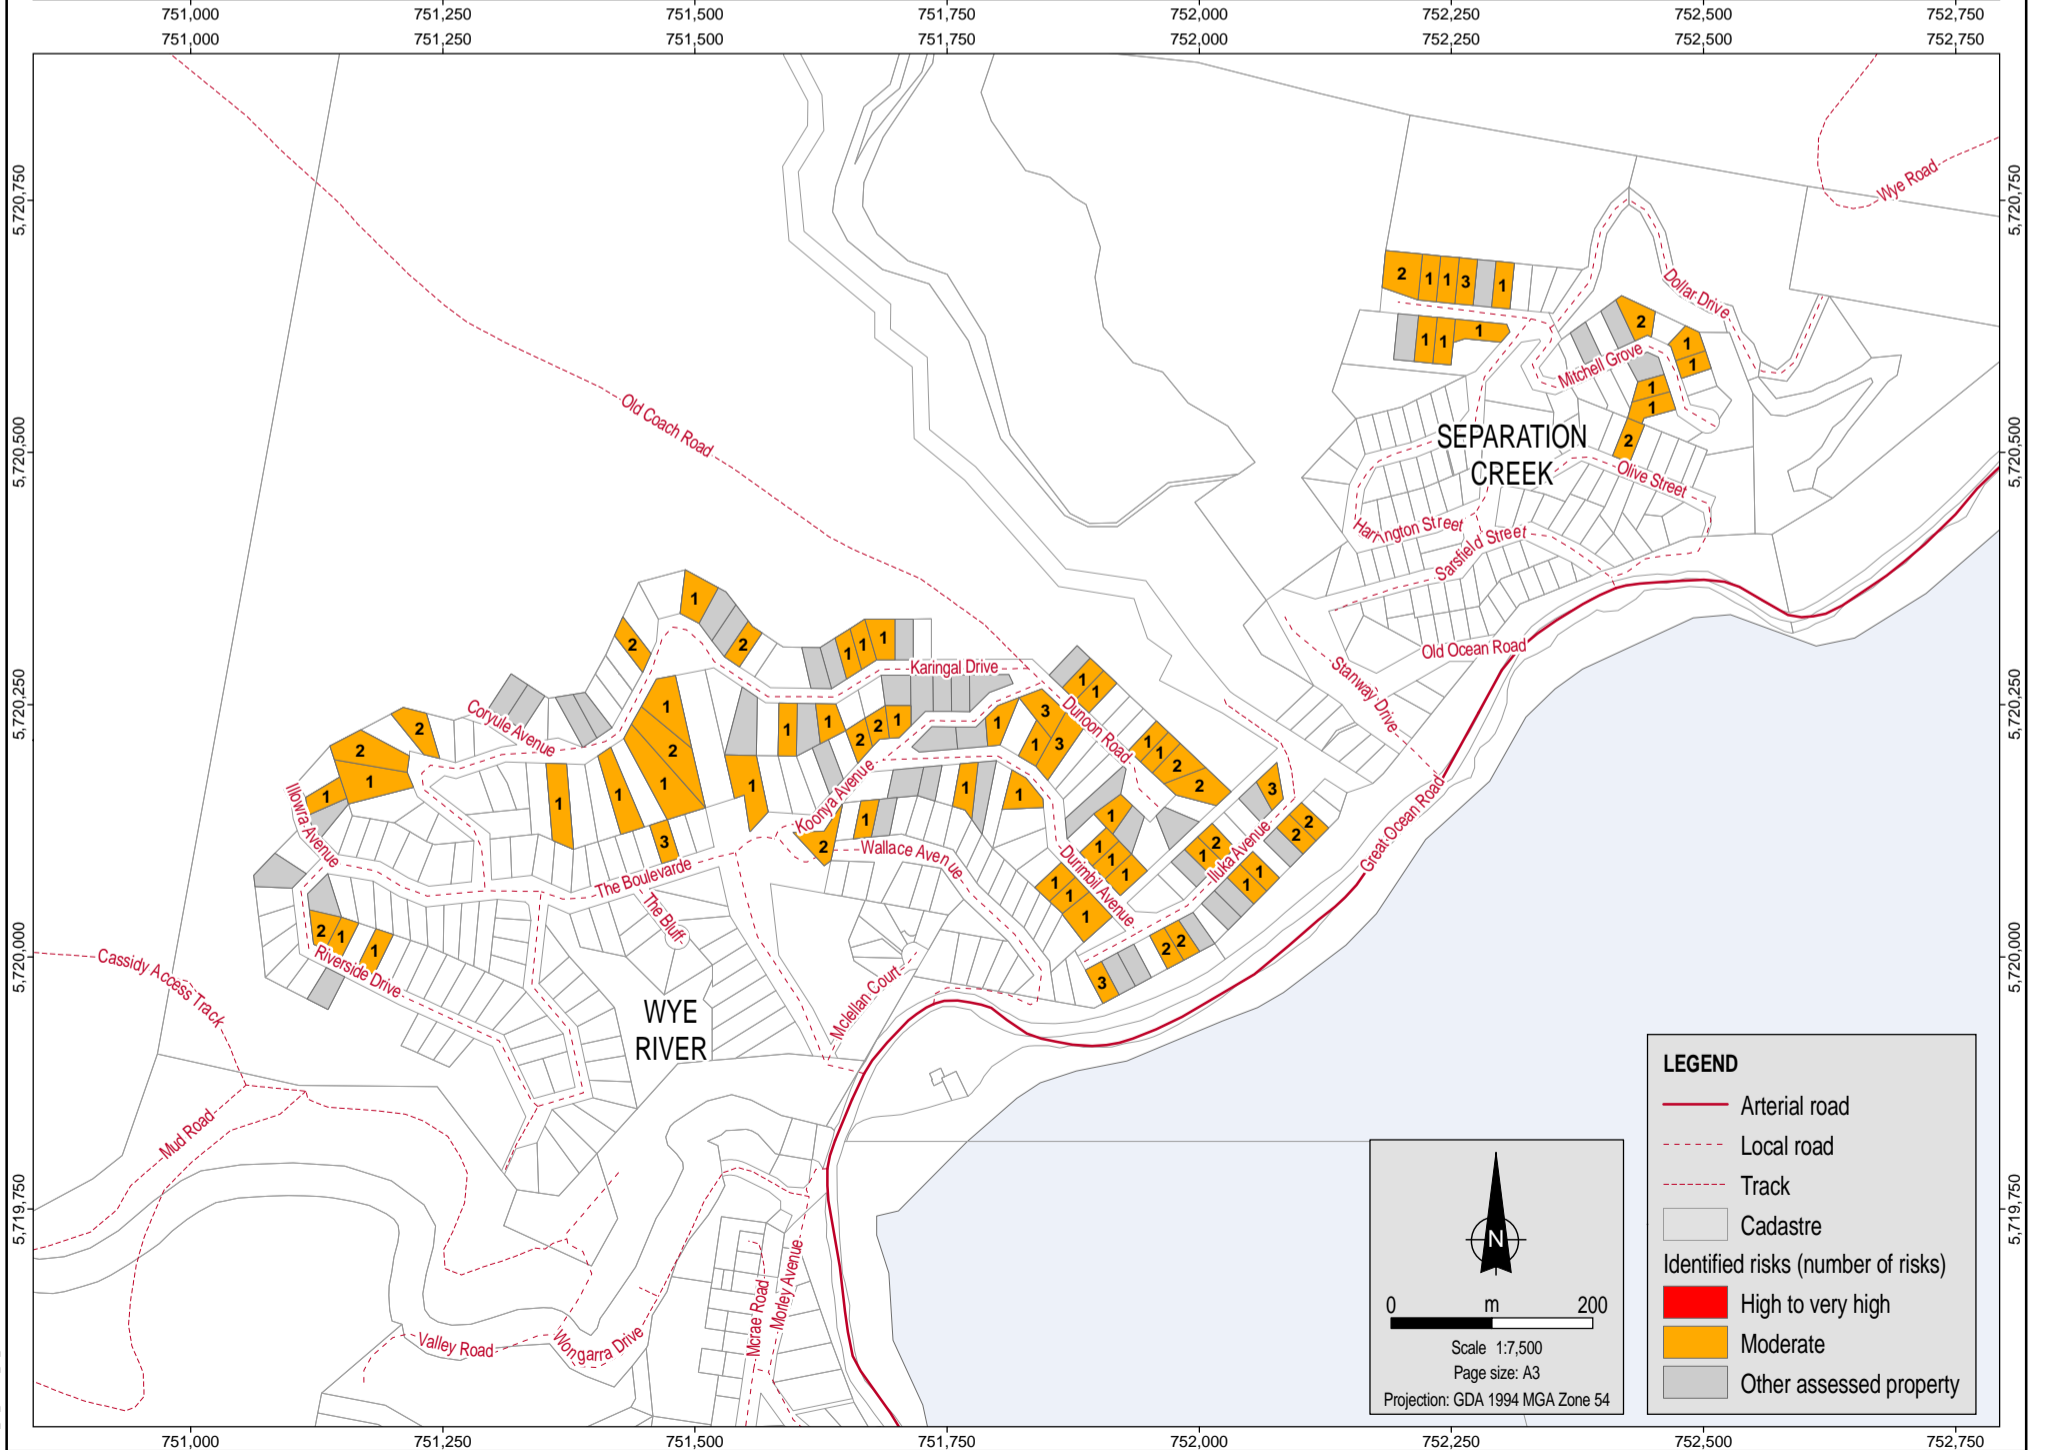
Figure 4 and Table 3.1 present information about the known active landslides in the immediate Wye River - Separation Creek areas. There are three large active landslides and all these large active landslides lie beyond, and will not impact upon the properties that are the subject of this study.

We considered the more plausible hazards at the 109 sites we visited in the field. Of the hazards identified and given a risk rating in accordance with AGS 2007, there were 10 considered to be 'Very High' and 48 considered to be 'High'. The property locations of the Very High, High and Moderate hazards are shown in Figure 4.
